Building Performance Evaluation

A design approach for refurbishment of a small traditional building in Scotland

Land Sea and Islands Centre - Arisaig

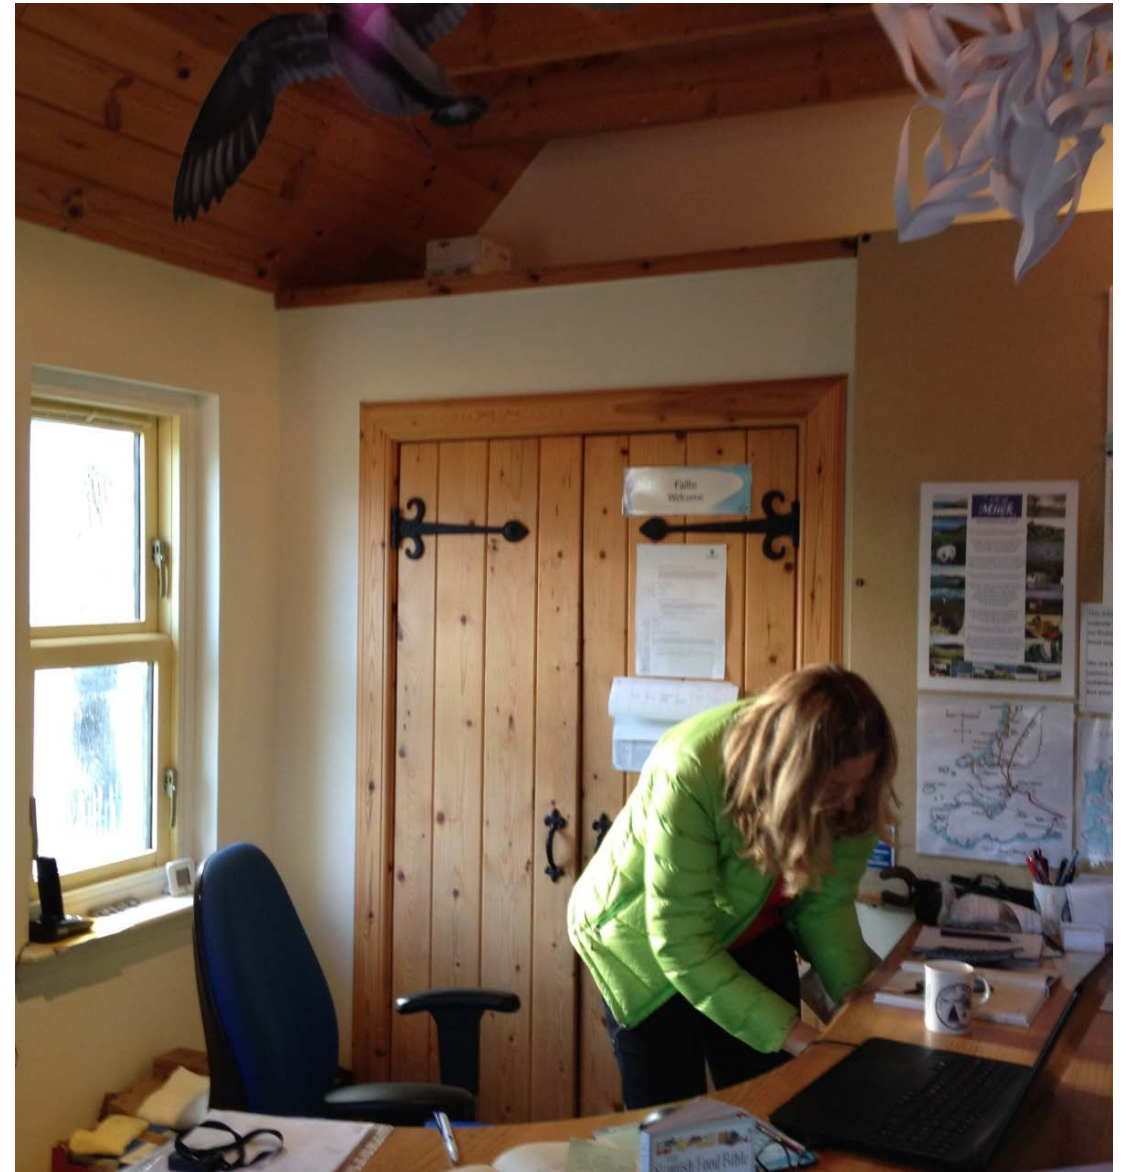
- Internal temperature too cold
- Bulk up with layers in winter
- Building too draughty in winter
- Heating on all of the time
- Condensation forming on some windows
- Not certain how to operate all controls in the building

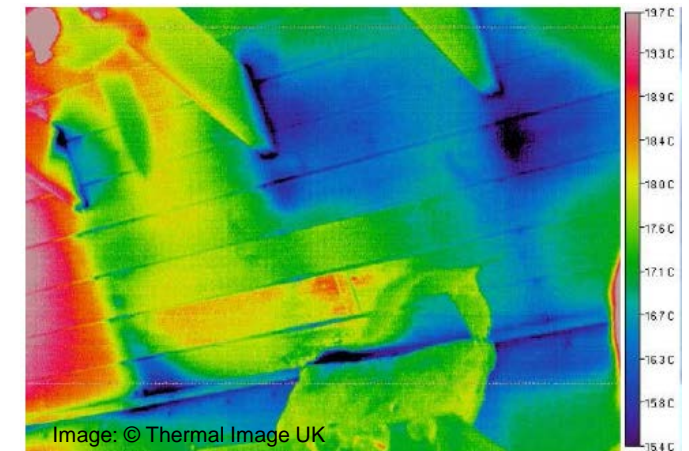
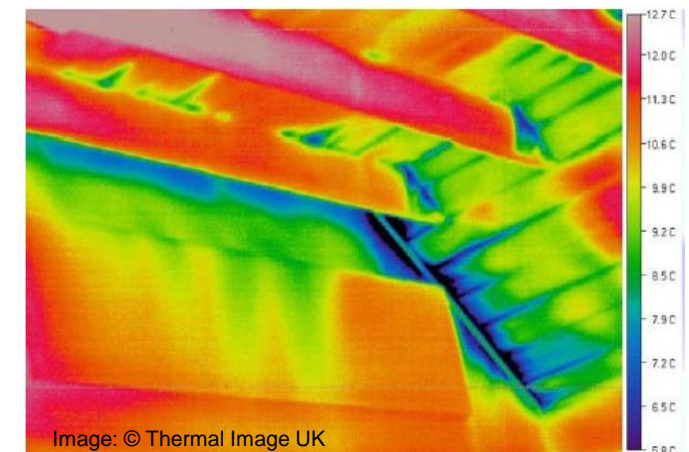
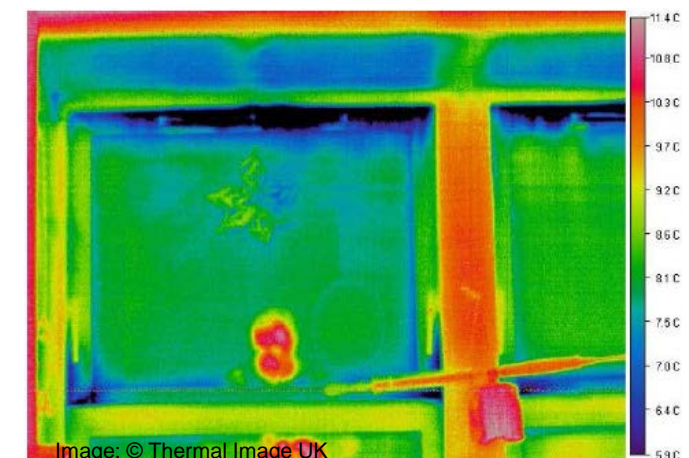
- Joist ends
- Wall junctions
- Window heads and sills
- Pipe penetrations
- Electrical penetrations
- Air permeability - 18.04 m³/h.m² @ 50Pa
- Air changes per hour ~ 0.9ACH

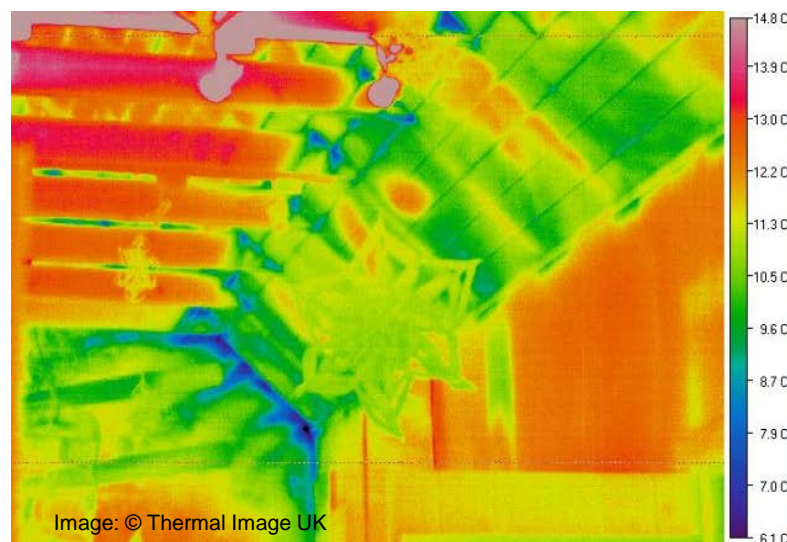
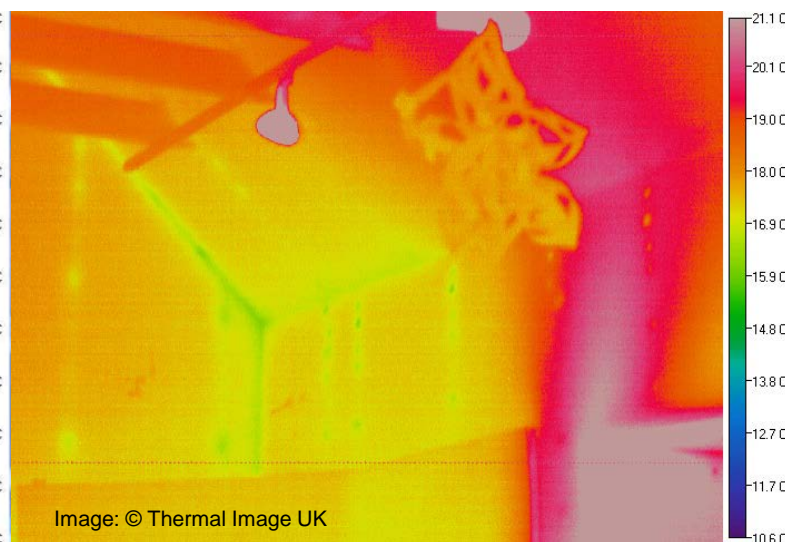
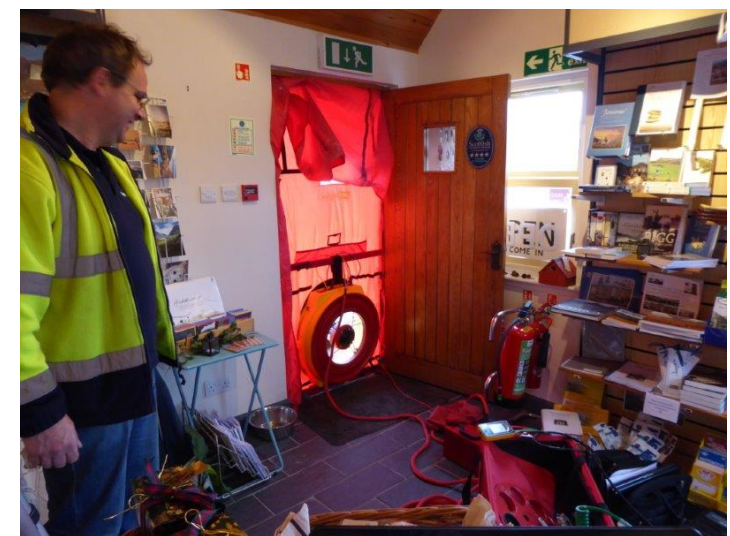
Air permeability – 85% Reduction infiltration to the building
