Building Performance Evaluation – A design approach for refurbishment of a small traditional building in Scotland

J. A. Foster¹, A. Poston¹ and S. A. Foster².

¹Mackintosh Environmental Architecture Research Unit, The Glasgow School of Art (GSA), Glasgow, G3 6RQ, UK. j.foster@gsa.ac.uk

²Sam Foster Architects (SFA), Dunfermline, Fife, KY12 8HZ, UK. sam@samfosterarchitects.co.uk

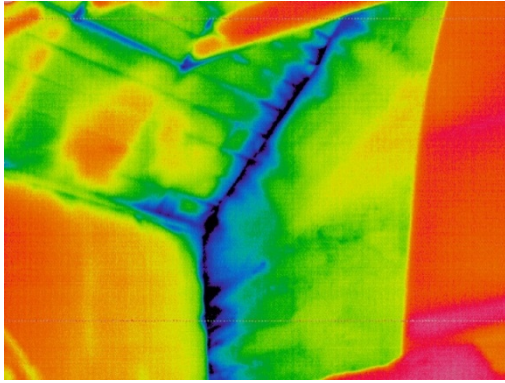
replacement roof (added in 1999) connected to the existing stone building (Figure 4). The most significant air entry points were at all joist ends, mains electricity incoming cable and the soil vent pipe adjacent to the WC. In addition, the infrared thermography identified areas of incomplete insulation, where a consequence of this was localised cooling and an increased risk of condensation.

Figure 4. Thermogram of the uninsulated north gable junction with the insulated west wall and ceiling. This indicates significant air leakage at joist ends, cool spots behind timber ceiling and air ingress at the corner.

The architect had previously developed an airtightness strategy for the building, however, the extent of air leakage pathways identified were unexpected. There were significant infiltration pathways at the vertical junctions associated with the later building additions, as well as at both ends of the exposed roof trusses, also added in 1999. These weak points in the building fabric provided a means for unheated outside air to infiltrate the building, move freely behind the plasterboard and timber lined ceilings, entering the building at joist ends, sockets outlets and light switches which were detected in the building as draughts. In response to this the architect developed a sealing method for these using flexible vapour open building materials and added these to the drawings which identified a need for one single person from the contracting team to be an airtightness champion.

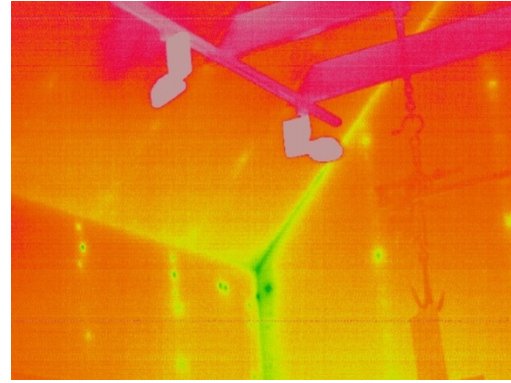
Figure 5. Thermogram of where the newly insulated and lined north gable junction with re-insulated west wall and ceiling. This indicates no cooler areas at joist ends, and a slightly cooler area at the corner.
