# Building Performance Evaluation

Lessons from studies of 26 Scottish low-energy homes

**MEARU: J Foster**

December 2018

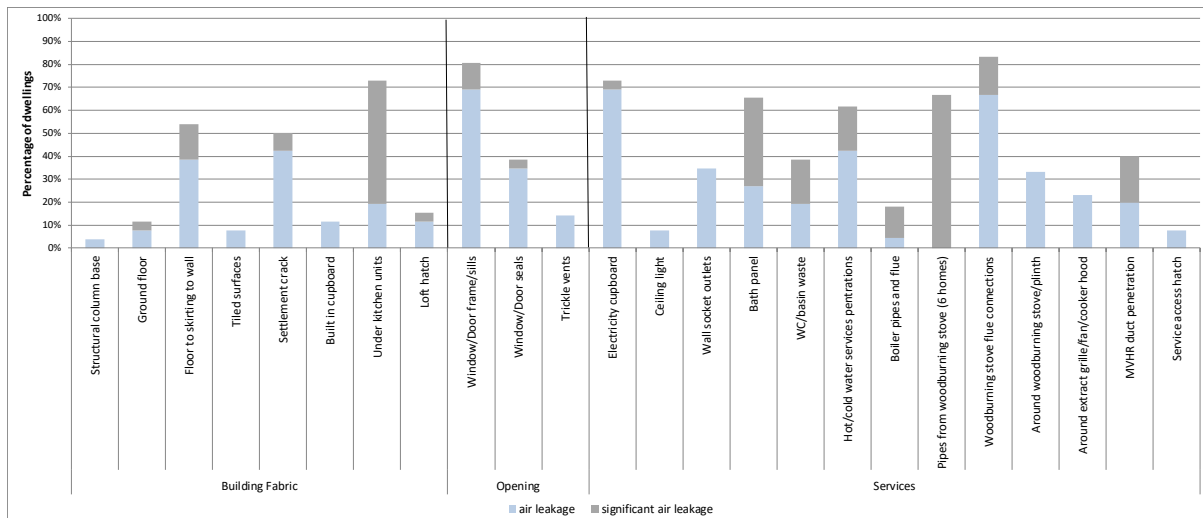
Air leakage from around the edges of window and door frames, and beneath window sills, were found in over 80% of the dwellings. Air leakage was commonly identified at pivot hinges at the top and bottom of side hung sash casements. 70% of dwellings had air leakage occurrence in the cupboard associated with the incoming electrical supply cable that entered the properties. It is also of note that 60% of dwellings exhibited air leakage around the bath panel. This was found to be significant in the majority of homes where some occupants reported feeling cold draughts in their bathrooms. Six dwellings (four in Dormont Park and two in Scotland's Housing Expo site) were fitted with wood burning stoves. Testing around the stove installations identified air leakage at the air supply flue, exhaust gas flue and, in Dormont Park, penetrations associated with the route of the piped hot water service connections.

**Figure 3: Common areas of air leakage identified during air permeability testing.**

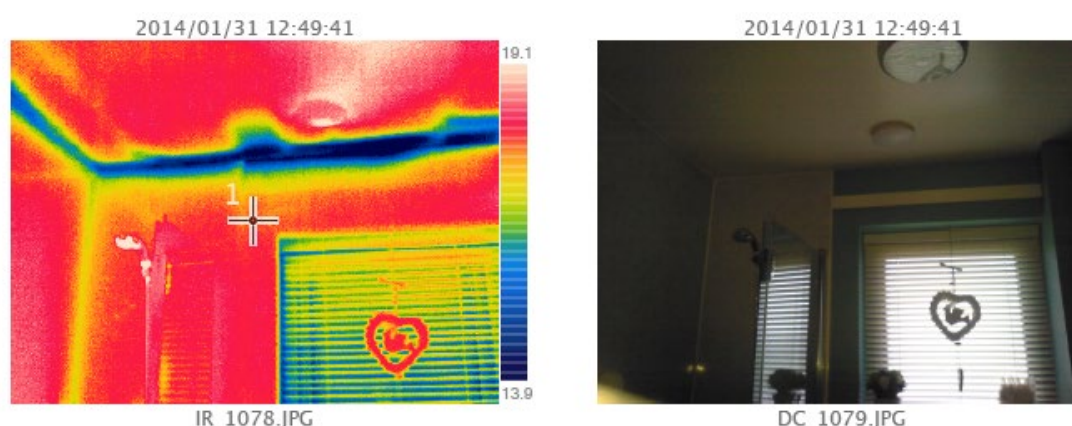
Common areas of fabric weakness were identified across all developments. These include skirting boards, wall heads (Figure 4), eaves details, loft hatches (Figure 5), areas around entrance doors and the doors leading to gardens or balconies.

Figure 4: Significant cold areas at ceiling and external wall junction in first floor bathroom.

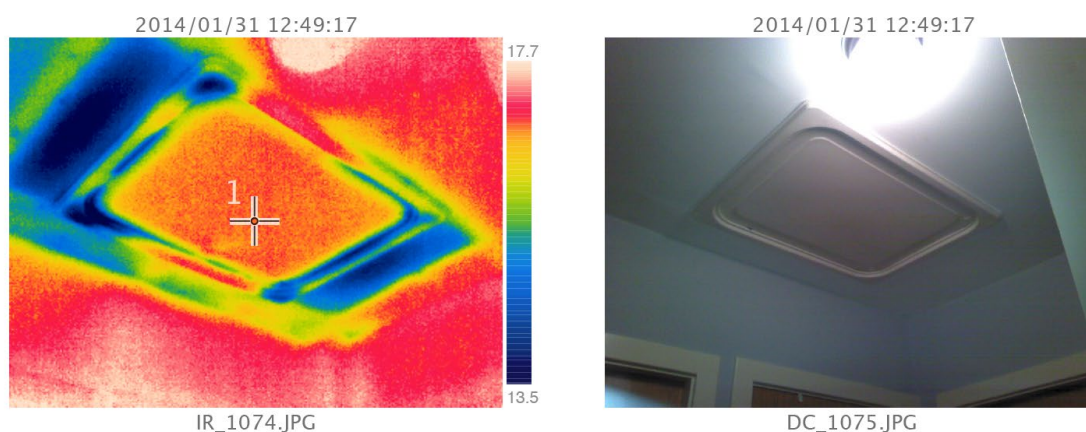
Figure 5: Missing insulation and heat loss around loft hatch.

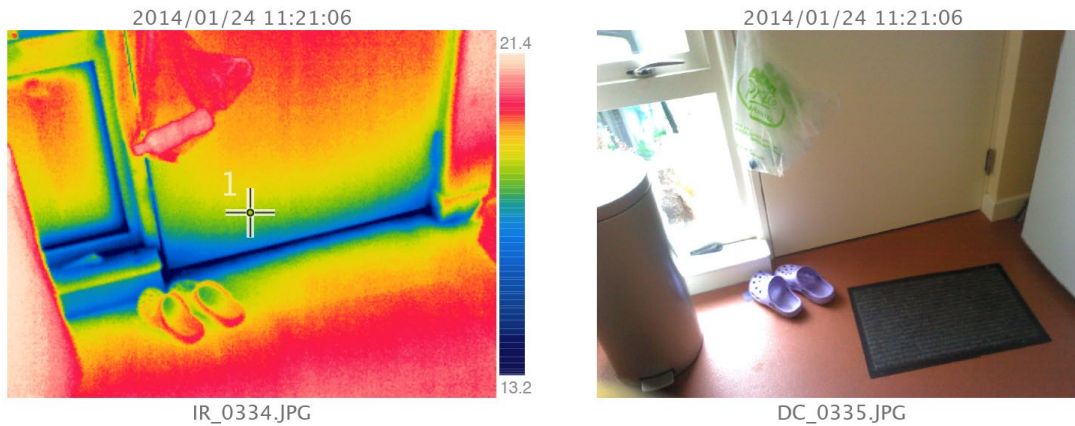
Some of the external doors exhibited thermal weakness at their perimeters and all homes exhibited weakness at door thresholds (Figure 6). This type of defect is not normally identified during an air permeability test as the blower door fan is normally installed in the door opening. Window and rooflight installations exhibited cooler internal surfaces at the structural openings into which the windows were installed. Thermography commonly identified heat loss at window and door seals, as well as areas of missing insulation surrounding roof lights (Figure 7).

**Figure 6: Heat loss at door threshold and at seals of windows to the left of the door.**

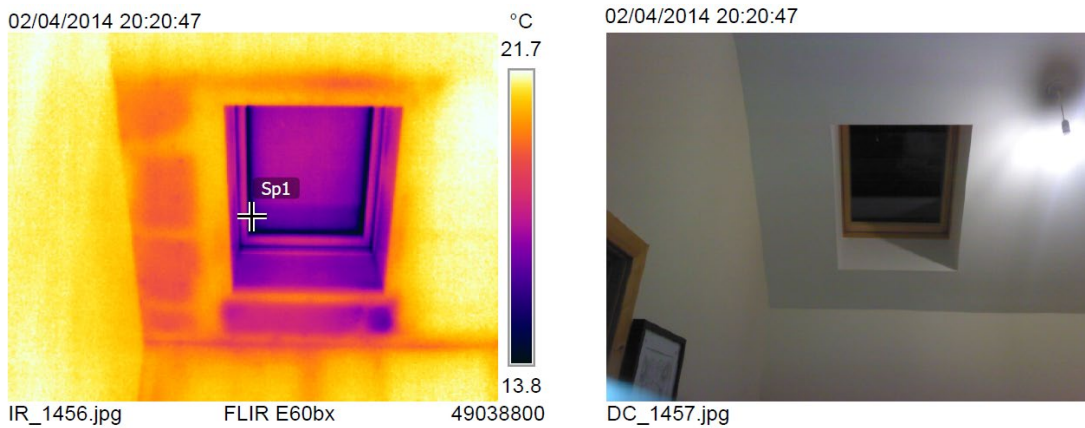
**Figure 7: Missing insulation at bottom and left of rooflight, window reveals also exhibit significantly cooler temperature.**

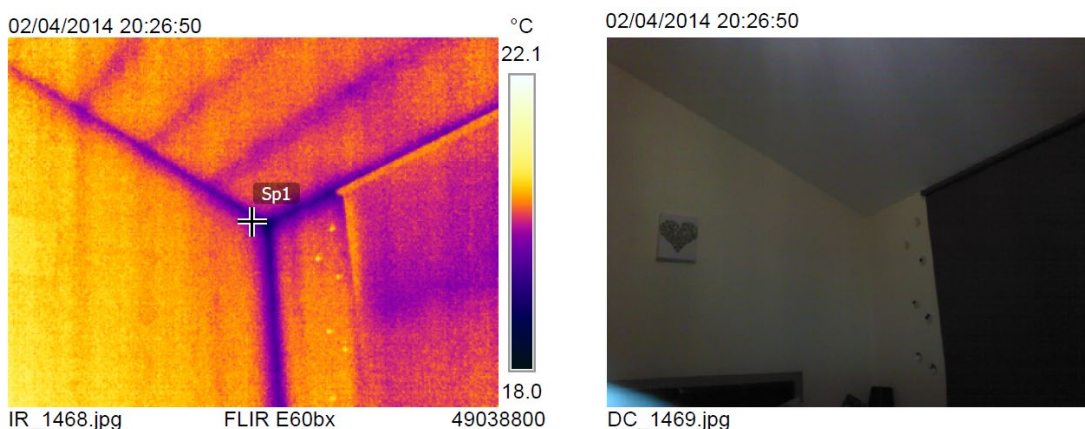
The timber framed dwellings exhibited heat loss through repeating thermal bridges at the timber studs. Two of the monitored timber frame houses were designed with an insulating layer applied externally over the timber I-joists in order to reduce thermal bridging. However, when constructed this insulated layer was not included due to inconsistent information between the design drawings and specification that was not queried. As a result, thermal bridges were evident (Figure 8).

**Figure 8: Thermal bridging at ceiling joists that are designed to minimise thermal bridging.**

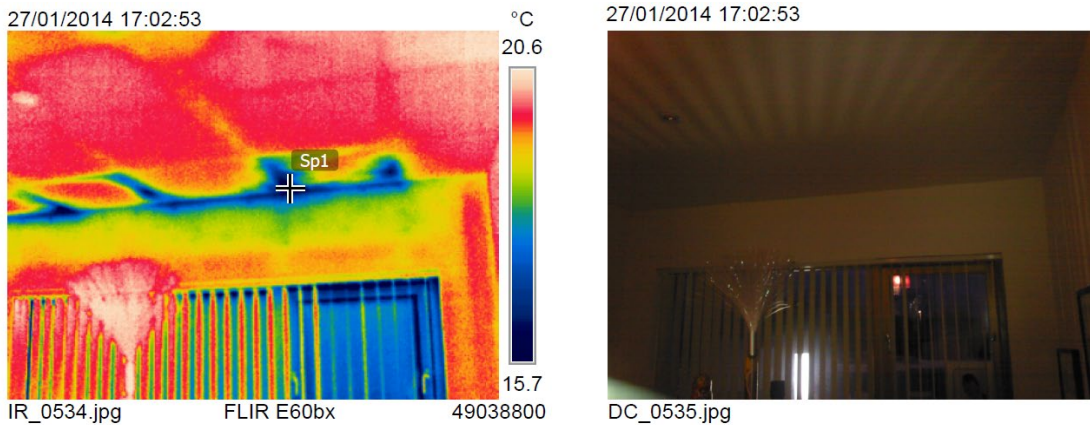
**Figure 9: Repeating thermal bridge at intermediate floor level in a two-storey house.**

Thermal bridging at joist ends (Figure 9) at intermediate floor levels was commonly found in all houses.

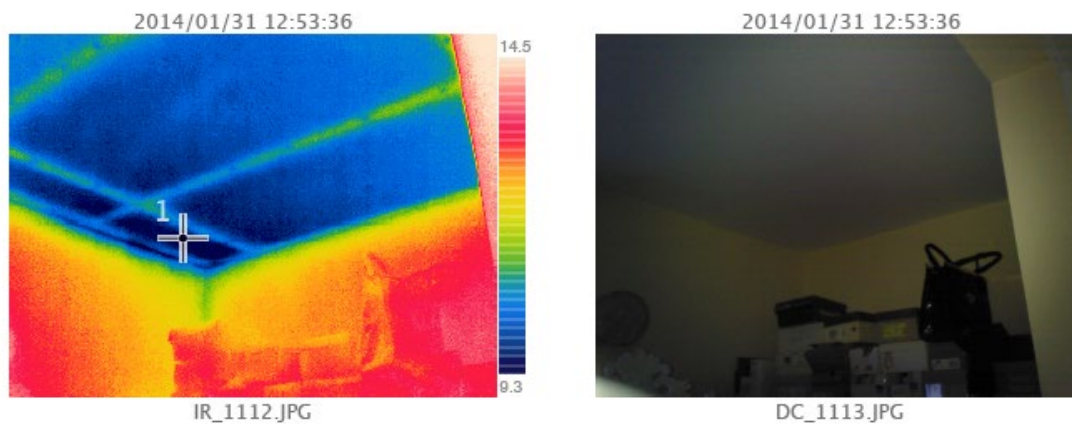
**Figure 10: Missing insulation over a built in storage cupboard off a bedroom.**

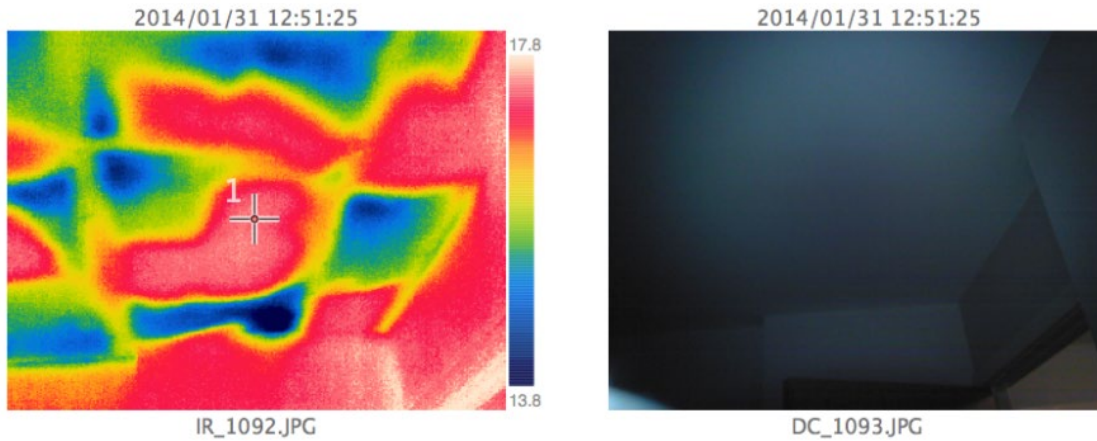
**Figure 11: Poorly fitted insulation within an insulated ceiling.**

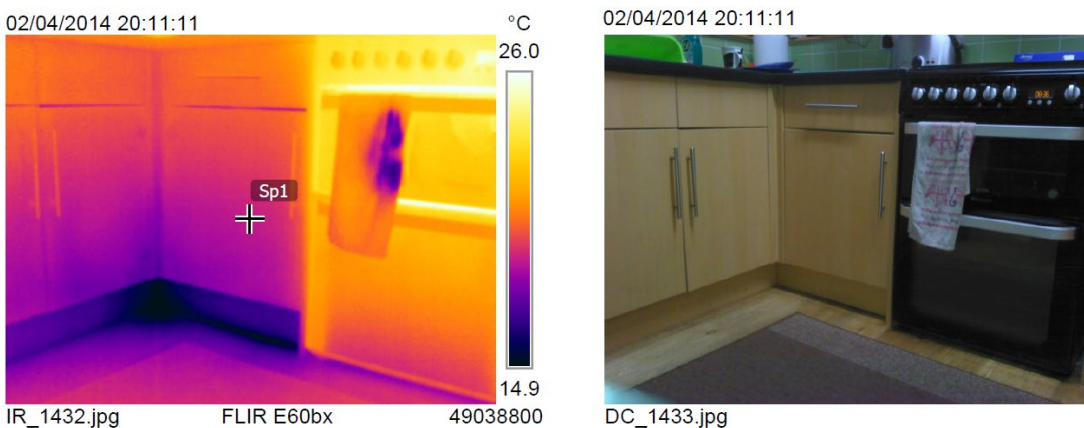
**Figure 12: Cold air leakage from beneath plinth of built-in kitchen cabinets, possibly due to poor or lack of sealing at piped penetrations serving kitchen sink (just visible on top left).**

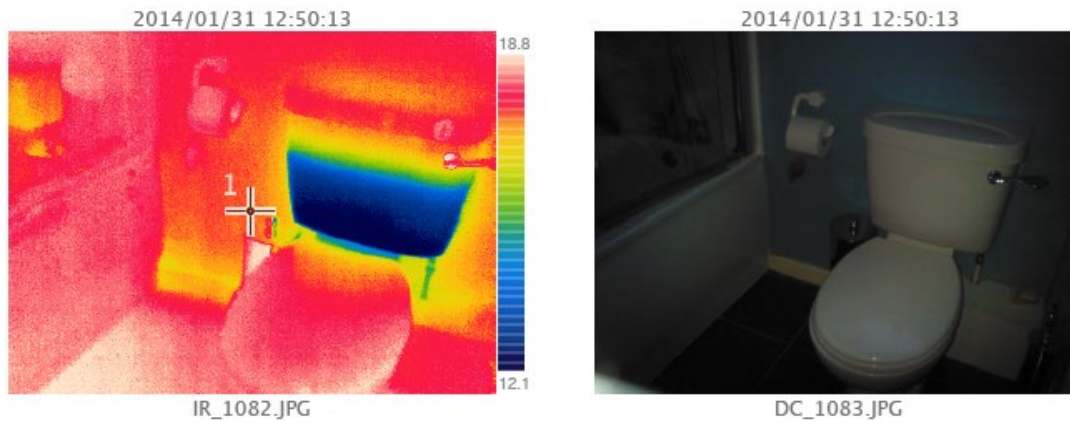
**Figure 13: Cold water within un-insulated toilet cistern, condensation was common on this type of toilet cisterns.**

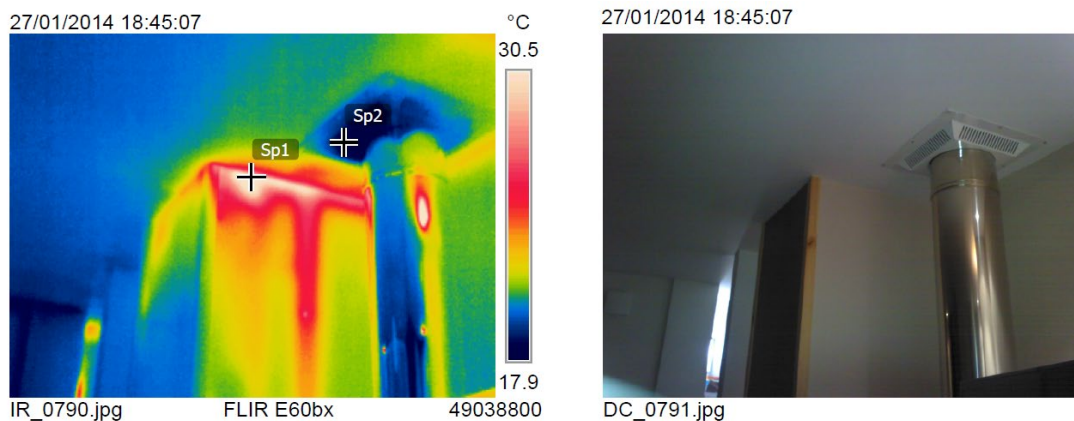
There were six homes with wood burning stoves. In each case thermal bridging and heat loss were identified where penetrations were made at floor level for the stove air supply and at the fire stop plate at ceiling level (Figure 14).

**Figure 14: Cold air falling in to room through fire stop plate at top of wood stove flue, heat gain visible at top of boxing out that houses wood stove flue from property below.**

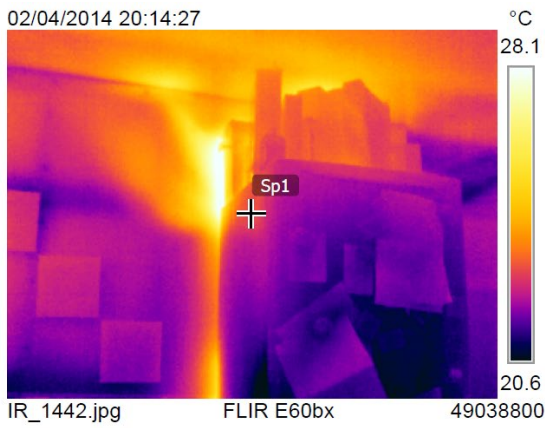
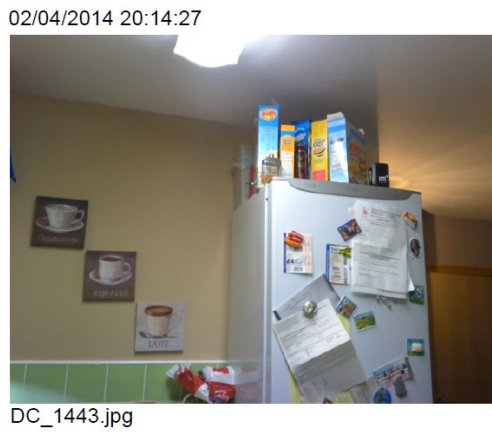
**Figure 15: Heat plume from fridge/freezer creating warmer wall and ceiling surfaces.**

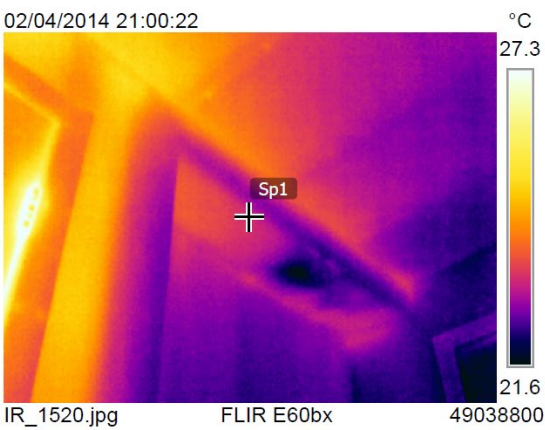
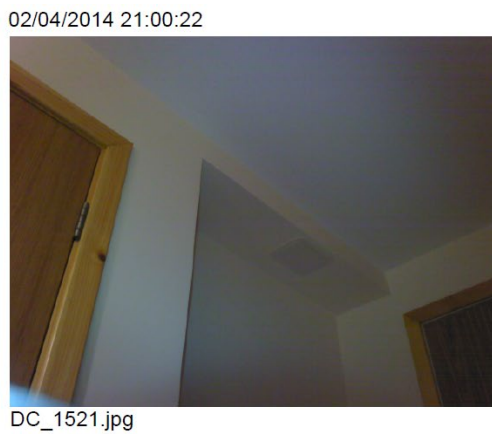
**Figure 16: Heat gain from district heating pipework and heat interface unit in cupboard to the left, note that highest temperature is 27°C, heat gains from this unit are emitted year round.**

- Inadequate insulation to hot water pipework and other services causes localised heating that can result in discomfort to occupants.
- When installing heat interface units for district heating systems, consider their location to prevent heat transfer to other rooms.

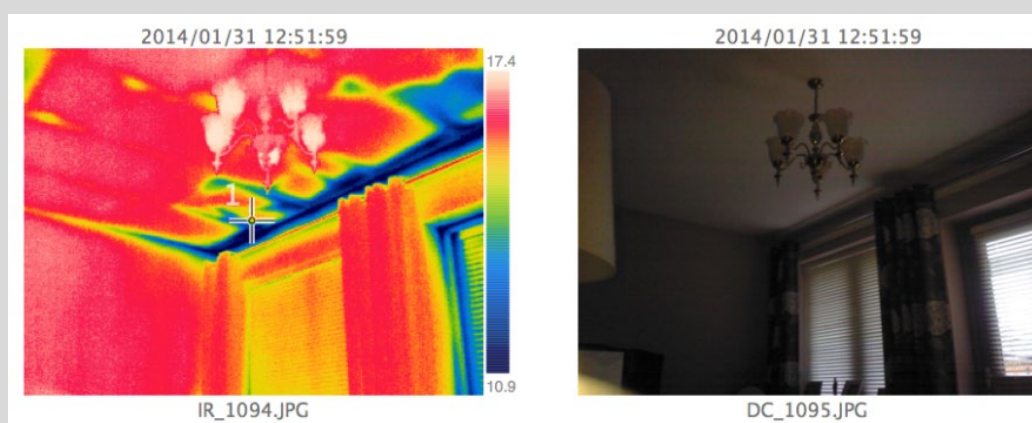
At the Barrhead site the installation of insulation at the wall head/eaves and around perimeters was generally found to be problematic due to the practical difficulty of installing insulation over the wall plate, due to limited space for installation. This problem was detected in all three of the monitored homes and prompted remedial work as well as a review of the architect's details, which were based on industry wide 'standard' details.

The thermogram in Figure 17 indicates that cool external air is entering the building at the eaves and cooling the plasterboard finishes. This problem has been exacerbated by poor quality installation leading to increased heat loss, higher fuel bills and an increased risk of condensation and mould forming on these internal surfaces. The insulation at the original eaves detail was to be installed at a pinch point, where a builder would have difficulty in fitting the insulation in-situ, and there was a thermal bridge present.

Figure 17: Thermal bridge to eaves detail.

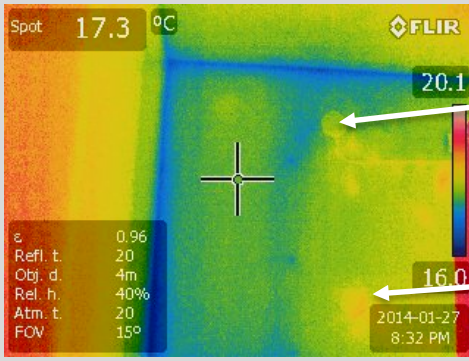
3.3 In-situ u-value elements	Case Study
<p>In House Type D at the Expo site (a ground floor flatted dwelling) the thermography (Figure 20) indicated an area of wall at high level that exhibited a considerable cooler surface temperature compared with the remainder of the wall. This is likely to have been caused by missing or ill-fitting insulation within the timber framed wall structure. Heat flux plate (HFP) B was set up in the vicinity of the thermal bridge and HFP A was located in an area representative of the fully insulated wall. The results indicate HFP A to have achieved a u-value of 0.14 W/m<sup>2</sup>K - 6% lower than the design u-value of 0.15 W/m<sup>2</sup>K and 53% lower than the then backstop value of 0.30 W/m<sup>2</sup>K. In contrast, the test at HFP B revealed a u-value of 0.40 W/m<sup>2</sup>K - <u>240% poorer</u> than the design intent and 33% poorer than the building regulations backstop u-value. This highlights the significance of missing or ill-fitting insulation and can have a large impact on the heat loss from that area of wall, potentially impacting energy bills, occupant comfort and health due to the risk of condensation and mould growth.</p> <div style="text-align: center;">

</div> <p><b>Figure 20: Thermal image of wall under test, highlighting location of HFPs mounted at 1.2m and 2.5m above finished floor level (AFFL).</b></p>

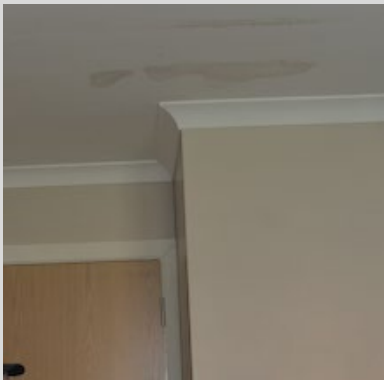
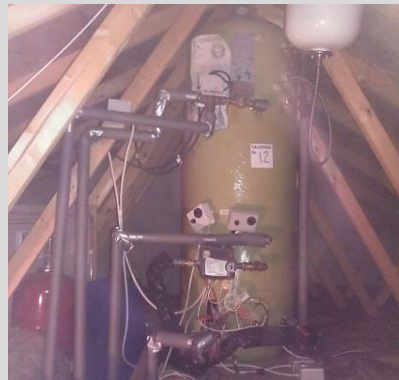
In house BC1, the solar water system did not function correctly due to poor controls installation to the hot water cylinder. This resulted in additional cost for the occupant due to the gas boiler providing all hot water during this time. The hot water cylinder did not have an accessible drain down valve and the placement in the loft space also meant that there was no space to place a container under the unit. When the unit required to be drained down for repair, water leaked through the ceiling to the living room and caused water damage. The staining on the living room ceiling resulted in significant distress for the occupants. See Figure 33.

Figure 33: Left: Water damage due to a leak from the solar thermal system. Right: Cylinder located on the floor of the loft.
