Building Performance Evaluation – A design approach for refurbishment of a small traditional building in Scotland

J. A. Foster¹, S. A. Foster², T. R. Sharpe¹ and A. Poston¹.

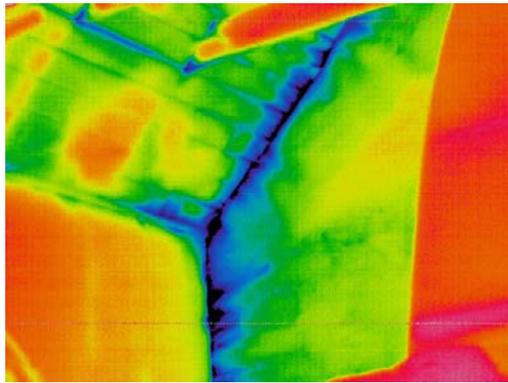
The thermography, performed together with the airtightness testing, visually identified these infiltration pathways. In the pre-refurbishment state areas of missing insulation and air passages behind plasterboard and timber linings were identified. Figure 3 and Figure 4 illustrate the contrast between the before and after refurbishment thermography of the north west area of the exhibition room. PR1 thermograms were taken during December 2014 and PR2 thermography in February 2016. These were undertaken to indicate air movement patterns present behind the finished surfaces.

Figure 3. Thermogram of where the uninsulated north gable joins with insulated west wall and ceiling, indicating significant air leakage at joist ends, cool spots behind timber ceiling and air ingress at the corner.

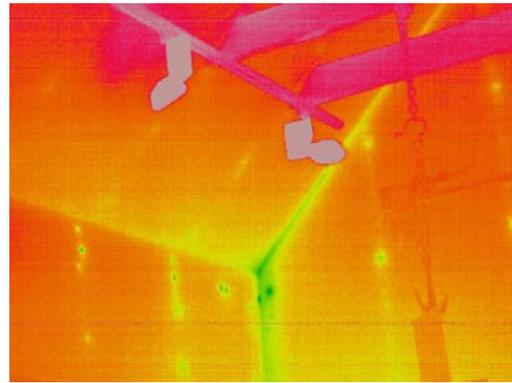
Figure 4. Thermogram of where the newly insulated and lined north gable joins with re-insulated west wall and ceiling, indicating slightly cooler area at the corner and no cooler area at joist ends.

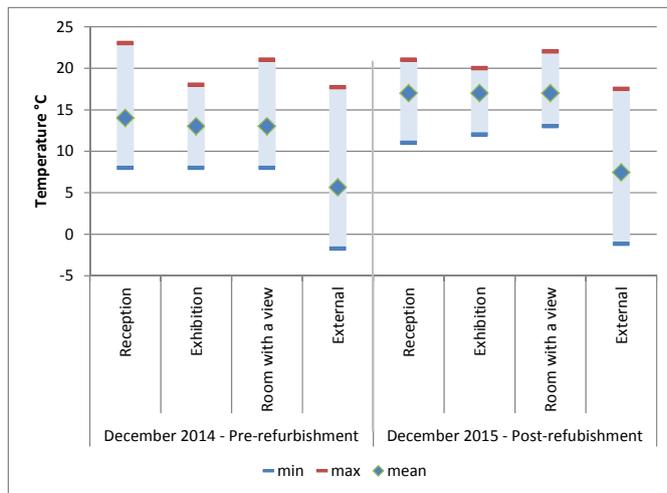
The temperature comparison in Figure 5 indicates that both of the minimum and mean internal temperatures have improved from 8°C and 13°C respectively by 4°C compared to the PR2 monitoring. The PR2 temperatures provide a more comfortable internal environment with less of a temperature swing. The indoor maximum RH for December 2014 and 2015, shown in Figure 6, indicates a 10% reduction in the two rooms that underwent major refurbishment. Although the reception RH has reduced, the maximum RH remains close to 70% RH which can negatively affect the building fabric and artefacts within this area.

Figure 5. Minimum, maximum and mean temperature comparison, 2014 and 2015 monitoring.

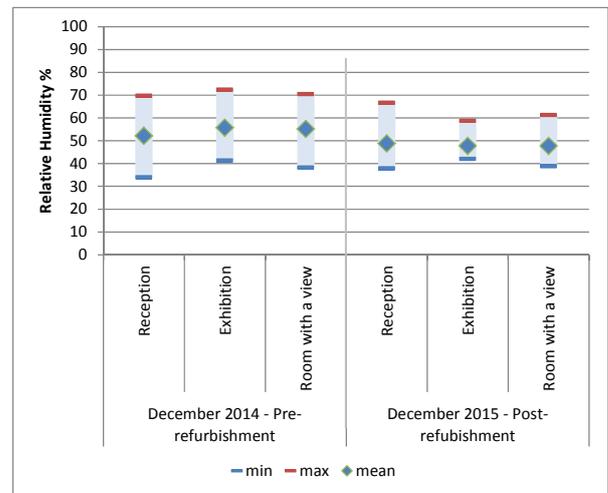
Figure 6. Minimum, maximum and mean relative humidity comparison, 2014 and 2015 monitoring.
