Investigation into the Environmental Condition of GSA Student Residences

BUILDING PERFORMANCE

Rosalie Menon

July 2014

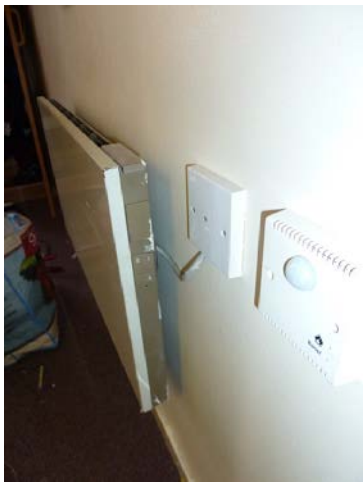
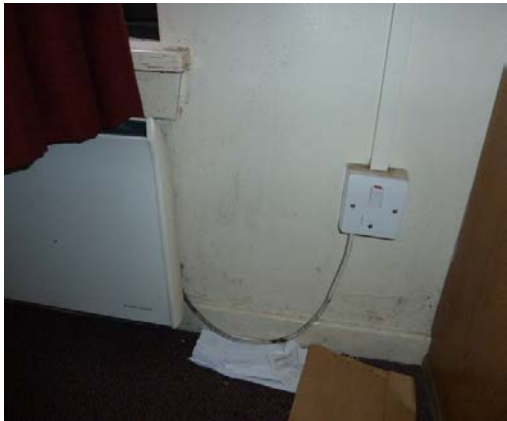
Electric panel heater with boost touch control as standard in bedrooms.	Additional electric convector heaters in flat AG.

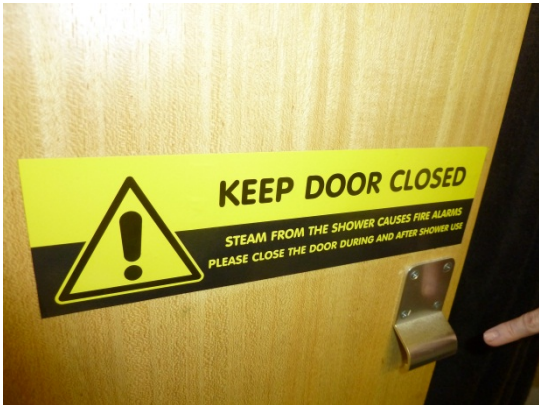
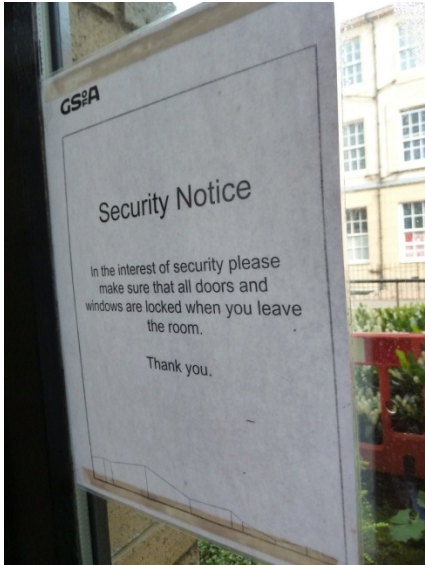
90% of residents noted that the extract fans in the bathrooms were not effective at removing steam from their room and resort to opening windows to remove excess moisture. One resident commented that this was problematic due to the security risk of leaving windows open when the room is vacant.

Students are discouraged from opening windows on ground floor when room is not occupied due to security risks. It was noticeable that the flats on the ground floor experienced greater dampness problems - this could be attributed to less frequent window opening. 100% of residents confirmed that they regularly opened their windows to ventilate their room and are encouraged to do so by the resident manager and wardens however, for security purposes students on the ground floor flats are discouraged from leaving windows open when they are not in their bedrooms. The window opener is the largest part of the window whereas if the window had a smaller hopper this could be opened for ventilation without security risk.

<p>Students are encouraged to keep bathroom doors closed</p>	<p>Students on ground floor are encouraged to keep windows closed whilst room unoccupied</p>

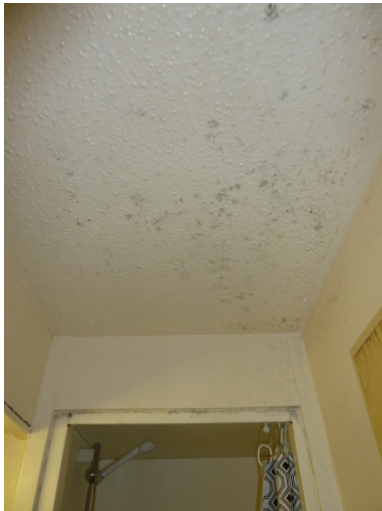
Several flats visited were stuffy and had a strong smell of dampness and mould. Mould was visible in all of the bathrooms (both shared and en-suite). The shower surrounds themselves were free from mould given the PVC easy clean panels but mould was very evident on painted ceiling and adjacent wall surfaces. In addition, mould was present on every bathroom door due to the hanging of damp towels on a timber veneered door without a heat source or sufficient level of ventilation. In addition there was evidence of mould which had been painted over rather than washed down and removed prior to re-decoration.

Mould on painted surfaces in bathrooms

- Extract fan grilles in require to be cleaned urgently. Fan ducts to be checked for any leaks and blockages in all locations including roof level. However the majority of these extract fans have reached the end of their life and would benefit from replacement extract fans with humidistat sensors. Given the intensity of use within the shared bathrooms these could be upgraded to 30l/s extract fans.

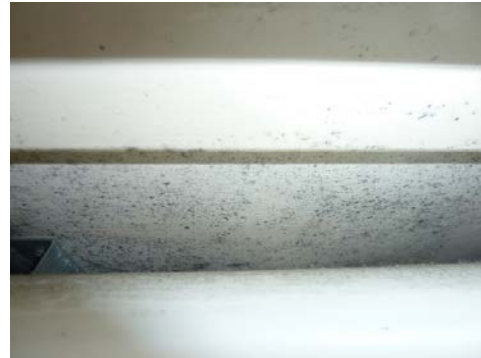
Mould growth spores above WC

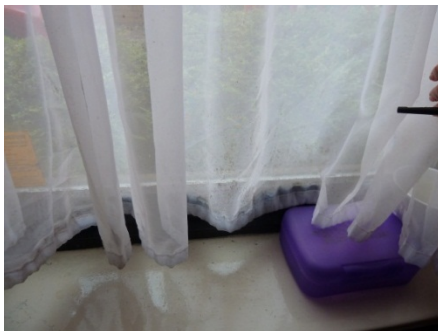
Mould was also visible around most window frames. This is most likely due to surface condensation running down the window and gathering on the sill and net curtain.

Mould and mildew on net curtains and window sill

- Replace windows with high performance double glazed timber framed windows (U value 1.6) with trickle vents and operable hoppers which can be left open all day without a security risk.
- Provide an effective means to dry a damp towel in bathroom. Install electrical towel warmers in bathrooms set on a thermostat to provide low grade heat (running costs paid for by GSA).

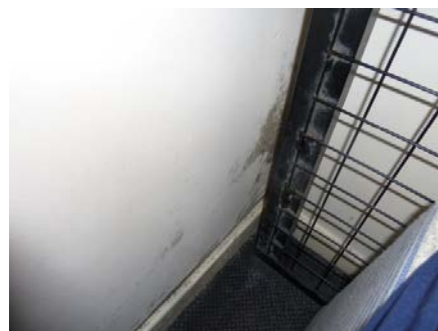
Mould was also evident in the corners of rooms and behind furniture/ beds. These are areas which do not get any air movement and due to the restricted size of the rooms and the requirement for desk and storage, the capacity for air movement within rooms is very limited. During Christmas and Easter breaks the students will often be away and the accommodation is left uninhabited and unheated for up to 3 weeks during the coldest months of the year. Periods of un-occupancy without heating will cause the surface temperatures to drop leading to the formation of dampness and mould on cold spots of the building fabric.

Mould in corner of bedroom behind bed

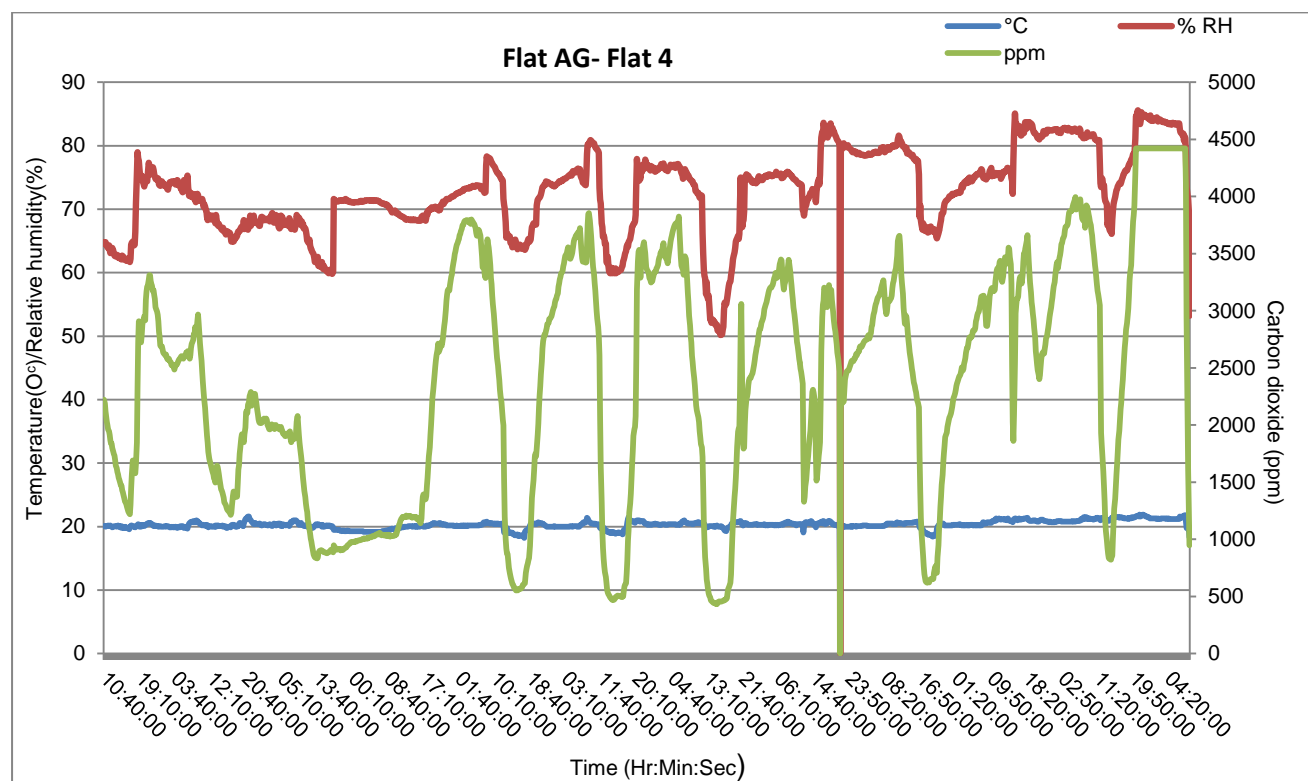
CO² levels in all bedrooms in flat AG are at very high levels. This suggests that windows are not being opened on a regular basis - perhaps due to the security risk from being on the ground floor.

Average humidity levels are high however a key concern are the maximum levels of 87% in bedrooms- this indicates that steam must certainly be migrating from the shower room. These high levels also highlight that an effective fan is critical to remove the moisture.

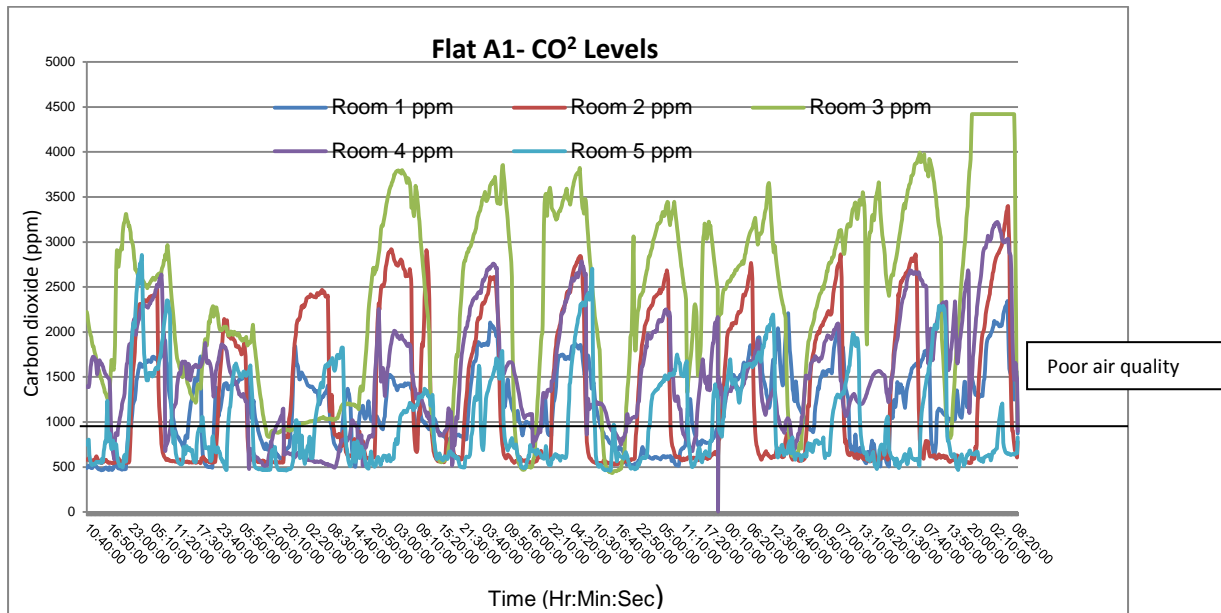
The CO² levels in flat A1 are very high despite being on the upper floor and having greater opportunity for more liberal window opening. Again average CO² levels are at very high levels in all rooms in this flat suggesting that there is insufficient fresh air entering the flat- despite survey responses indicating that windows are opened frequently. The black line indicates the value of 1000 ppm- this is the tolerable indoor air quality and above this level tiredness and lack of concentration can occur.

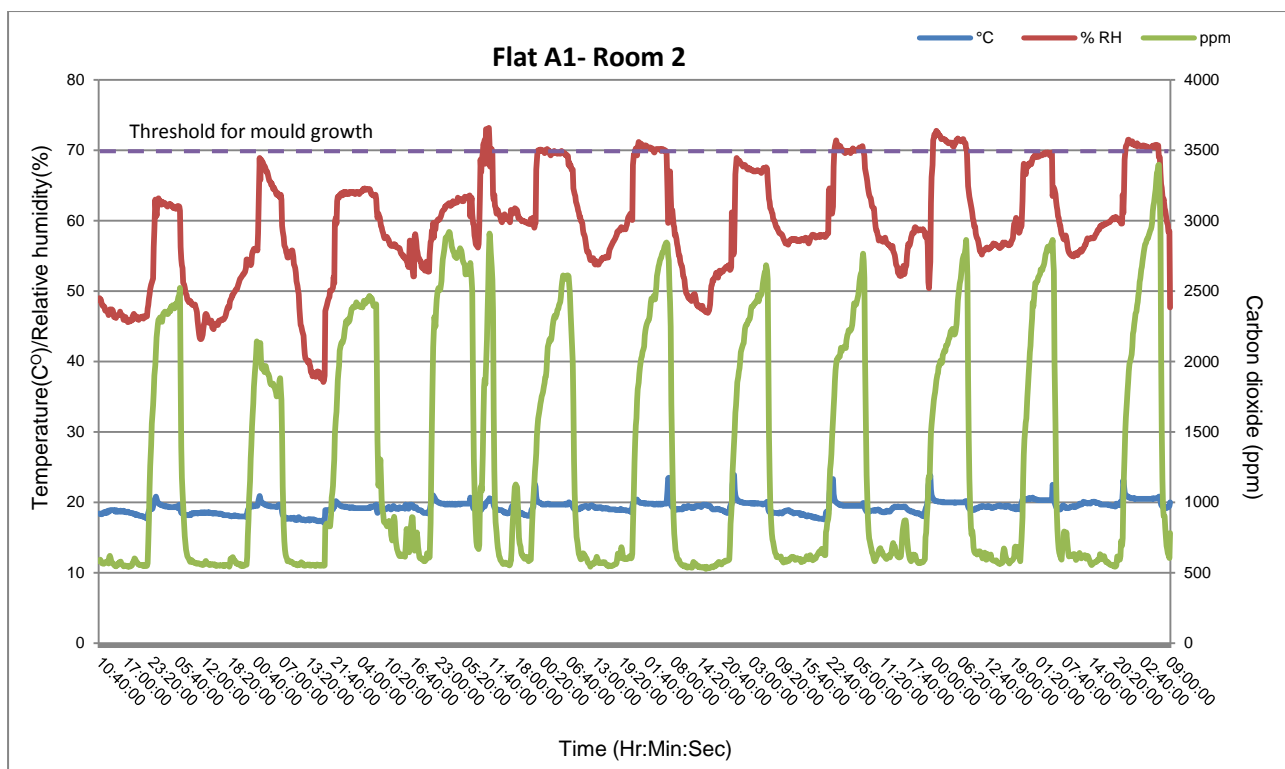
The profiles for Flat A1 Room 2 indicate a clear diurnal cycle with CO² peaks at night time and temp peaks each evening.
