# Multiple Occupancy Residential Accommodation-Ensuring Good Indoor Environments.

**Rosalie Menon**,

MEARU – Mackintosh Environmental Architecture Research Unit, Mackintosh School of Architecture, 167 Renfrew St, Glasgow, UK. Email- r.menon@gsa.ac.uk

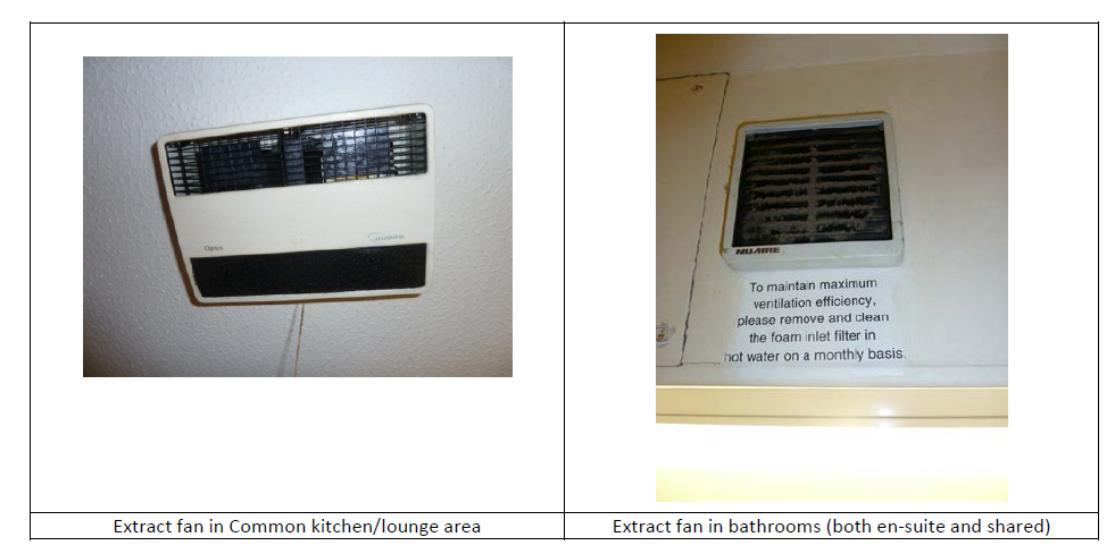
Extract fans (activated with light switch) in the en-suite bathrooms are on a timer with a 10 minute runon period. Bathroom doors on shared bathrooms have metal door ventilation grilles and the doors themselves have self-closing devices (although not all these are functional). The ducted extract fans run up the central core of the building and outlet is at roof level. Students are also requested not to shower with bathroom doors open as this may trigger smoke alarms. Defective self-closing devices on en-suite doors let moisture migrate into the bedroom so the importance of an effective ventilation system in the bathrooms is paramount. On initial visual inspection it was evident that the grilles needed to be cleaned on a regular basis to ensure optimal performance (Image 1).

Image 1. Extract fan grilles in a typical flat.

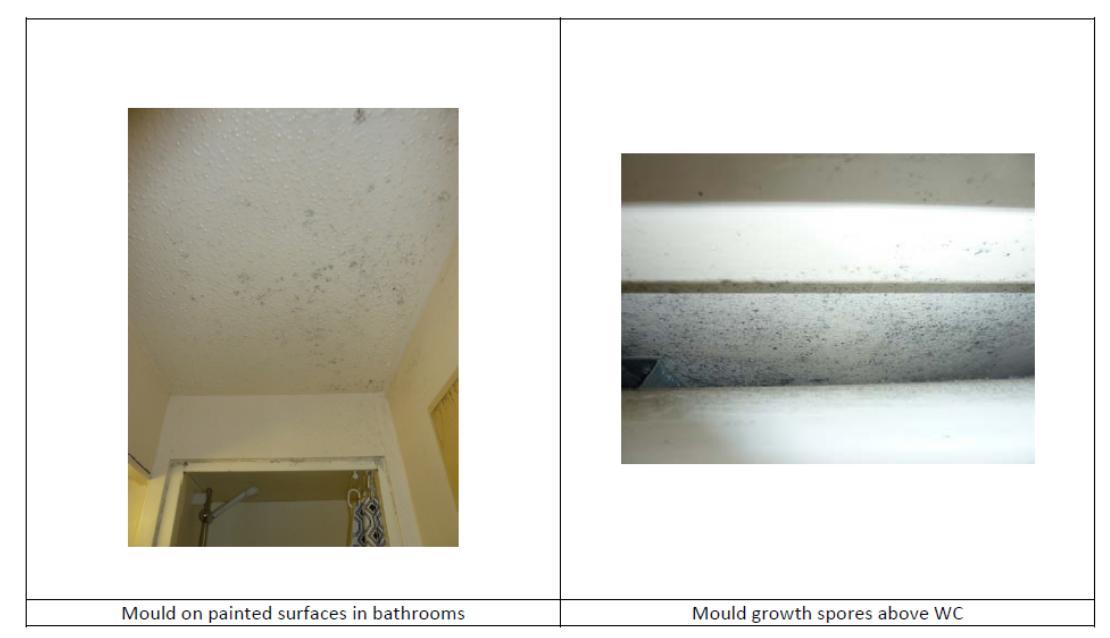
Several flats visited were stuffy and had a strong smell of dampness and mould. Mould was visible in all of the bathrooms (both shared and en-suite). The shower surrounds themselves were free from mould given the PVC easy clean panels but mould was very evident on painted ceiling and adjacent wall surfaces. In addition, mould was present on every bathroom door due to the hanging of damp towels on a timber veneered door without a heat source or sufficient level of ventilation. In addition there was evidence of mould which had been painted over rather than washed down and removed prior to re-decoration (Image 2). Mould was also visible around most window frames- this is most likely due to surface condensation running down the window and gathering on the sill and net curtain.

Image 2. Evidence of mould growth on painted surfaces within the bathrooms.

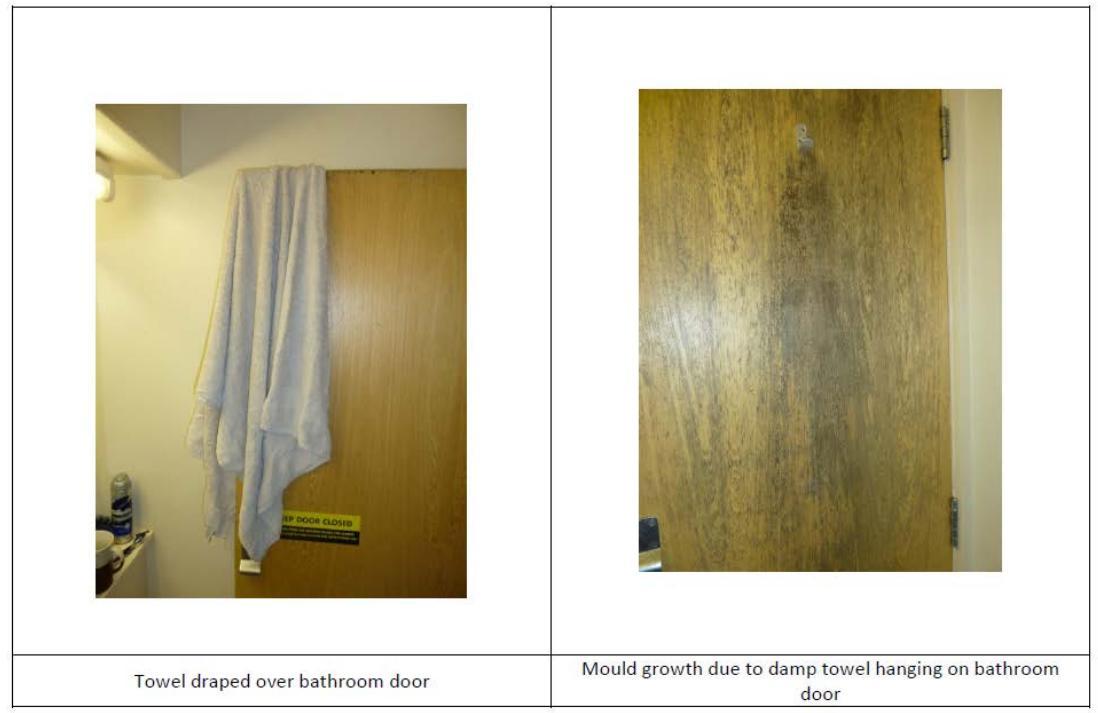
Students are forbidden to dry clothes over the convector radiators due to fire risks however there is no heated towel rail to dry damp towels in bathrooms and during visual inspection it was evident that all rooms had damp towels draping over doors and/or furniture (Image 4).

Image 4. In adequate provision for drying damp towels.

In addition to the poorly performing ventilation system there were other problems with the building which makes it difficult for residents to maintain good indoor environment. Moisture and a musty smell caused by the lack of a drying provision for towels. This study highlights that a provision should always be made for drying otherwise mould and mildew will form on the surfaces where the towel is left to drape. Work completed by MEARU's EPSRC funded project titled 'Environmental Impact of Domestic Laundry' (R.Menon and C.Porteous, 2012) identified the potential impact of drying laundry in living spaces and the negative impact on both occupants indoor air quality and associated health issues which residents may experience. The design guide produced as an outcome of that study recommended that all homes should have a designated area which is independently heated and has an effective air extract system.

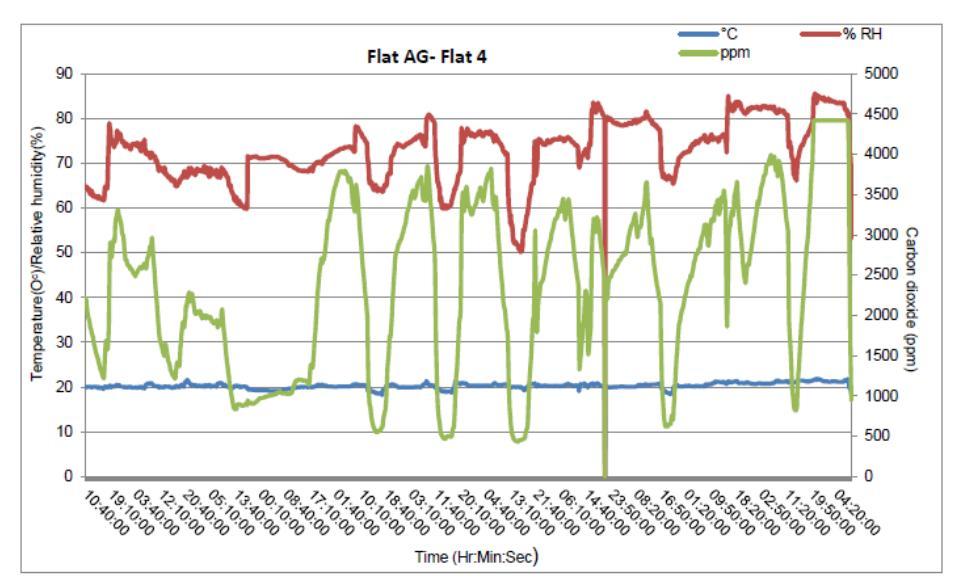
$CO_2$  levels in all bedrooms in flat AG are at very high levels. This suggests that windows are not being opened on a regular basis - perhaps due to the security risk from being on the ground floor.

Figure 3. Graphical data results (Flat AG).

Average humidity levels are high however a key concern are the maximum levels of 87% in bedroomsthis indicates that steam must certainly be migrating from the shower room. These high levels also highlight that an effective fan is critical to remove the moisture.

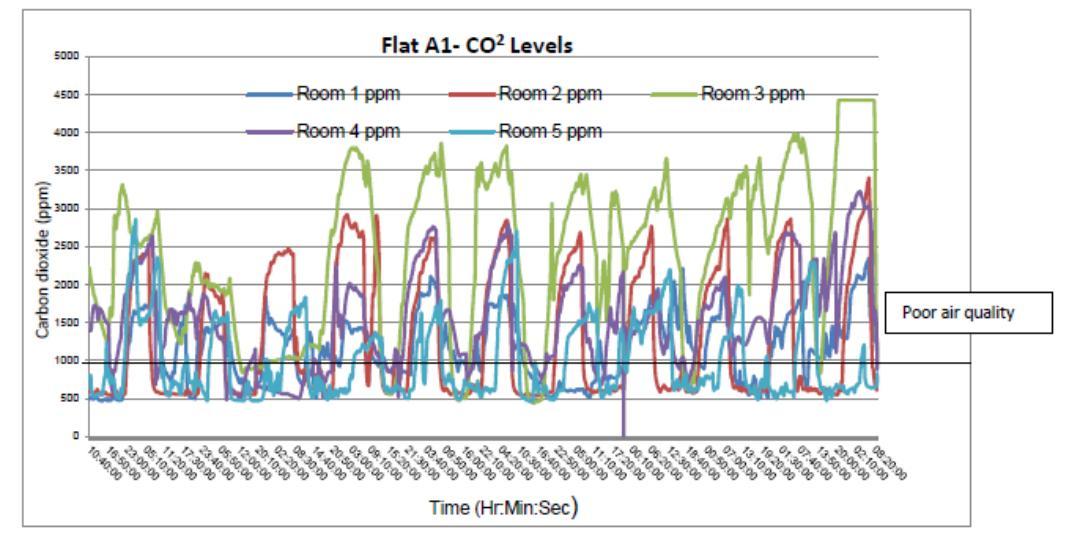
Figure 5. Graphical data results (FlatA1).

Again average  $CO_2$  levels are at very high levels in all rooms in this flat suggesting that there is insufficient fresh air entering the flat- despite survey responses indicating that windows are opened frequently. The black line indicates the value of 1000 ppm- this is the tolerable indoor air quality and above this level tiredness and lack of concentration can occur.

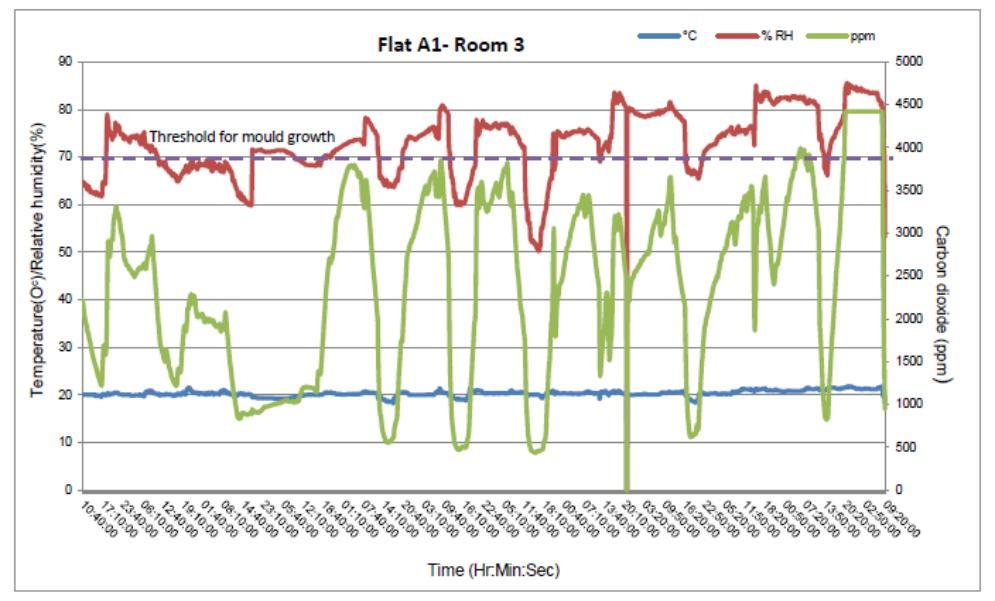
Figure 6. Threshold for mould growth(flatA1, room 3).

Room 3 (as above) has both extremely high  $CO_2$  levels and spikes in RH levels. These reading are consistent with mould observed within both the bedroom and bathroom. The dotted line indicates the 70% RH threshold for mould growth. These high levels of humidity can cause both mould growth and dust mites both of which can trigger respiratory illness in susceptible individuals. To further investigate these results a fan test was undertaken to determine the efficiency of the bathroom extract fan. The reading of 2.4l/s as opposed to the required 15l/s was recorded which explains the excess moisture in the air.

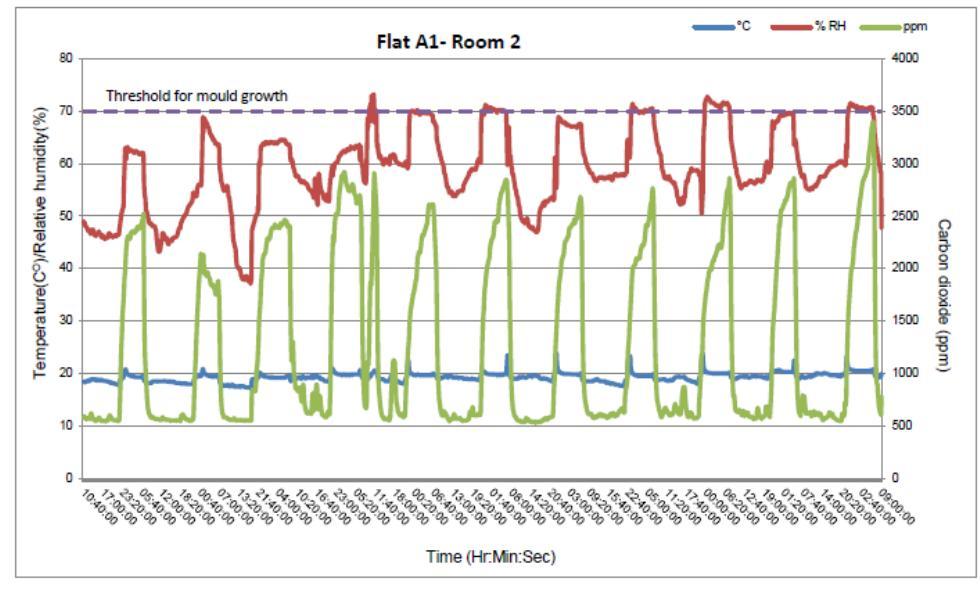
Figure 7. Threshold for mould growth(FlatA1, room 2).

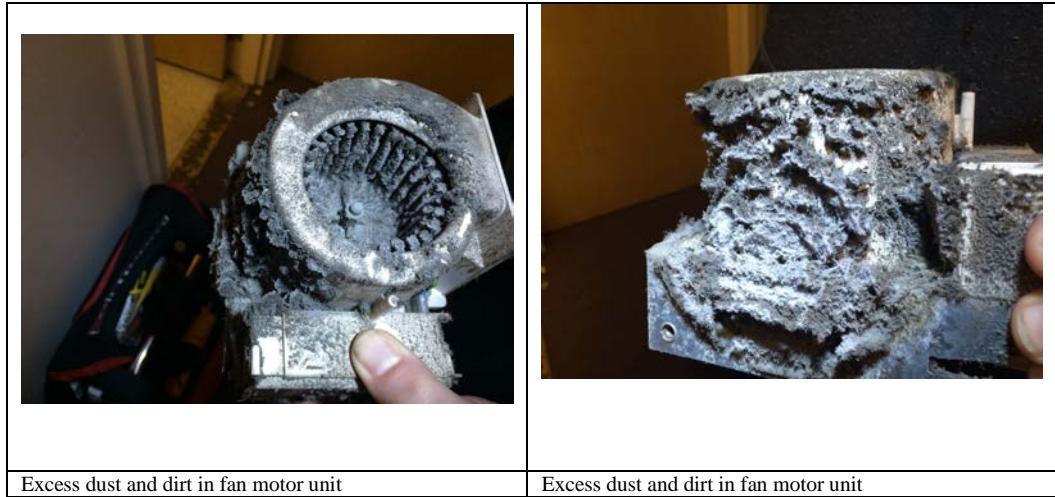
Average of air flow through all fans tested was 6.86 l/s (as opposed to required 15l/s) which is 45% of the efficiency of that required by Building (Scotland) Regulations. The fan with the lowest flow was only working at 16% effectiveness and of those measured there was one fan not working at all. It is evident from the testing undertaken that deficiencies exist with the current ventilation system. Frequent under-performance of mechanical extraction units is most likely a major cause of the excess moisture and mould growth within the flats and this required further investigation to identify causes of the defective extract fan system. The bathroom fan units in the problem flats were removed by an electrical contractor and the fan units and grilles were removed and thoroughly cleaned- the flexi duct from the fan unit to the grille was replaced in several locations.

Image 5. Fan unit once removed.

Testing to ascertain improvements were undertaken by using the air flow tool which produced unexpected results. In Flat A1, the fan readings were now achieving the required 15l/s rate and one in flat this was now exceeding this. However within the communal bathrooms in CG flat there were no improvements despite the extensive cleaning to the system.

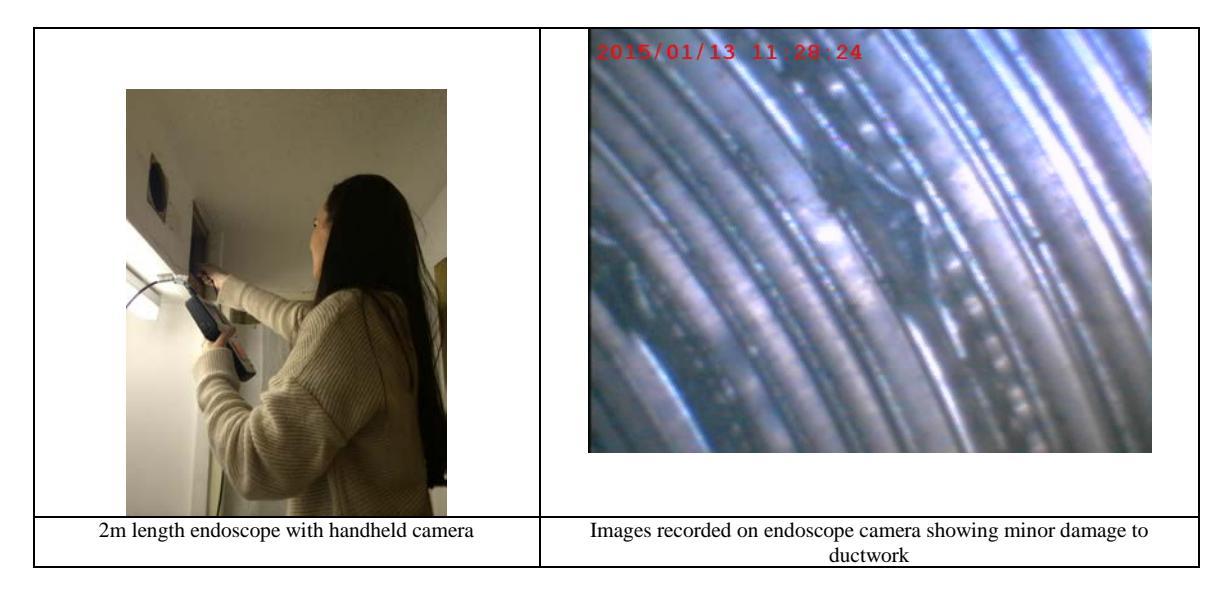
MEARU then further investigated potential blockages or damage to the ductwork by using an endoscope in flat CG (ground floor flat) and the flat above which shares the same duct run. This was the least disruptive method of checking without removing wall panels. The endoscope images identified minor damage to the metal ductwork but its use was limited due to tight radius bends in the ductwork which prohibited the endoscope travelling through the entire duct and into the main chase.

Image 6. Using the endoscope and images of ductwork.

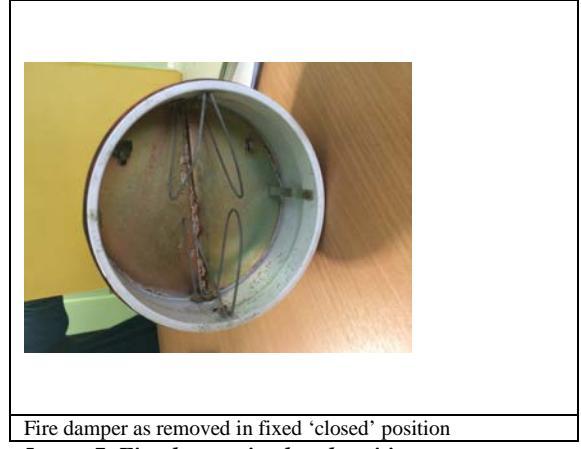
Ultimately panels within the bathroom were removed in order to access the main duct chase and check for any blockages. A fire damper which was in the permanently closed position was removed from the duct and which was therefore obstructing airflow from the bathrooms to the air extract at roof level. This fire damper must have been activated into the close position by the buildings fire suppression system and then not been put back into the open position thereby blocking air from extracting through the ventilation system.

Image 7. Fire damper in closed position.

Final flow rate testing was then completed in all flats which had bathroom extracts on that ventilation run using the air flow meter. The results indicated that all the extract rates were now meeting the required extract rates.
