## **Two Avenues for Data: Rosslyn Chapel as a Terrestrial Scanning Case Study**

**H.CHRIS MCGREGOR, DAVID S. MITCHELL, LYN WILSON, Edinburgh  
DOUGLAS K. PRITCHARD, Glasgow**

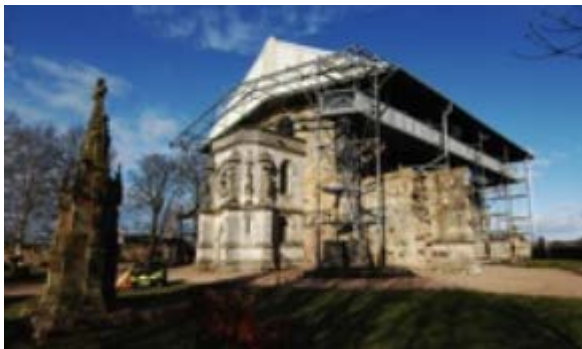
Image One: Chapel exterior with temporary protective metal shed roof

In 1995 it was determined that the saturated stone and high levels of humidity had to be immediately addressed and in 1997 a temporary, freestanding steel roof was erected over the entire Chapel to allow it to dry out.

The ScanStation 2 is capable of a point-cloud scan density of 1.2 mm x 1.2 mm at 50 meters but because of the considerable data overlap from the numerous scan stations, the typical set scan density was 8 mm x 8 mm. The tripod-based ScanStation 2 scanner is capable of acquiring data from the line-of-site of the scan head, approximately 1.4 m off the ground. Exterior scanning was done from the ground but also on the temporary roof walkway (Image One) and on the Chapel vault (Image Two).

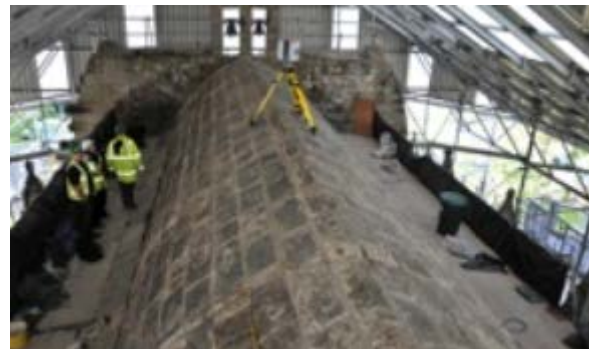
Image Two: Chapel vault with original exterior vault roofing removed and HDS6100 scanner in place

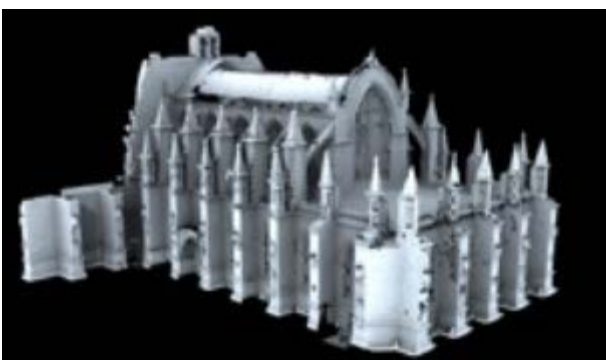
Image Five: 3D Mesh Model of Chapel exterior – metal shed roof virtually removed

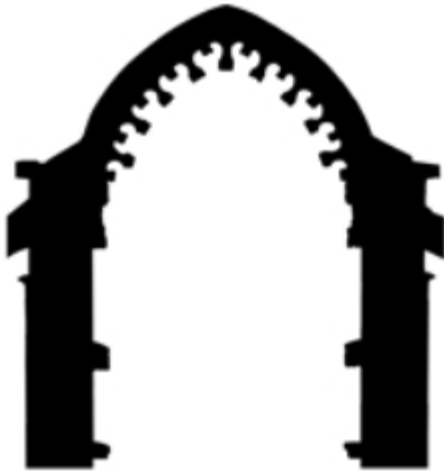
Image Seven: Cross-Section of Chapel Vault

To provide the roofing contractor with a better understanding of the depth of the vault, eight lateral cross-sections and four longitudinal sections were derived from the combined interior and exterior point cloud data (Image Seven). The location of the sections were initially selected by reviewing the 3D point data in Leica Cyclone then drawn up in 2D CAD format using Autodesk Architectural Desktop in combination with the Leica Cloudworks plugin.

In this situation, the terrestrial scanning system proved beneficial over traditional survey systems such as the Total Station in that the scanner provided comprehensive surface documentation (millions of points) as opposed to individual point documentation. As both the exterior and interior were fully scanned and properly registered, sections could be easily cut through the data to provide the contractor with a precise depth of the stone vault<sup>iii</sup>.

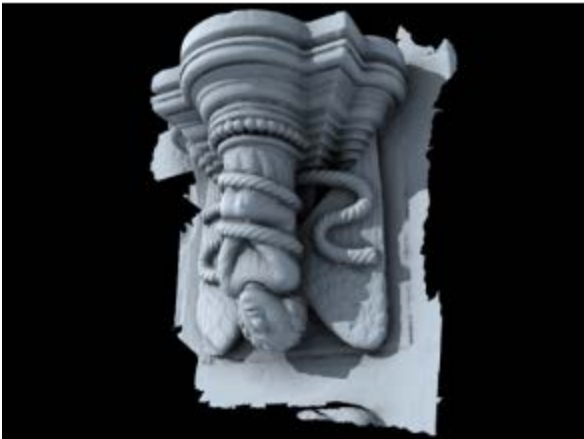
Image Ten: Detail rendering of the Lucifer sculpture

Ten interior sculptures - The Mason and Apprentice Pillar, the Dance of Death, Lamb of God, Green Man, Lucifer, Knight on Horseback, Angel Holding a Heart, Seven Virtues and Seven Sins - were individually scanned using a Perceptron sub-centimetre hand scanning system at 0.5 mm resolution.

The acquired scan data was converted into a 3D mesh and 'data holes' filled using PolyWorks. The data was then imported into 3D Studio Max, textured and animated at 1080p. The developed content was then integrated into a series of touch screen panels with corresponding descriptive text.

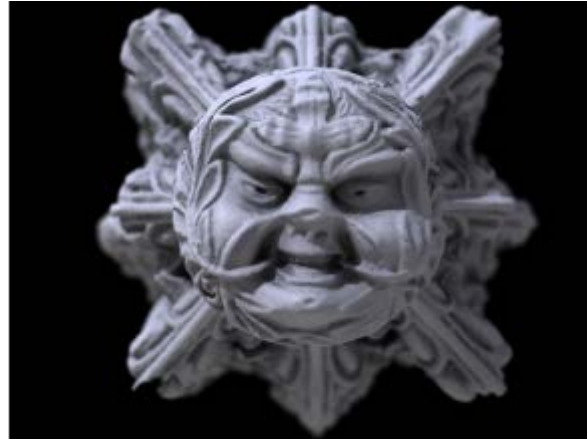
Image Eleven: Detail rendering of the Green Man sculpture
