Scenario Testing of the Energy and Environmental Performance of “The Glasgow House”

Tim Sharpe * and Donald Shearer

Mackintosh Environmental Architecture Research Unit, Glasgow School of Art, 167 Renfrew Street, Glasgow G36RQ, UK; E-Mail: d.shearer@gsa.ac.uk

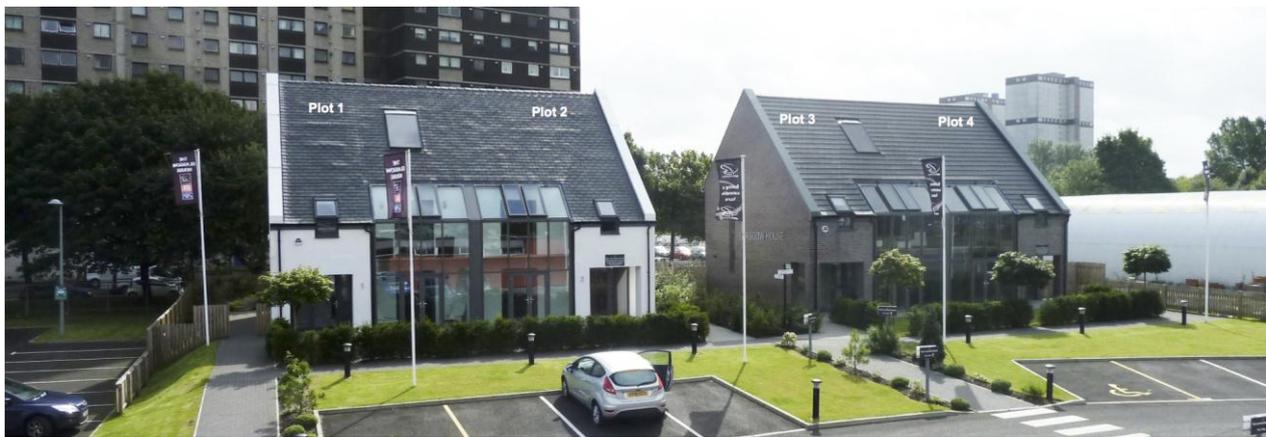
Figure 1. The Glasgow House: Plots 1 and 2 (left); Plots 3 and 4 (right).

There are four houses, two of each construction type, two of which are complete, the other two left unfinished to show construction systems. (Plot 1, Clay block complete; Plot 2, Clay block incomplete; Plot 3, Timber frame complete; Plot 4, Timber Frame incomplete). These were built at the Skills Academy in Norfolk Street, Glasgow, utilising trainee and apprentice construction workers, and are available for site visits for interested professionals and users.

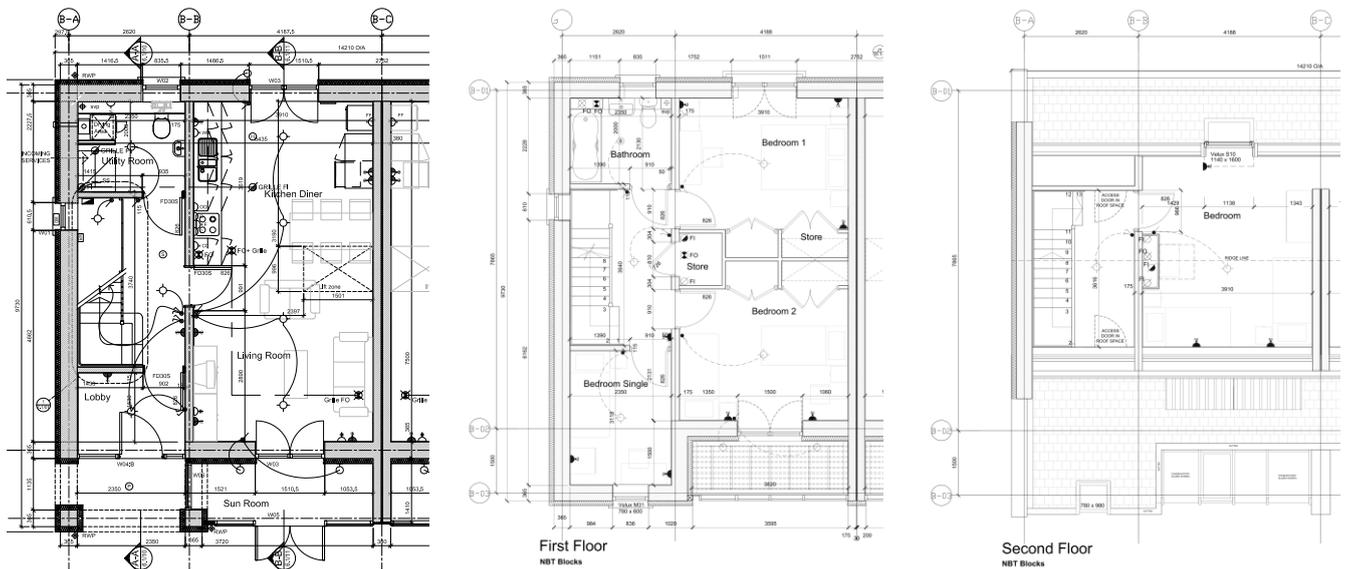
Figure 2. Floor plans.

The dwellings are three-storey semi-detached townhouses (Figure 2). Accommodation comprises entrance lobby, hall, open plan living/kitchen/dining, sunspace, and utility room on the ground floor, three bedrooms and bathroom on the first floor and one bedroom and plant/store on the second floor. They have been orientated on an east-west axis. This was deliberate and was intended to examine a non-optimum orientation that may be required in future developments.

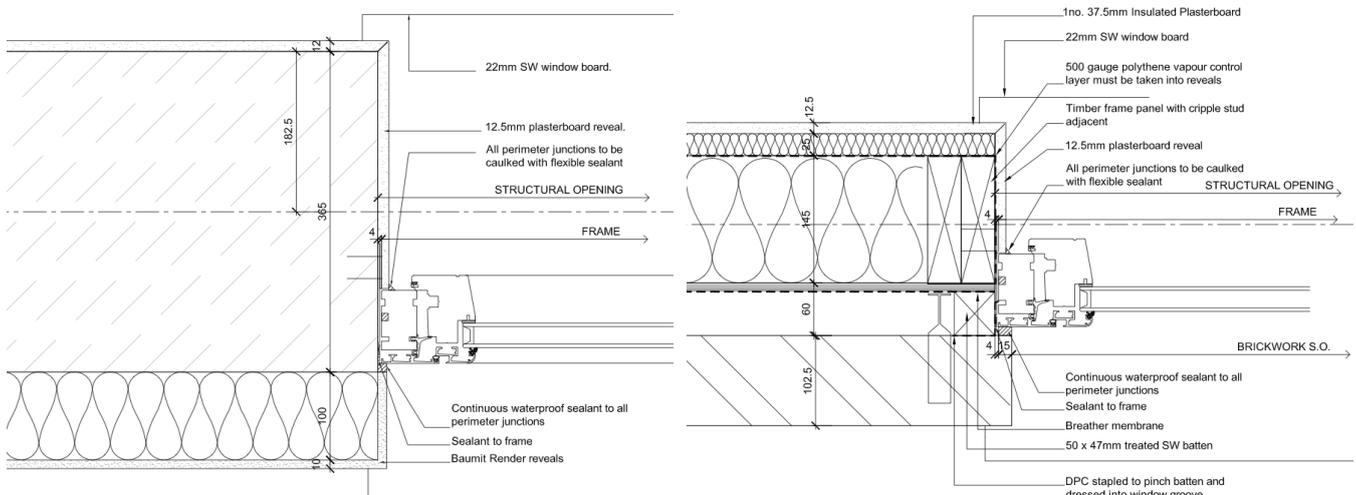
Figure 3. Plot 1 (left) and Plot 3 (right) wall construction.

The clay block wall system has a 6 mm render, 100 mm insulation, 365 mm clay block and 12 mm mineral plaster. The timber frame is 100 mm brickwork, 60 mm cavity, breather membrane on 9 mm Oriented Strand Board (OSB) sheathing board, 145 mm insulation between studs and 37.5 mm insulated plasterboard with 25 mm insulation (Figure 3). Roof construction is prefabricated timber cassettes filled with 300 mm insulation finished with rubber slates on Plots 1 and 2, and conventional slates on Plots 3 and 4. Heating in both dwellings is by means of a conventional gas-fired central heating system, with a 28 kW condensing boiler located in the ground floor utility room, serving radiators, fitted with TRV's in each apartment. There is a programmer located at the boiler and a thermostat located in the ground floor hall space. This was a conscious decision to avoid a radically different heating system that would not be familiar to occupants. The boiler supplies a thermal store for hot water located in the top floor plant space and this is supplemented by a solar thermal hot water heating system. Panels are located on both the east and west facing roof slopes. The dwellings also

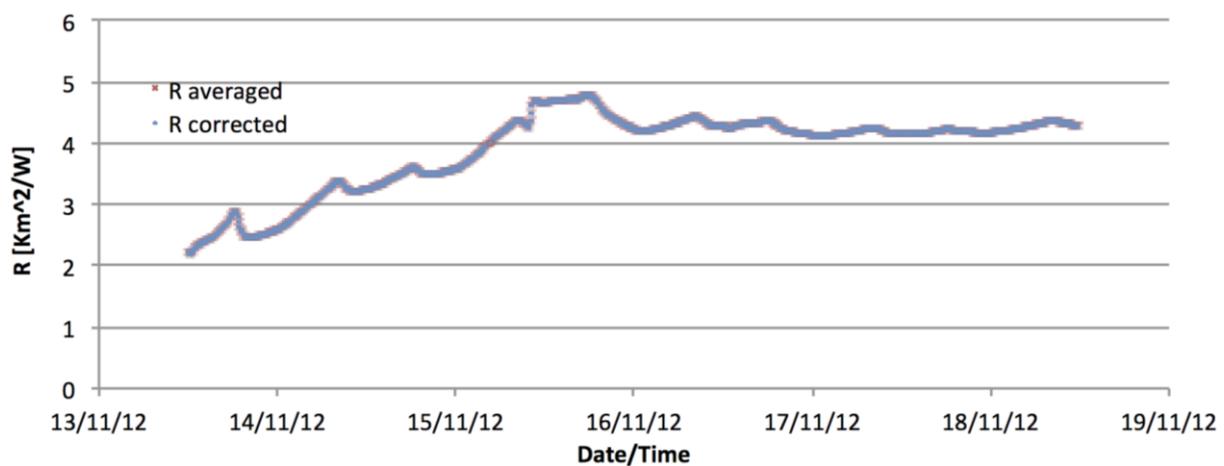
Figure 4. U -value test—thermal resistances.

The design U -value for the project was originally considered as $0.15 \text{ W/m}^2 \text{ K}$ and was derived from project specifications and drawings. Using as-built construction information gave a theoretical design performance of $0.17 \text{ W/m}^2 \text{ K}$. Testing initially undertaken in April 2012 gave a result for the through wall construction of $0.32 \text{ W/m}^2 \text{ K}$ in Plot 1 and it was evident that this result warranted further investigations. Repeat testing in November 2012 initially indicated a figure of $0.27 \text{ W/m}^2 \text{ K}$. When the full data set was checked, the test did not pass the assessment relative to the 5% accepted error of International Organization for Standardization (ISO) 9869 and the calculated R -value was highly uncertain. However, towards the end of the test period the resistance values can be seen to stabilize (Figure 4), and it was found that using the last 3 days of data created a data set which met all the test criteria.

This gave U -values for the walls of $0.23 \text{ W/m}^2 \text{ K}$ for plot 1, and $0.18 \text{ W/m}^2 \text{ K}$ for Plot 3—both $0.17 \text{ W/m}^2 \text{ K}$ design values. It is unclear exactly why the thermal resistance profile takes so long to reach a point of stability but it is likely to be the result of a combination of the prevailing weather conditions, heat regime within the house (noting the properties were not occupied throughout) and thermal mass effects (although these are accounted for in the calculations). Plot 1 walls remain 26% higher than the design values. Possible explanations for this could include test error, effects at block edges, filling of end joints and thicker mortar joints (noted in the adjacent Plot 2), dynamic effects due to the mass or the proximity to a window opening, or possible moisture absorption in the external insulation, and are subject to on-going investigation. It is noted that previous whole wall tests on similar construction have produced comparable results [10], however certification obtained from the German Institute of Construction Technology confirmed the measured conductivity of the blocks as 0.11 W/m K .

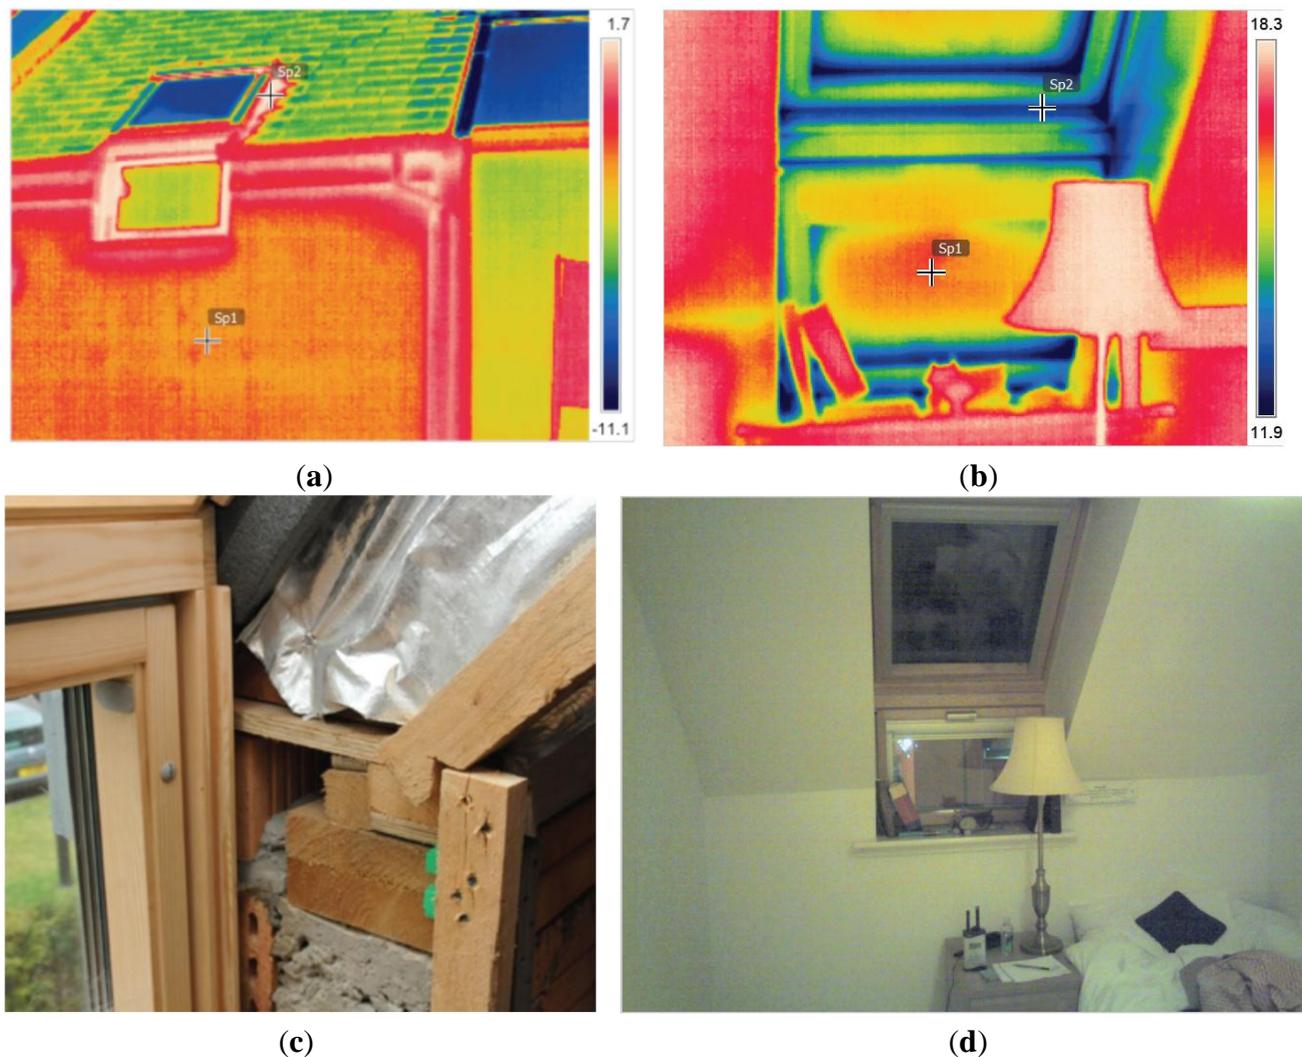
Figure 5. Thermal weaknesses at window openings. (a) Dormer window external thermographic image; (b) Dormer window internal thermographic image; (c) Construction of the dormer detail; (d) Internal view of finished dormer window.

Nevertheless, overall thermal integrity was good in both houses. Thermographic imaging revealed some weakness, particularly at windows and window openings and doors, particularly seals (Figure 5).

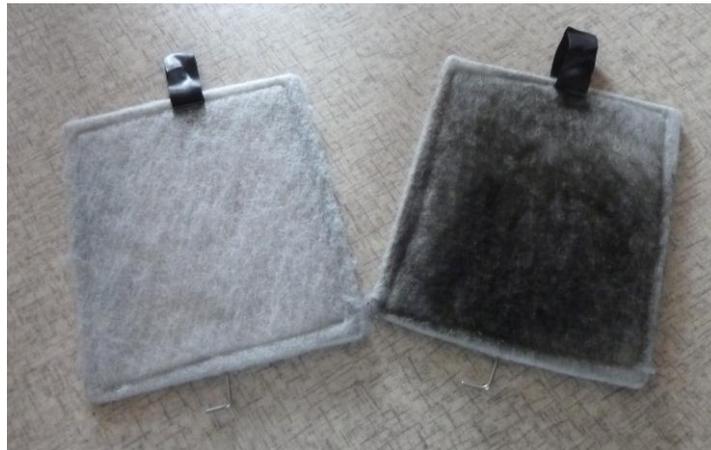
Figure 6. Mechanical Ventilation with Heat Recovery (MVHR) filters, dirt accumulation between scenarios.

In the pilot study conducted in 2011, a number of defects were identified in the MVHR system. These included crushed and damaged ducts, additional bends, a high amount of 100 mm flexible ducting being used, debris in the duct from construction, filters being dirty (Figure 6), and the unit being connected using the horizontal spigots, which restrict airflow. The system had been re-commissioned prior to SC1, with some remedial work undertaken, but some areas of ductwork were inaccessible and could not be replaced or repaired.

Of note are the values for individual rooms compared with a desired ventilation rate of 8 L/s per person. Given that most rooms could reasonably be expected to have several occupants, this provision appears deficient. There is no other provision for background ventilation in the dwelling, so concerns were raised about consequences should the MVHR system fail or be disabled. Furthermore, the location of the unit in the loft will compromise regular and effective filter cleaning and general maintenance. It was also found that the filters quickly became dirty between scenarios, a period of weeks rather than months.

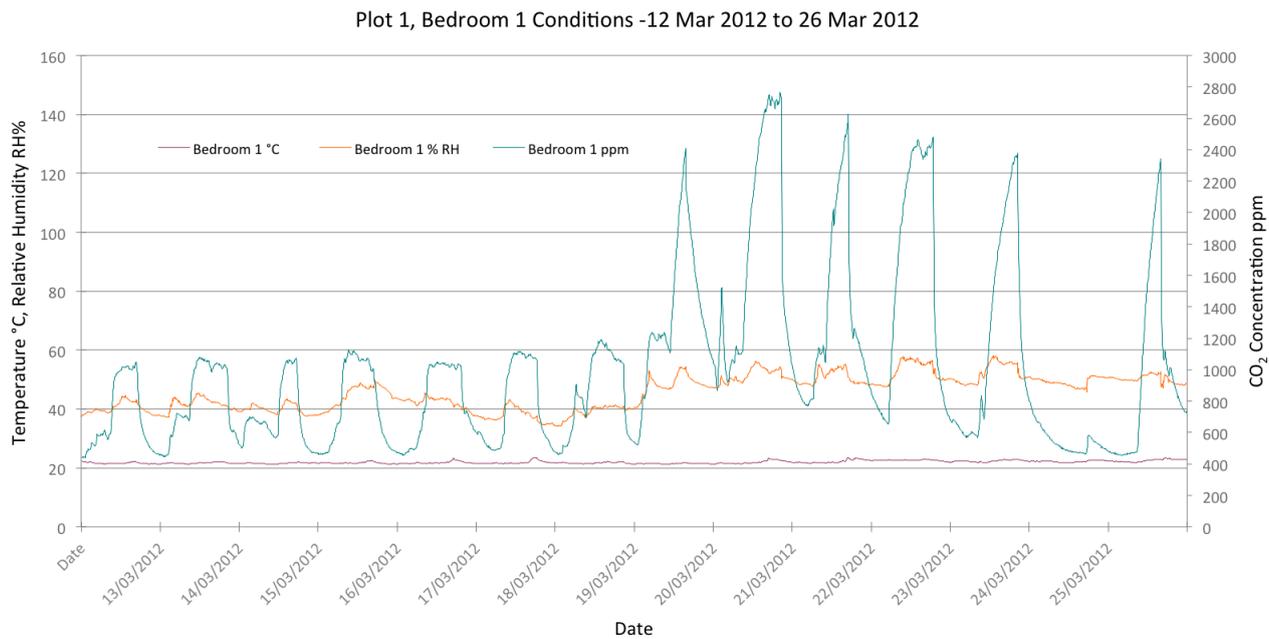
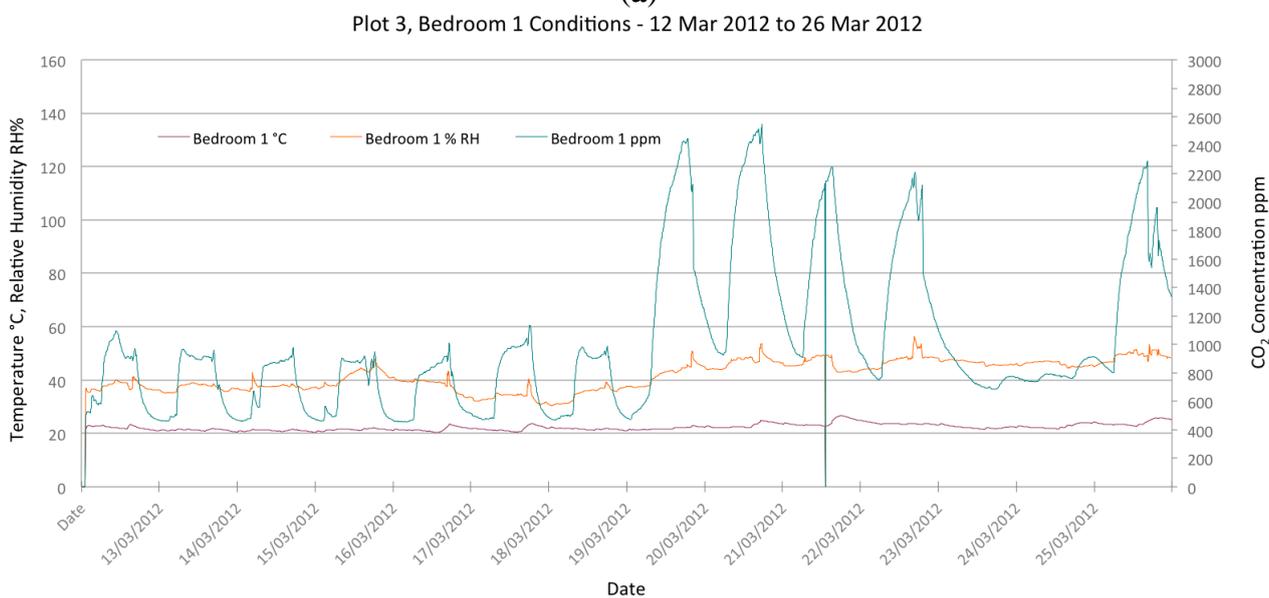
Figure 7. (a) CO₂ temp and RH levels SC2, Plot 1, Bedroom 1; **(b)** CO₂ temp and RH levels SC2, Plot 3, Bedroom 1.

Conditions deteriorated in all apartments, but the effects were most marked in the bedrooms (Figures 7 and 8). During the first week of occupation, the same diurnal relationship of CO₂ concentration and RH is evident through all apartments. In general, the peaks in CO₂ concentration are comparable to those seen in SC1 and this suggests that the impact on performance of the 50% occlusion is limited. Higher CO₂ levels are noted in the attic room, which had two occupants (Figure 7). Measured airflow in this period was similar to the un-occluded period, suggesting that fan speed is increased (with a consequent energy penalty). In week 2, when the system was disabled, the impact on CO₂ is far more pronounced. The peaks in CO₂ concentration reach levels, particularly in bedrooms, that are indicative of very poor ventilation rates. This also extends to include water vapor as RH levels are seen to incrementally increase independent of the internal temperature.

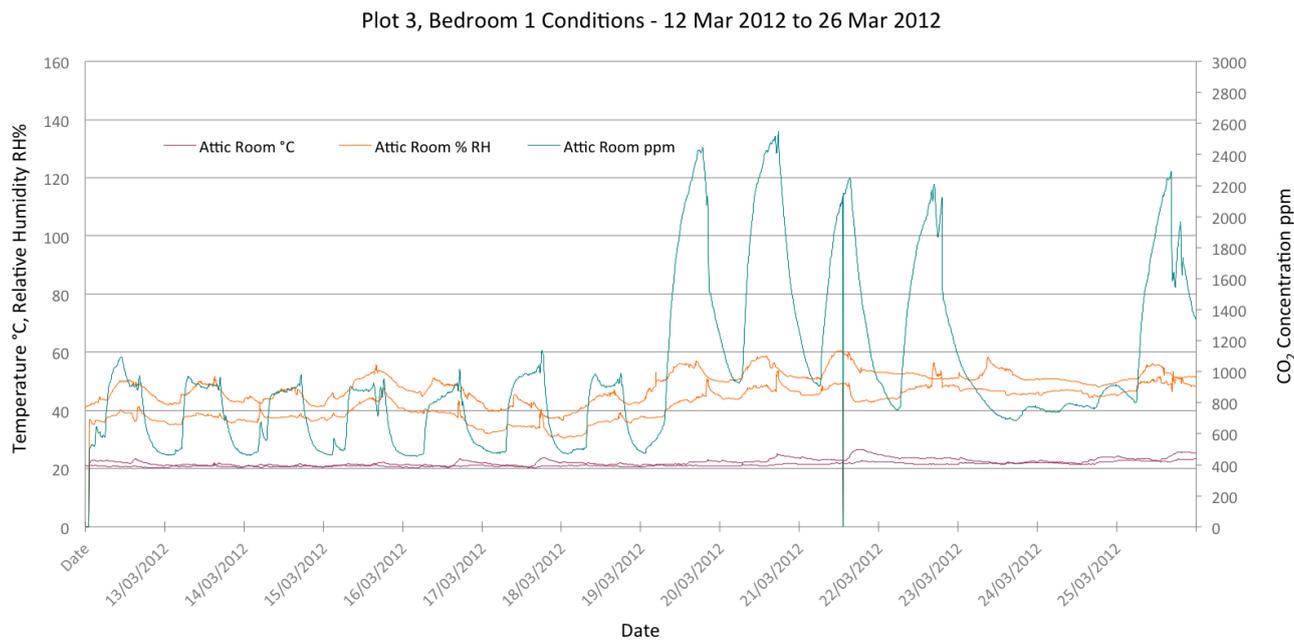
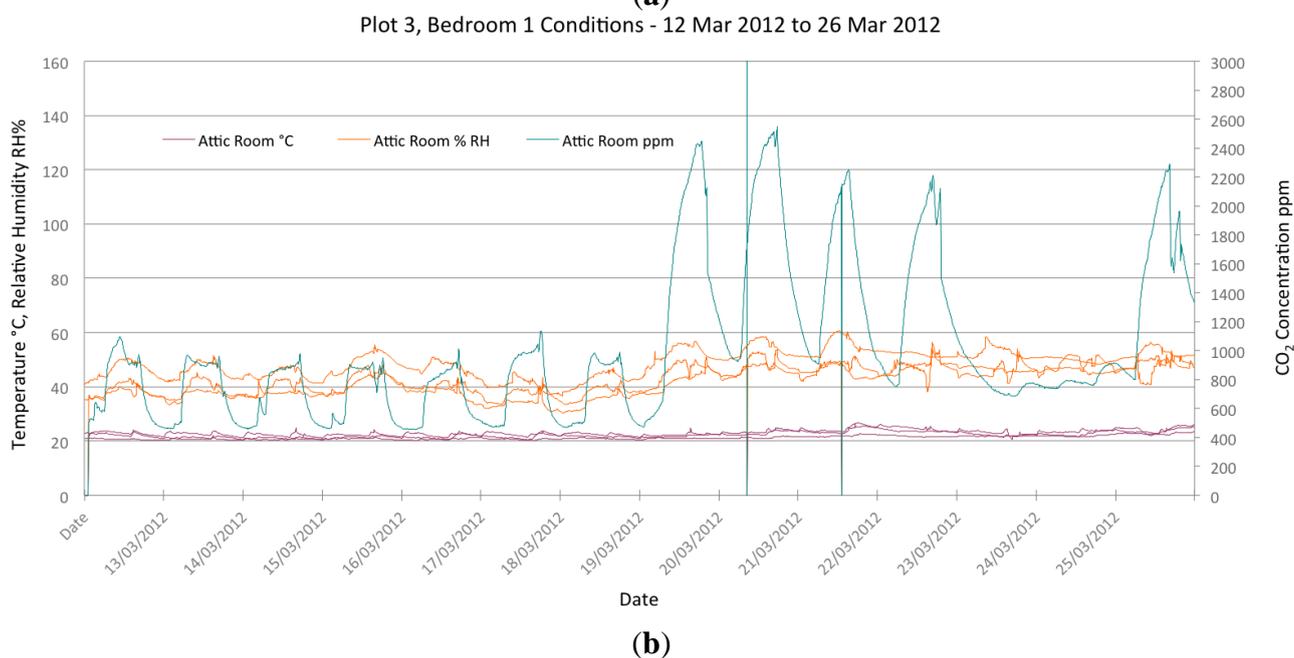
Figure 8. (a) CO₂ temp and levels SC2, Plot 1, Bedroom 4 (attic); (b) CO₂ temp and RH levels SC2, Plot 3, Bedroom 4 (attic).

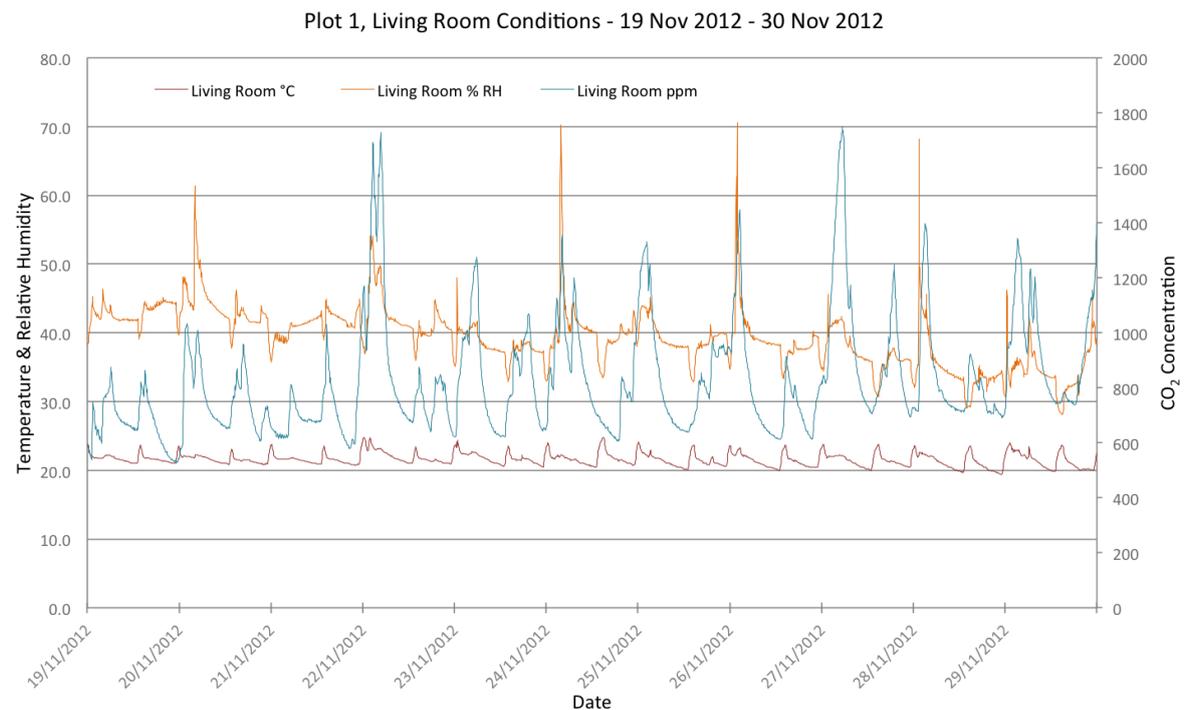
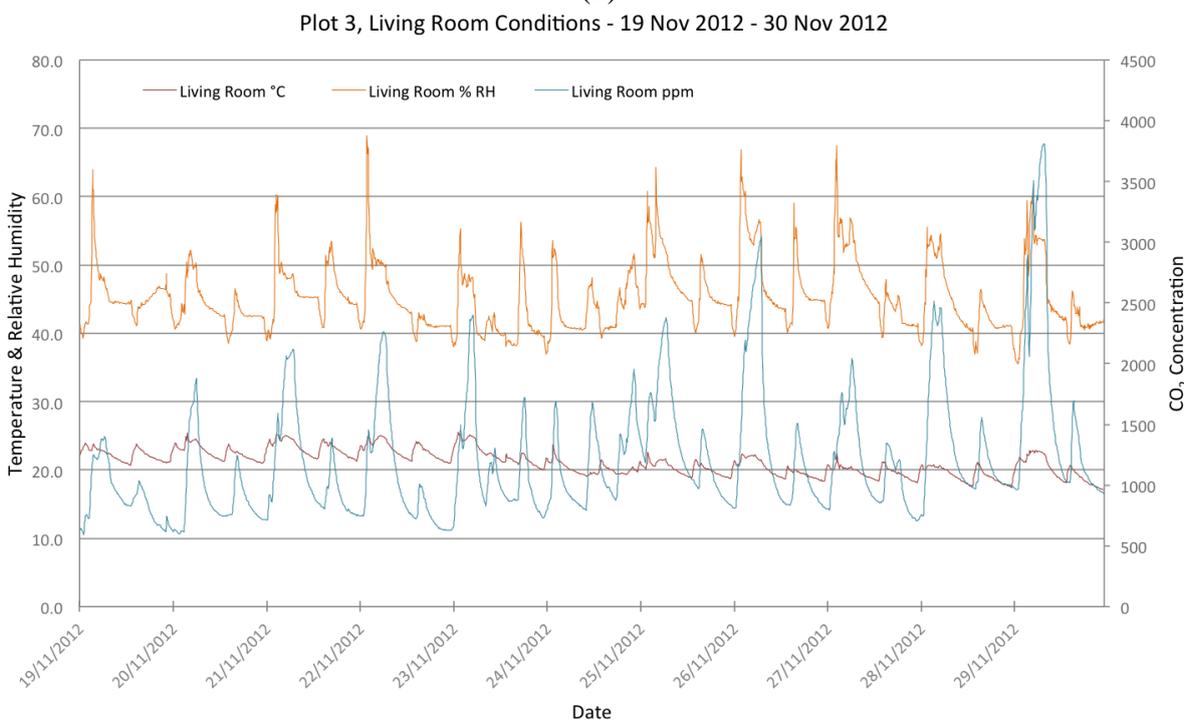
Figure 9. (a) CO₂ temp and RH levels SC6, Plot 1, Living room; (b) CO₂ temp and RH levels SC6, Plot 3, Living room.

It is apparent that there is a marked deterioration in mean CO₂ levels in the dwellings between the two weeks (Table 4). The living room effects are apparent where peaks of CO₂ are experienced during periods of high occupancy, but adaptive behaviour leading to window opening mitigates these (Figure 9). However, the difference is marked when comparing the bedrooms, in which week 2 conditions are very much worse (Figure 10).

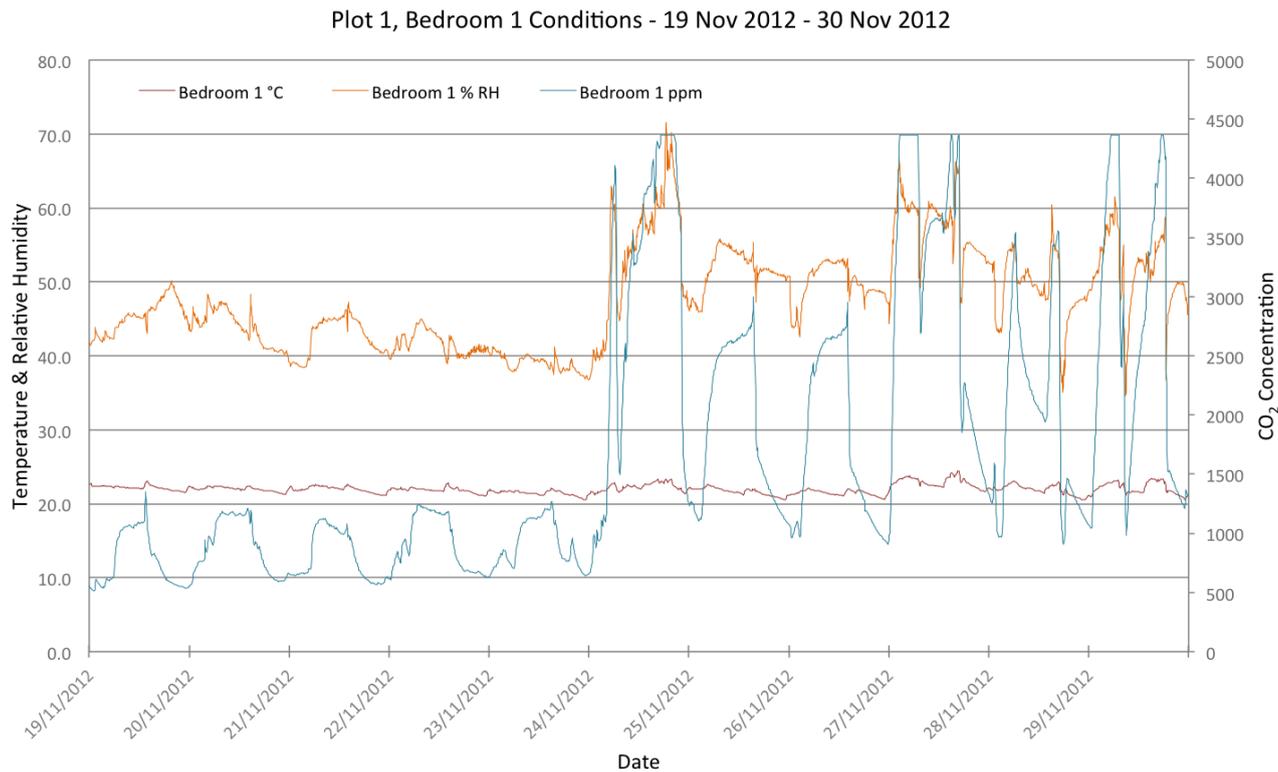
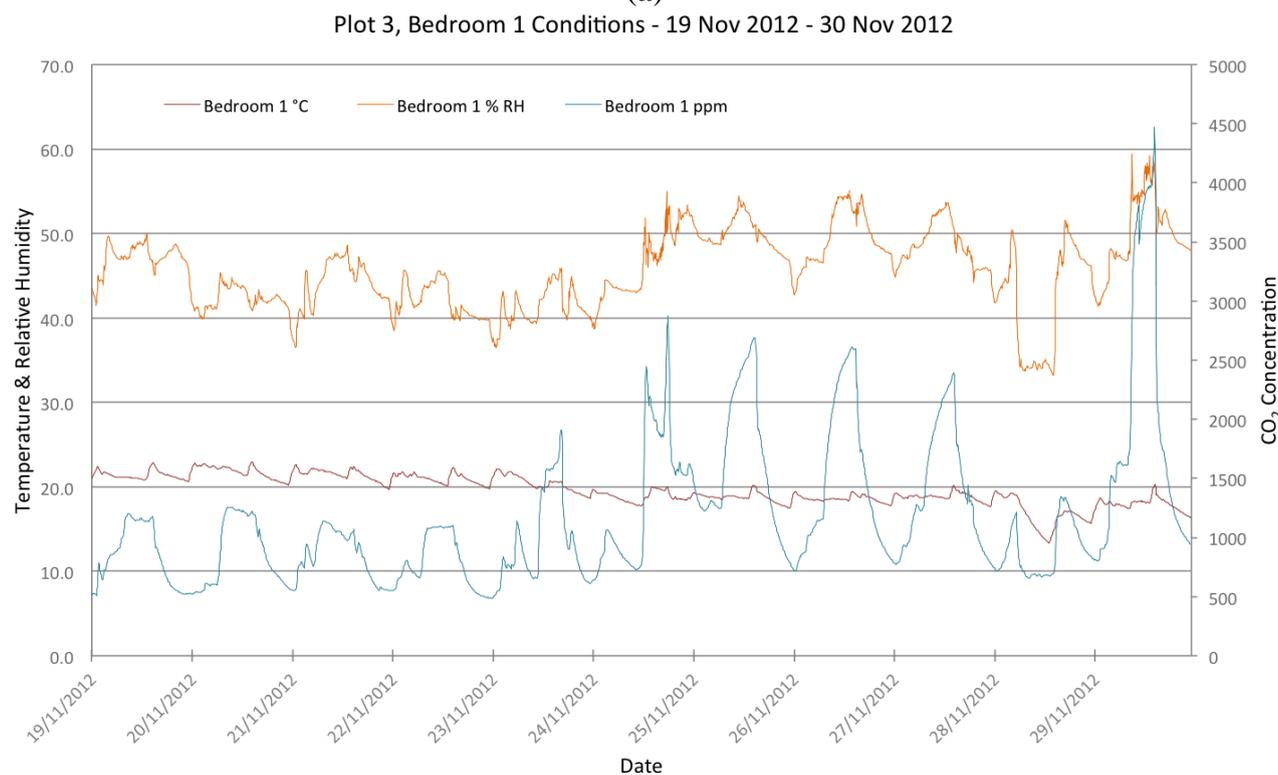
Figure 10. (a) CO₂ temp and RH levels SC6, Plot 1, Bedroom 1; (b) CO₂ temp and RH levels SC6, Plot 3, Bedroom 1.

In the bedrooms, an identical pattern to the first week of SC2 was observed, with very high CO₂ levels recorded overnight. From the monitored data it is clear that the actual Indoor Air Quality (IAQ) was markedly worse during the second week; therefore, it is worth considering why the residents would not perceive this.

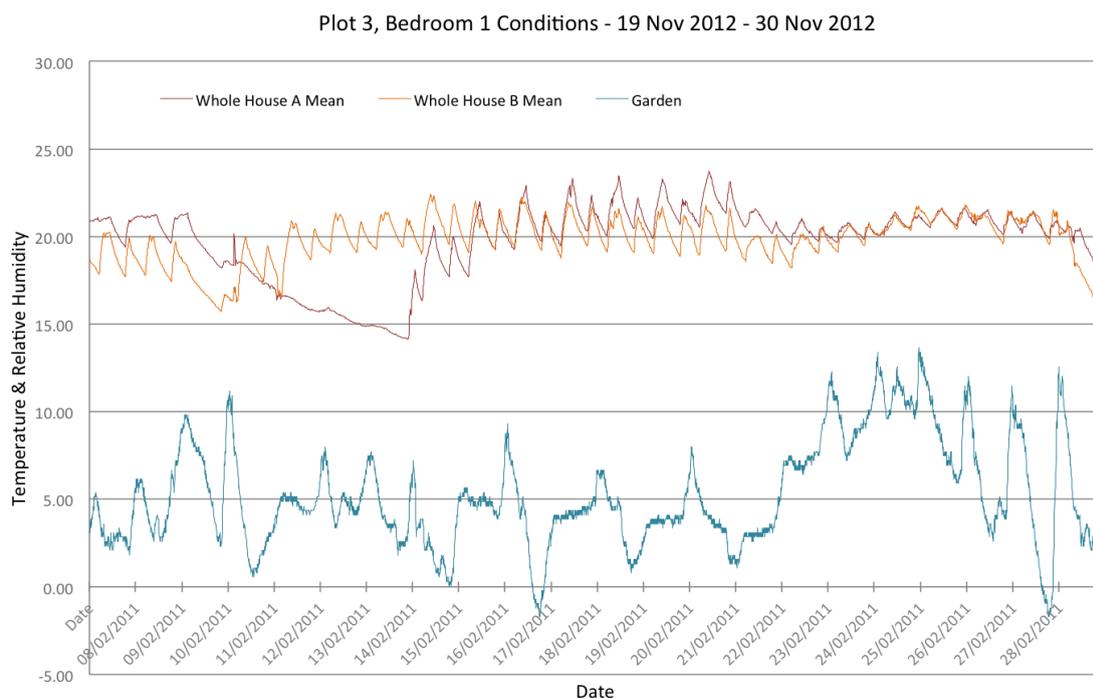
Figure 11. Pilot study, average temperatures Plot 1 and Plot 3.

In the original pilot study, the standard regime had set TRVs to 4 and the thermostat was set to 21 °C. This was found to produce temperatures that were uncomfortably high, despite very cold external conditions (Figure 11) and there was an indication that the fabric of Plot 1 was becoming warm, with an increasing temperature profile during the week. To address this in the second week, the TRVs were set to 2 and the thermostat was set to 20 °C and the change in heating regime resulted in a more stable thermal environment.

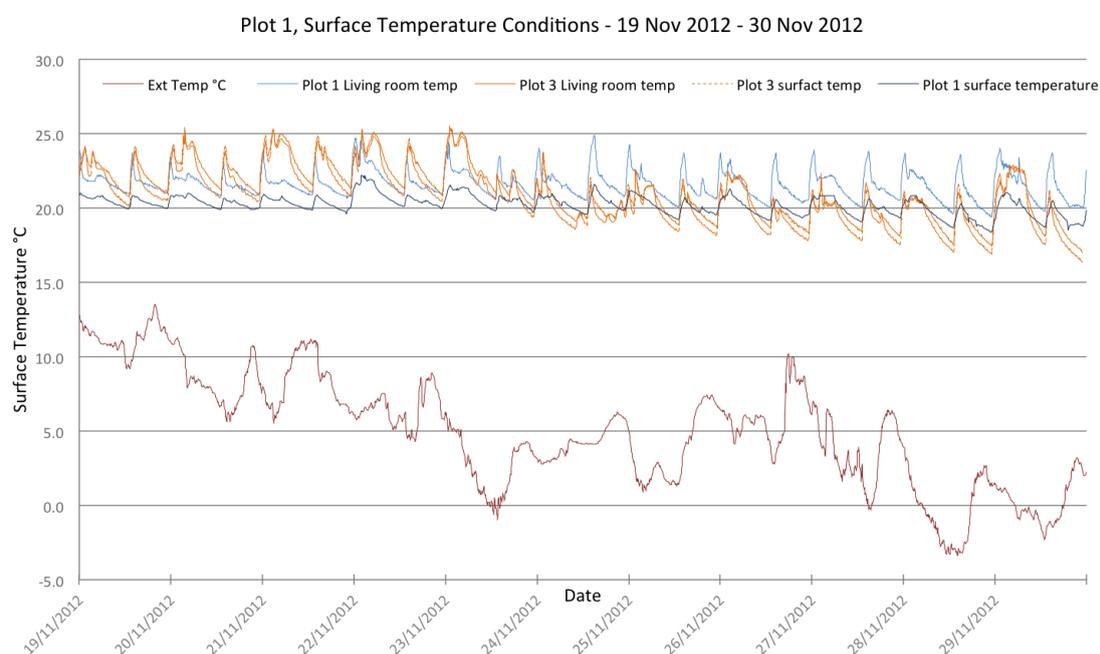
Figure 12. Comparison of air and surface temperatures SC6 (with MVHR vs. window opening).

Effects on temperature due to the variation in ventilation regime were apparent in SC6. In the second week, there was a greater degree of window opening that appears to impact on temperature more in the thermally light Plot 3 than in Plot 1. In Plot 1, the living room had a mean temperature of 21.8 °C in week 1 and 21.4 °C in week 2. In Plot 3, the living room week 1 mean was 22.6 °C, which dropped to 19.8 °C in week 2. It is apparent that the fabric in Plot 1 retains its temperature with a more liberal window opening regime. Comparing the air and surface temperature in Figure 12 clearly shows the relationship and is indicative of the benefits of the thermal mass at maintaining temperature with greater ventilation. This would have important implications for comfort and energy consumption, particularly in conjunction with a low level continuous heating regime.

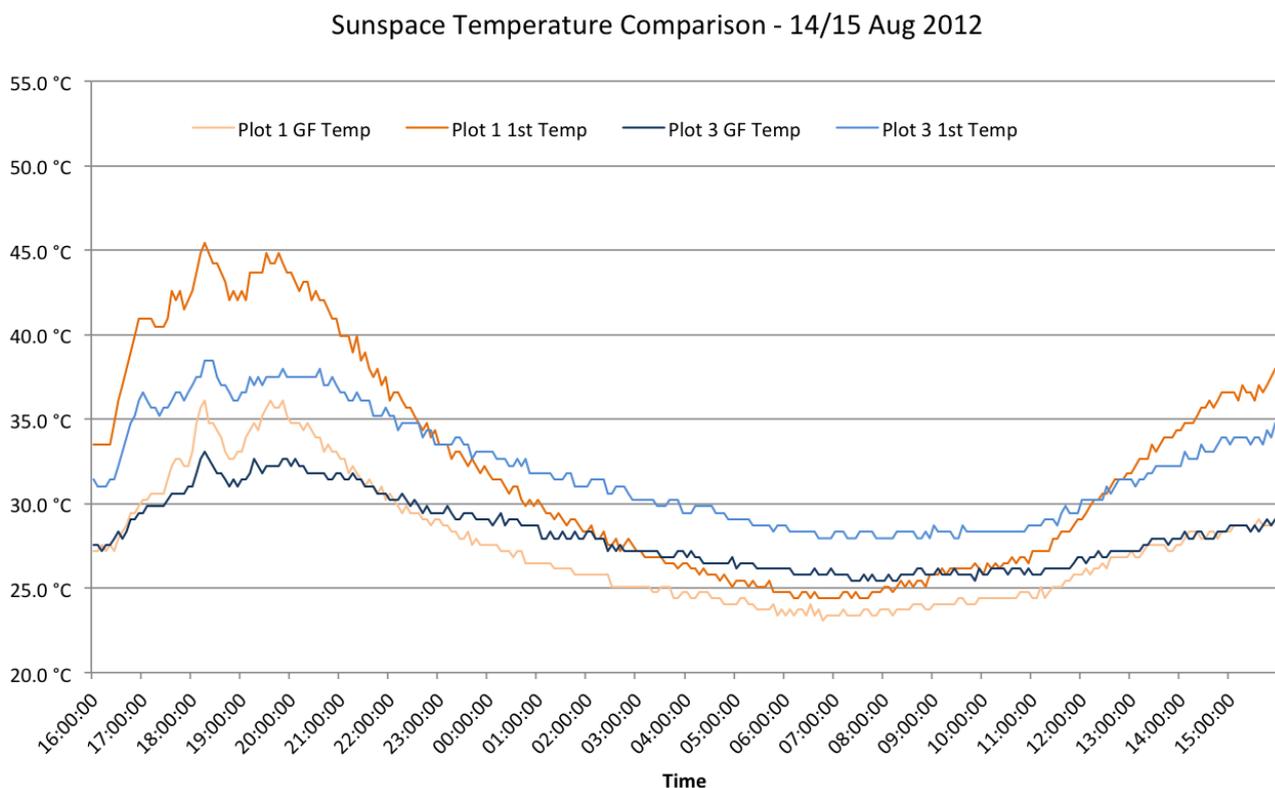
Figure 13. SC4 sunspace temperatures ground floor/first floor Plot 1; ground floor/first floor Plot 3.

The effects of thermal mass in the sunspace were also examined in SC4 and have been reported previously [26]. In this scenario, an unoccupied profile was used to avoid incidental gains but the MVHR system was left running. The effect of thermal mass in the sunspaces was apparent (Figure 13). Due to an irony of construction, in Plot 1 the sunspace is finished with white render on rigid board insulation, whilst in Plot 3 it is finished with a dark brindle brick outer leaf. The sunspaces are double height and temperatures readings were taken at both the lower and upper floor and shown in Table 8.

At present, there is no effective means of utilising these gains. There is no vent between the sunspace and the living or bedrooms, and so the only way to ensure air movement would be to open the door to these spaces, a relatively uncontrolled strategy.

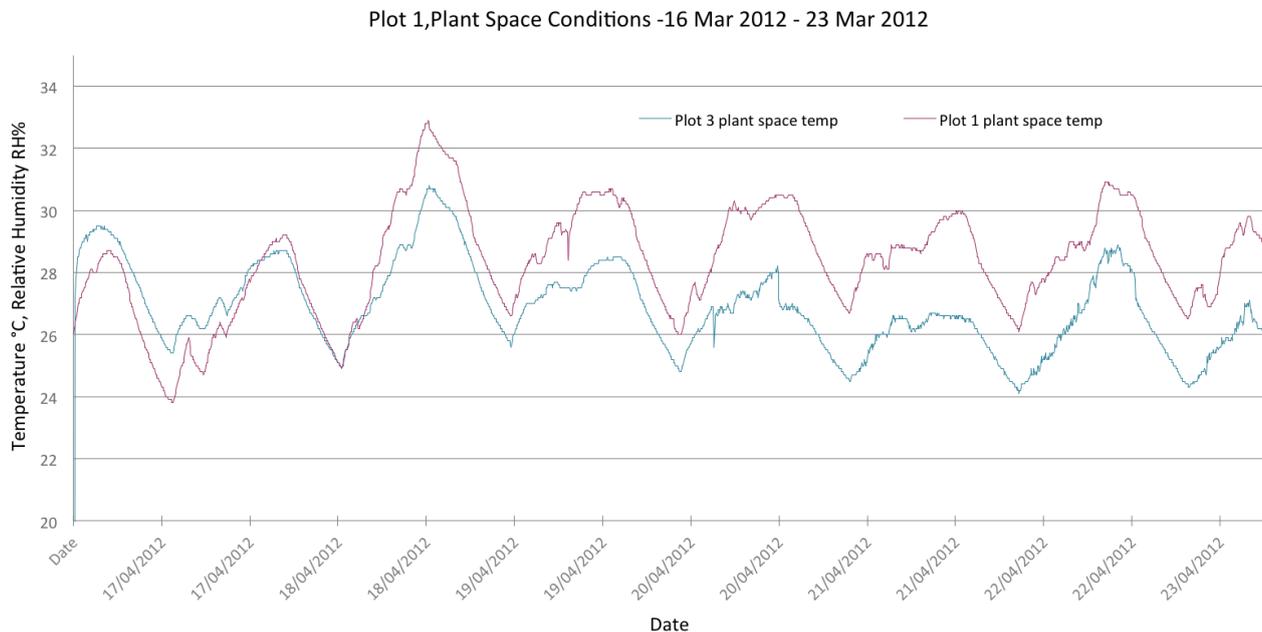
Figure 14. SC3 plant space temperatures Plots 1 and 2.

Some issues of overheating were also identified. A particular—and avoidable—source of this was the hot water system. The commissioning tests identified that the pipework from the hot water and solar thermal system was uninsulated. The solar thermal store is located in a top floor plant space and temperatures here were seen to be remaining between 25 °C and 30 °C (Figure 14).
