WHERE THERE'S MUCK...

The second of three studies of single inside cylinder brass locos

By Nicholas Oddy

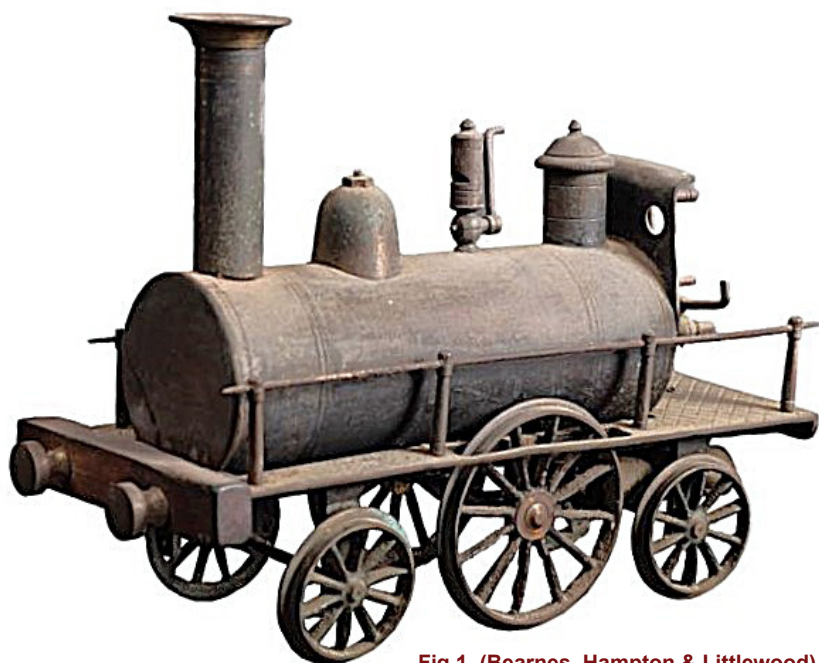
Fig 1. (Bearnese, Hampton & Littlewood)

In a moment of madness, I bought a three-axle dribbler for rather more than I should have. I was in the USA at the time and was working only from a single picture on a laptop. What attracted me to it was that it was inside cylinder and 'broad gauge' in pattern with fence-like siderails running its length. Both these features register high on the brass loco desirability stakes. Moreover, I suspected I had a suitable tender for it. The condition looked 'untouched back-of-a-shed', also hugely attractive **Fig 1**. Experience has shewn me that when looking at 19th century locos like this, the old Yorkshire adage of 'where there's muck, there's brass' is apt. Under thick grime like this often lurks a good original finish (notice the gleam of original lacquer on the dome – a good sign). Looking as sorry for itself as it

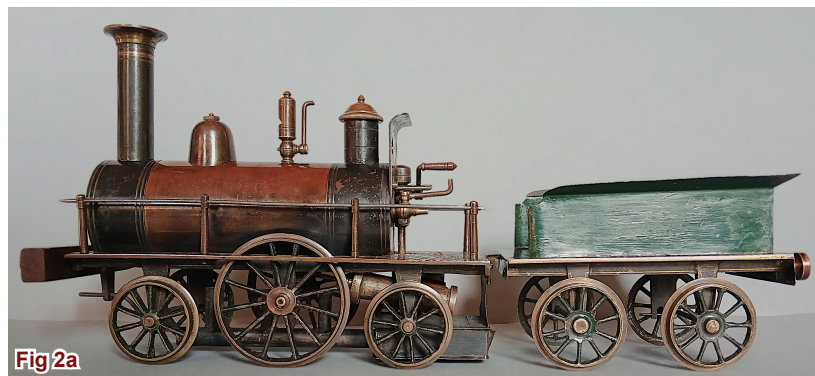
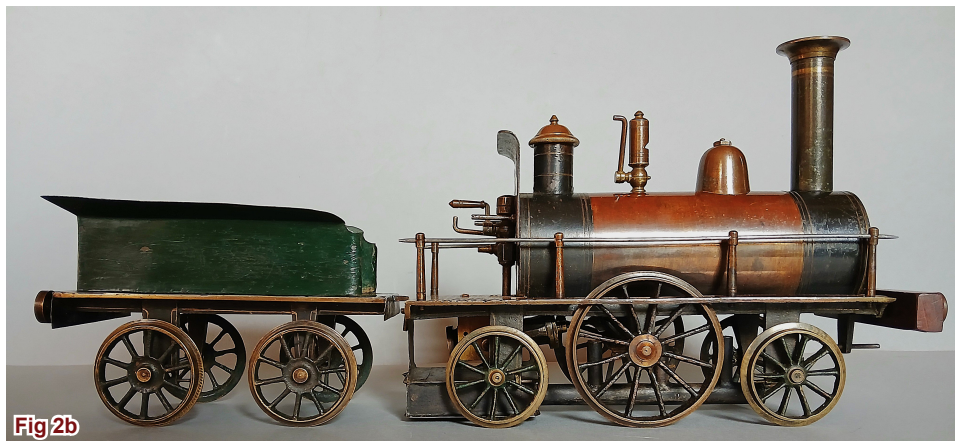
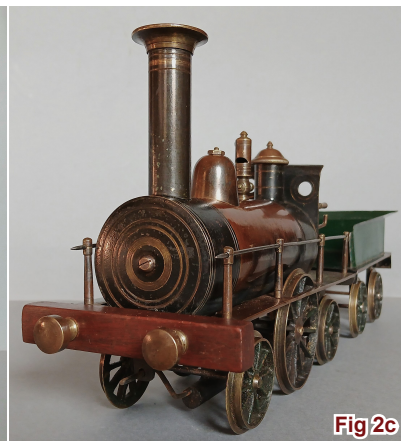
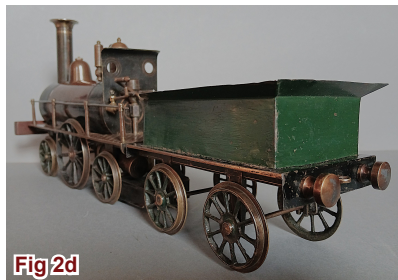
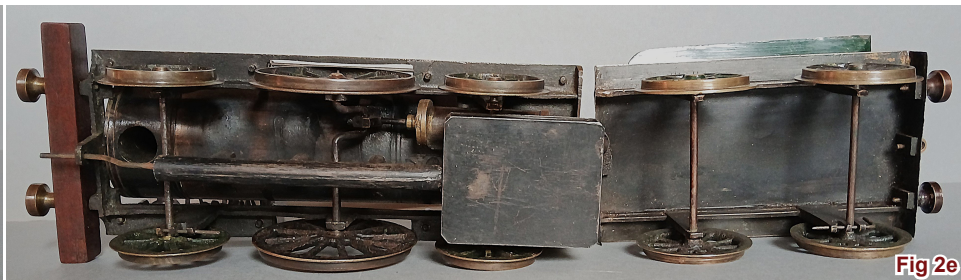
Fig 2a

bright and oxidised brass. **Figs 2a-e** show the loco and tender at the other end of the cleaning and fettling process.

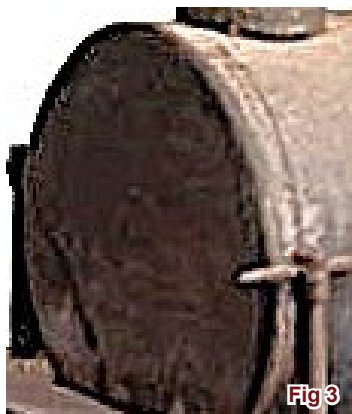
Fig 3

have thought it was odd in not having anything in its centre, usually there is a screw bung or a water check cock. However, it was only after I had worked close to it did it transpire that there was a lot of solder and no lacquer, then it was clear the boiler front was not lacquered brass but raw copper. Copper is very ductile and it was probably chosen because it could be easily beaten over the boiler barrel to form a lip, whereas brass is far harder **Fig 3**. There were obvious file marks to boot. It seemed inexplicable, the rest of the loco was very good, untouched, why would it need a new front? The answer was to become clear.

I finished cleaning the boiler, then took a pencil-flame blow torch to the front. In this way the front is brought up to solder melt temperature with minimum heat transfer to the boiler barrel. As soon as the solder melted, I pushed off the front with a wide screwdriver. The remaining solder is simply removed by aiming the flame at it until it melts and then, while still liquid, it is easily wiped off with a dry cloth. It's a process

that requires practice, but it is one that I have had a lot of experience of. The original front had been inset and soldered, as at the rear. I could make one, but I wanted an original. I dug through my stock of write-off dribbler boilers, to my delight I had one with a slightly oversize front, still in black lacquer with turned rings and, better still, soldered over the barrel. Here I do the reverse, heat the barrel to melt temperature to avoid overheating the front and push off the front, as far as possible retaining the lacquer and rings. Once off, it was a simple matter to spin the front in a lathe to take its diameter down to snug fit in the barrel. Then an easy soldering job and, hey presto, the boiler as first made.

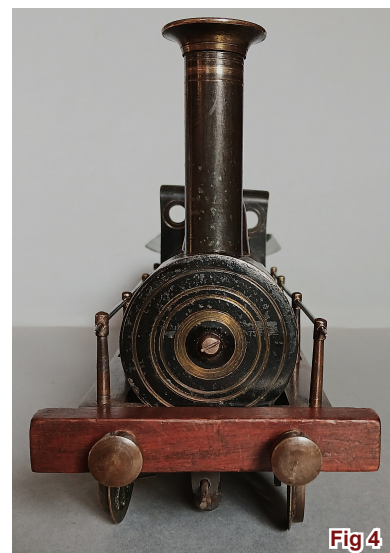
Fig 4

However, no matter how careful, there was considerable loss of lacquer at the front of the boiler, particularly where the solder had been, where I had had to remove file marks and where I had cleaned up the joint between front and barrel. It would be nightmare to match up chemical blackening in such a situation, but lacquer is a different matter, it is microscopically thin; so, does not show tide and 'cliff' marks like normal paint. It is much more easily controlled than chemical finishes that require careful preparation of the metal below, which has to be consistent. Lacquer was applied where required, stoved and then the whole boiler spun in the lathe to re-establish the banding. Then a coat of clear 'gold' instrument lacquer, a second stoving, and, finally, bit of weathering. I'd defy anyone to ever think such a heavyweight job had been done to it **Fig 4**. The reward of years of practice.

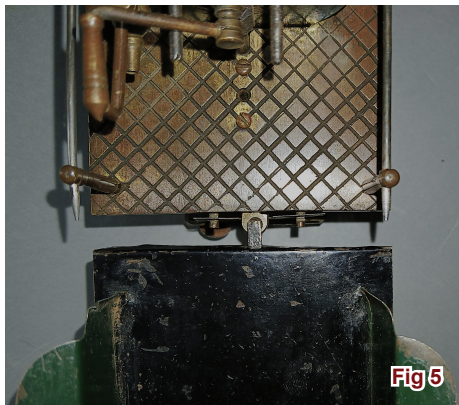
fairly basic loco, it has a regulator (not just a steam tap) and a nice, broad, tube whistle (not a bell type). Its wheels can be set to describe a circle or go straight. The burner is also of an early pattern, hooked over a couple of screws in the drawbar beam. Later brass locos tend to have screw-fixed or slide-in burners. The finish has a detail that also strikes me as unusual, in that the axle hangers and underframe are darkened then lined out with a scribe, the sort of nicety overlooked later on. A curiosity is the drawbar is offset towards the 'inner' side of the loco, presumably to allow an element of close-coupling were it set to describe a circle **Fig 5**.

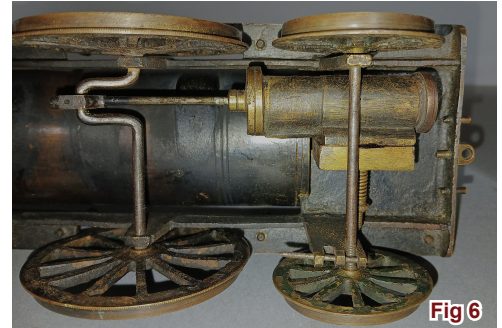
Meanwhile, underneath is a large, double-acting, single, oscillating cylinder **Fig 6**. This is 'one-sided' with the cylinder held

to its block by a threaded rod and spring, the thread is pleasingly coarse, typical of earlier locos. The block is internally ported to transfer steam from one side of the piston to the other. Unlike a single-acting block of this type, a double-acting one has port holes both sides of the pivot, aligning with the rocking of the cylinder, but it does not require the milled channels we saw in TC 74 and is cheaper and less space consuming than the traditional rockers both sides of the cylinder. This allows the

cylinder to be off-set to one side, giving space for burner wicks beside the motion. It is here we see the difference between a fully commercial approach to inside single cylinder drive from that of the conversion in TC 74. In this loco, the cranked axle is literally that, bent into a crank, rather than the far more elaborate (and engineering-like) constructed crank of the loco in TC 74. Reflecting its relatively basic nature, it has no piped exhaust to the chimney, but exhausts straight out of the block.

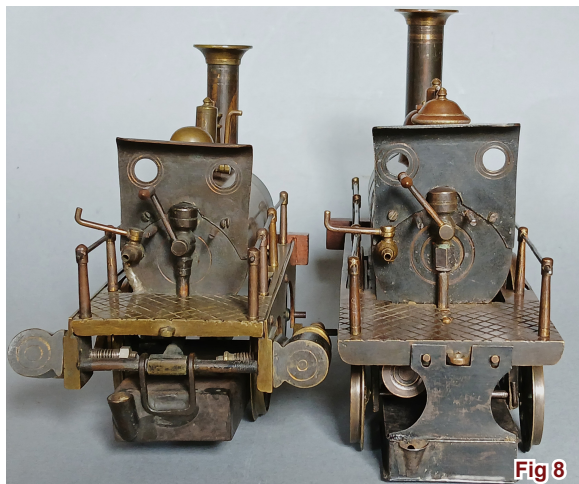
Who made it? Well, in many ways it has close similarity to *Pilot* **Fig 7**, a loco that may well be early Stevens, although we have seen in previous issues that ascribing makers to locos like this is very uncertain in all but a few cases. It shares an identical style of weatherboard. The wheels are identical pattern if different diameters. The regulator and handle are identical save for its steam pipe fixing **Fig 8**. The whistle is identical and on the same thread, as are the check cocks. The side rail supports are identical pattern, if slightly different heights. So, without better provenance, but given the similarities of its build and components, it may well share the same maker. I suspect it is London built, belongs to the late 1870s or early 1880s and was likely sold through Stevens' and Bell's model dockyards and other retailers. Who actually built it might remain forever uncertain, it *could* be Stevens, but equally it *could* be Bell, or equally a maker who supplied both. At this stage I'm *minded* to say Stevens and that is as far as I'll go.
