Building Performance Evaluation

A design approach for refurbishment of a small traditional building in Scotland

Land Sea and Islands Centre - Arisaig

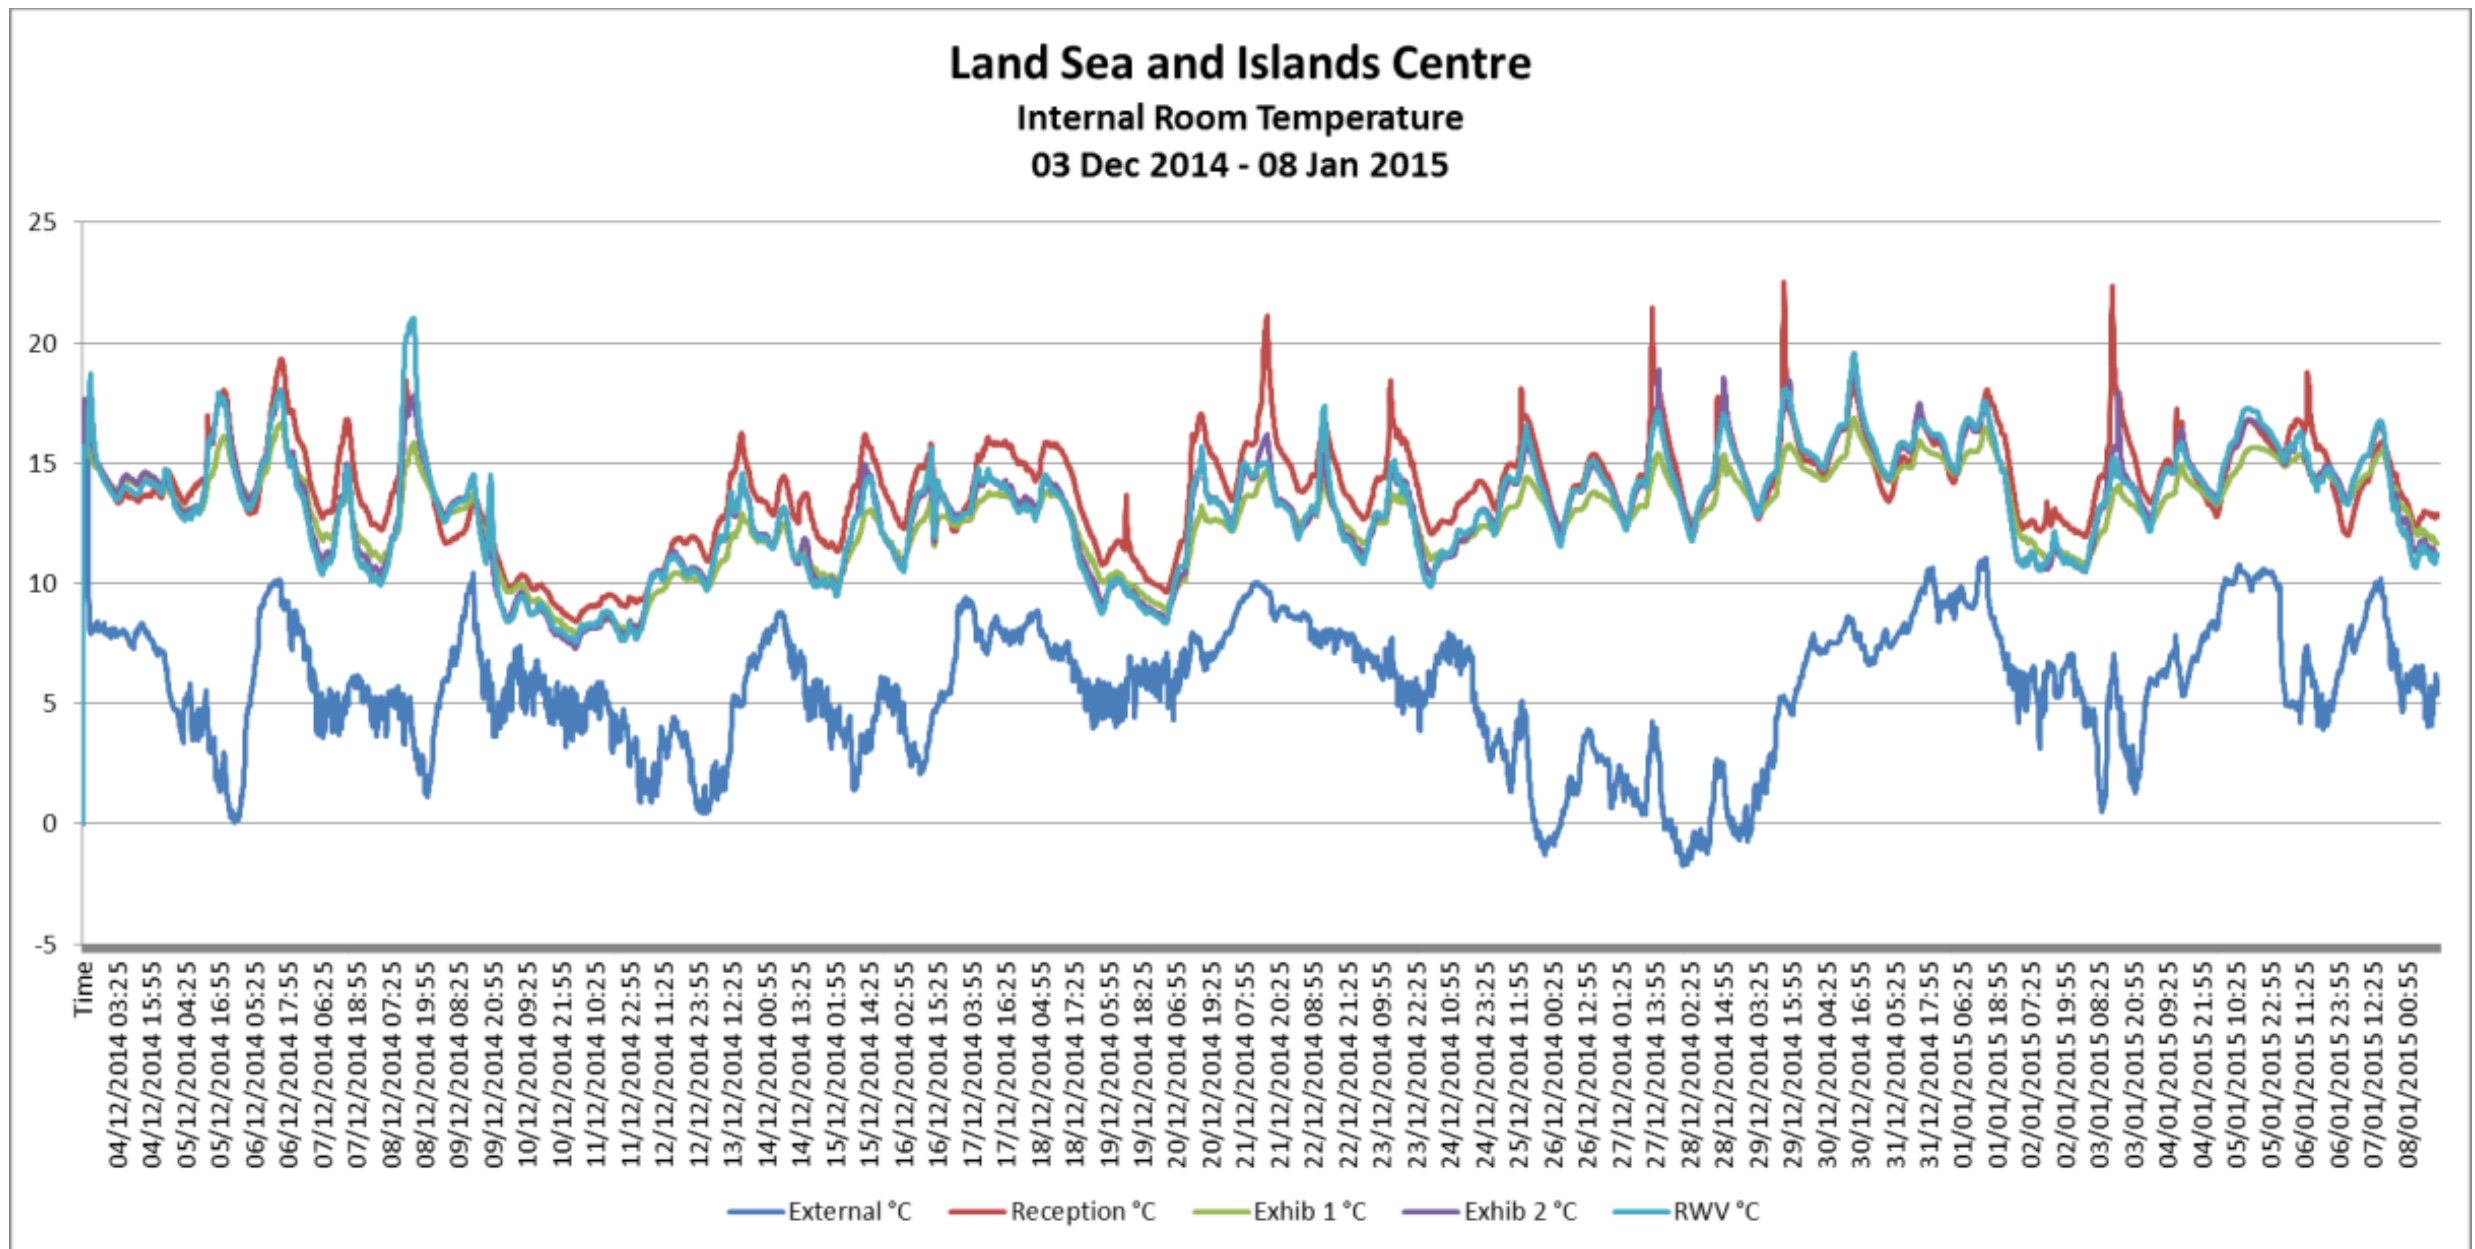
Results – Indoor Environment

- Internal temperature too cold
- Bulk up with layers in winter
- Building too draughty in winter
- Heating on all of the time
- Condensation forming on some windows
- Not certain how to operate all controls in the building

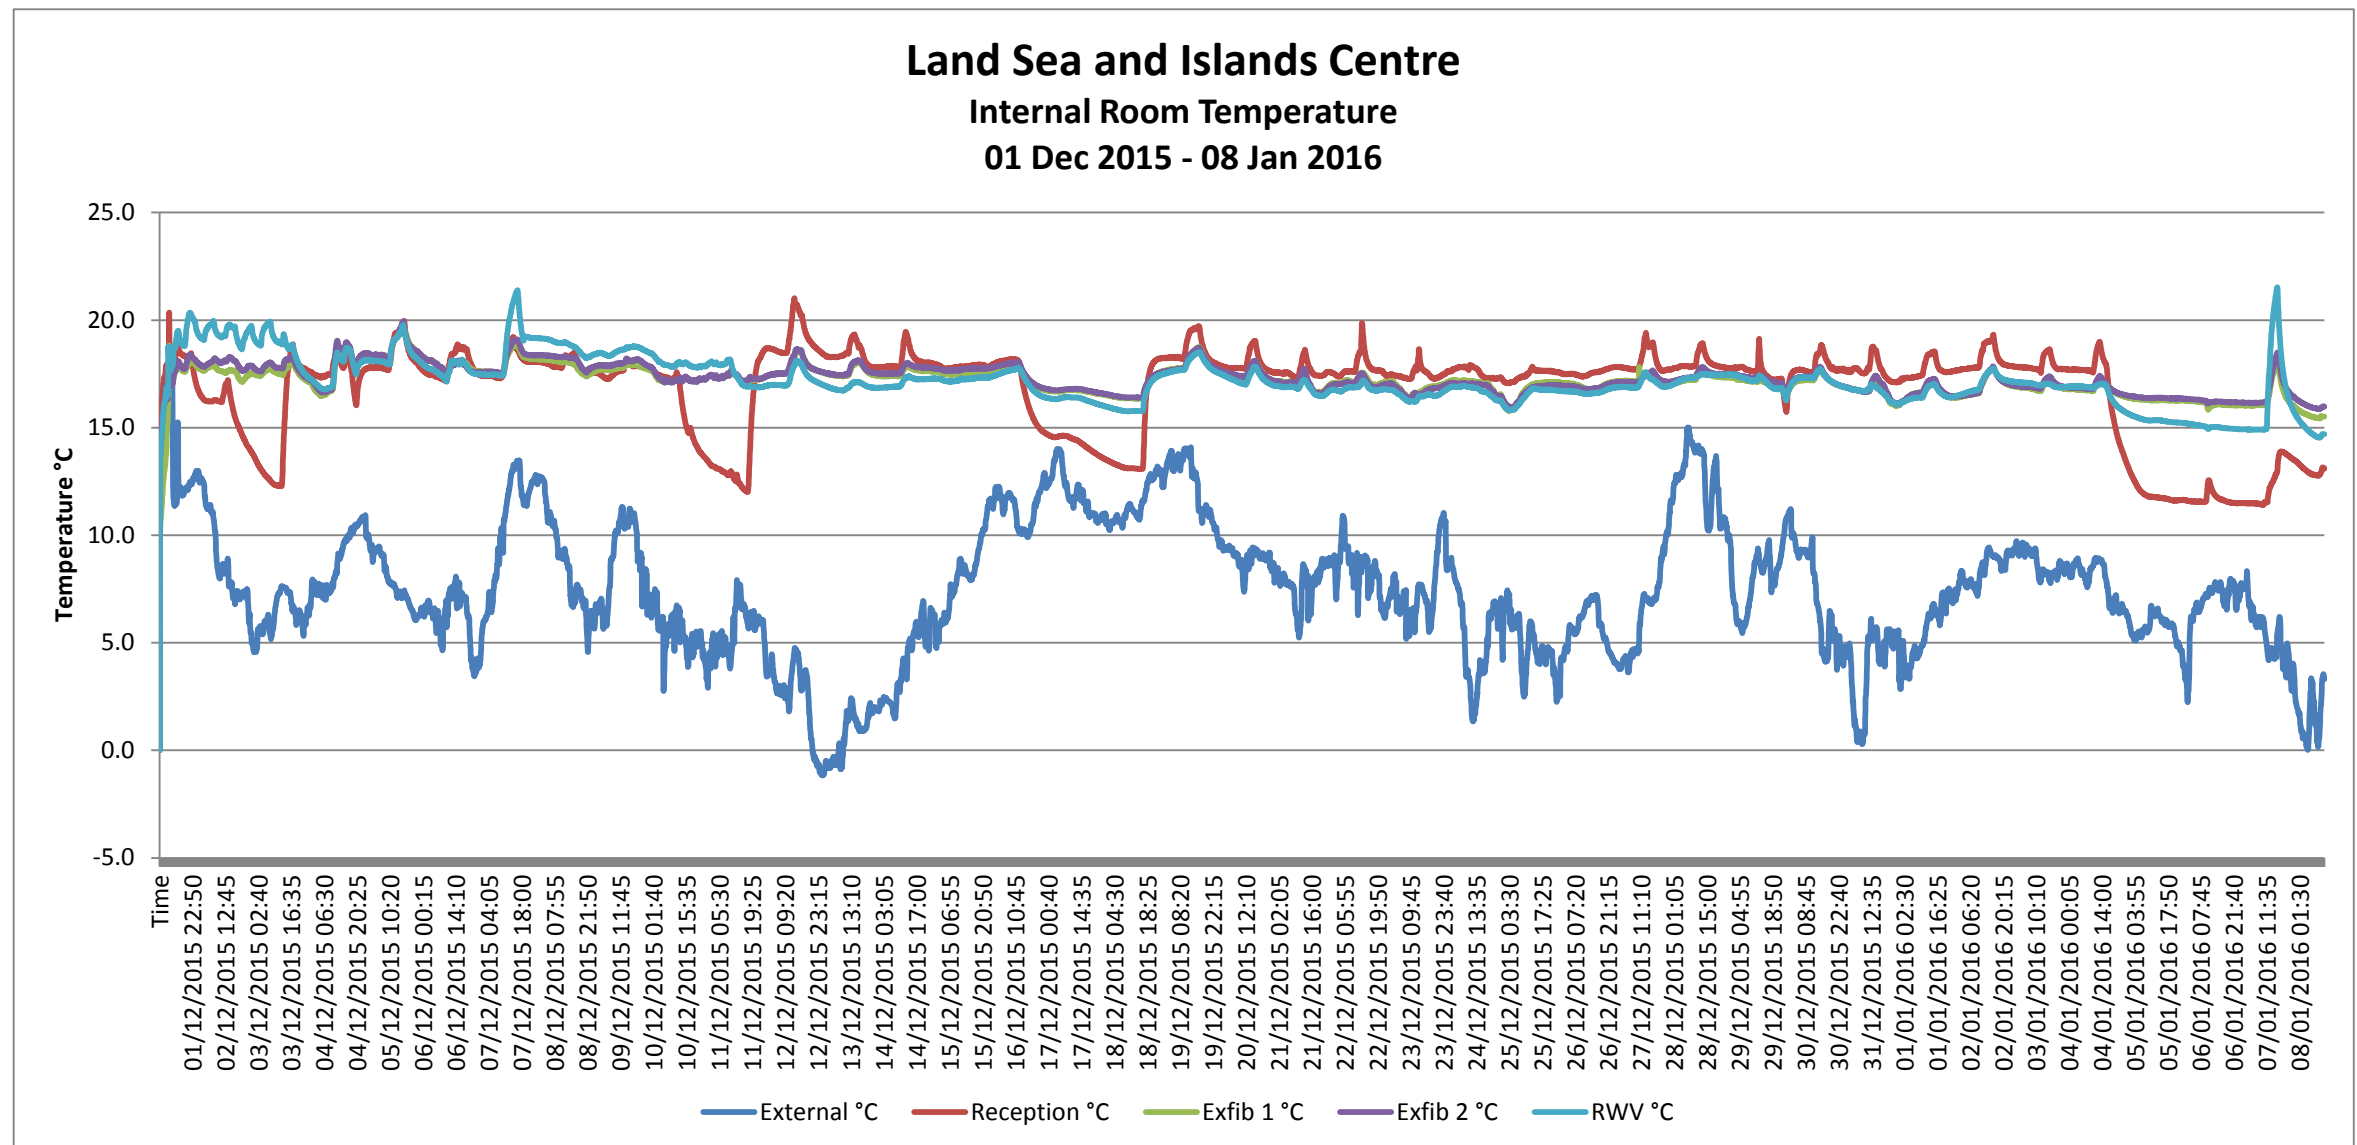
Results – Indoor Environment

- Comfortable internal temperature
- Only two radiators used for thermal comfort
- Windows now opened to ventilate
- All trained in how to operate systems
- Visitors remain in the building for longer
- Hosting more community events
- Building now used through the winter!

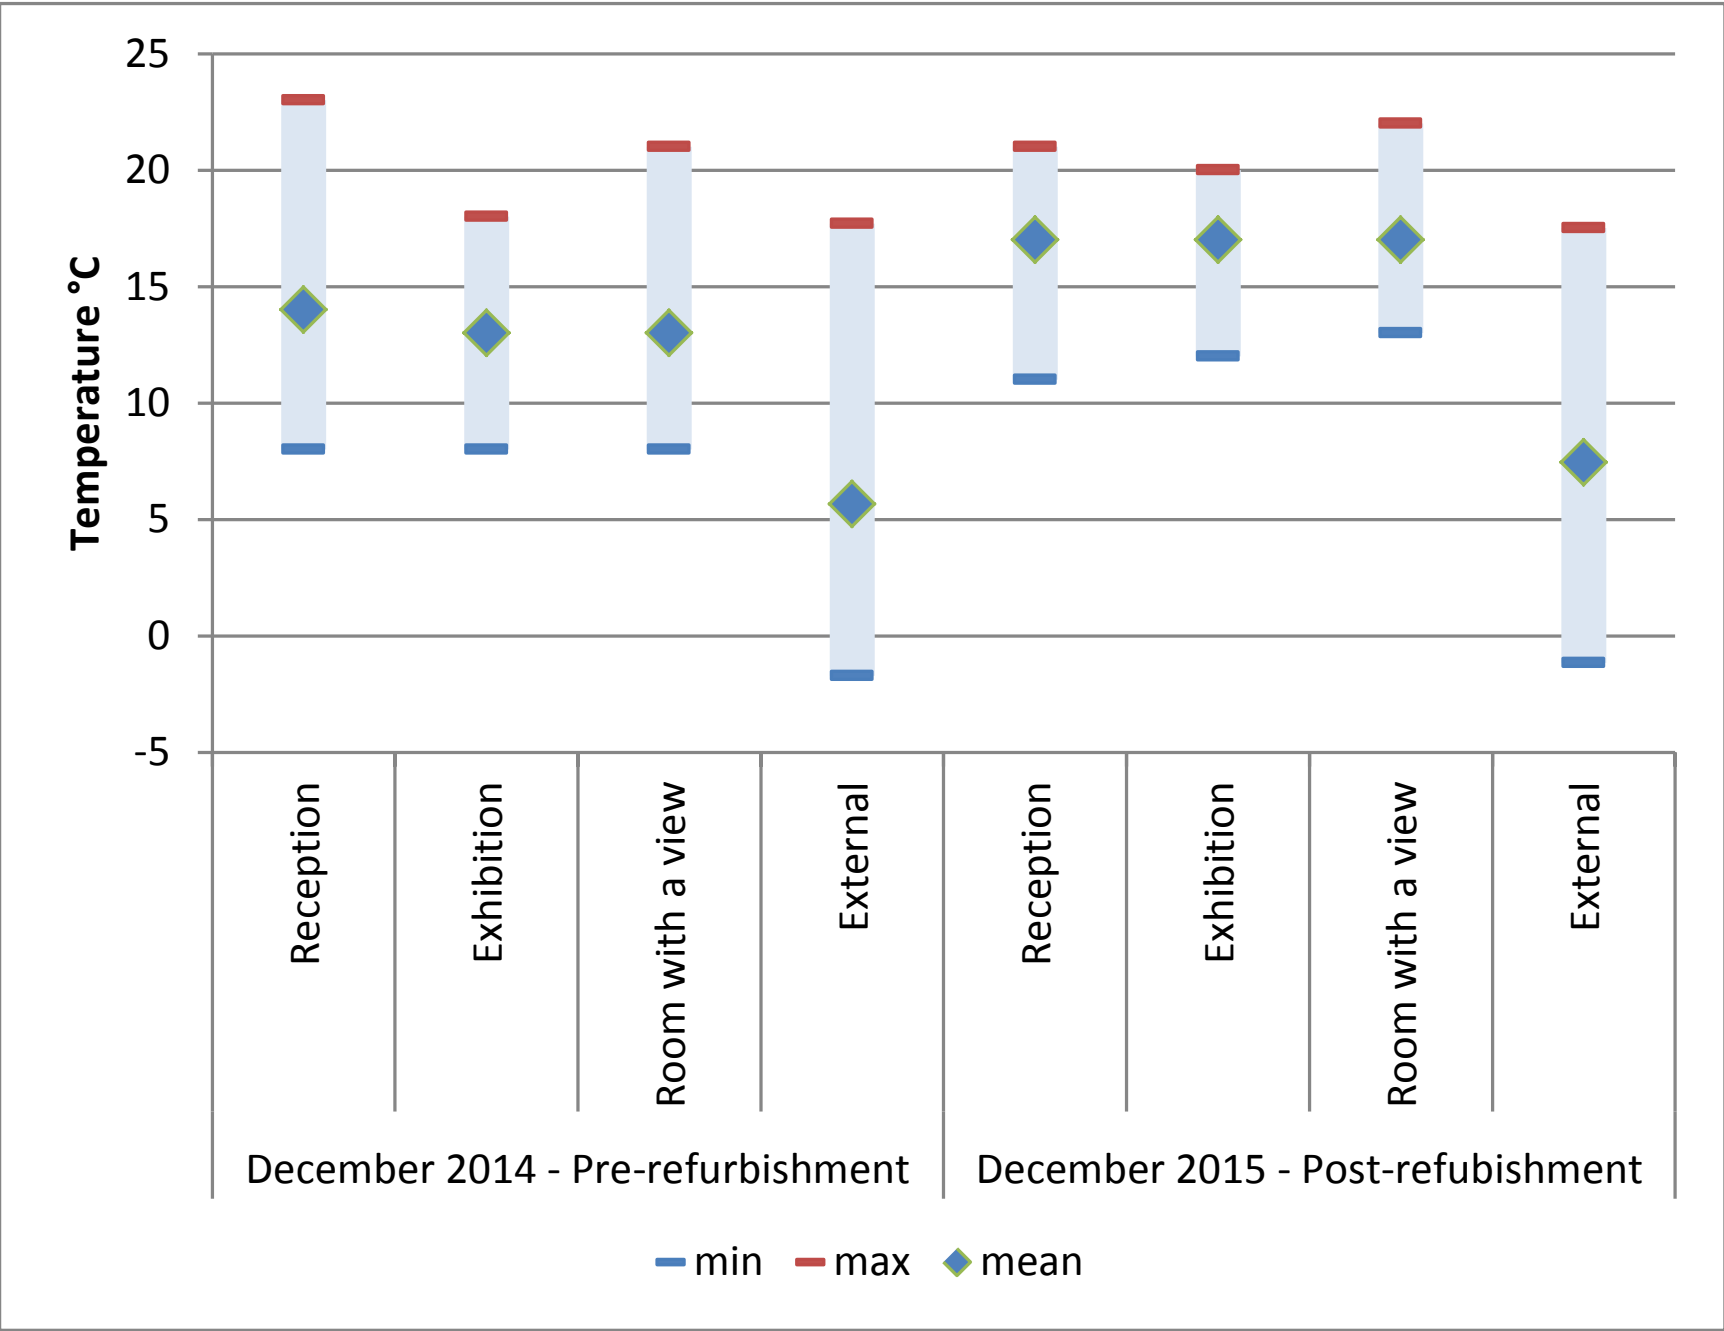
Results – Temperature

- Draughts reduced by 85%
- Less heat loss through walls, floor and roofs reduced
- More energy efficient heating and lighting installed
- Energy use reduced by 57%
- Clients can open throughout the year and heat the building to more than 16°C!
