Building Performance Evaluation – A design approach for refurbishment of a small traditional building in Scotland

J. A. Foster¹, A. Poston¹ and S. A. Foster².

¹Mackintosh Environmental Architecture Research Unit, The Glasgow School of Art (GSA), Glasgow, G3 6RQ, UK. j.foster@gsa.ac.uk

²Sam Foster Architects (SFA), Dunfermline, Fife, KY12 8HZ, UK. sam@samfosterarchitects.co.uk

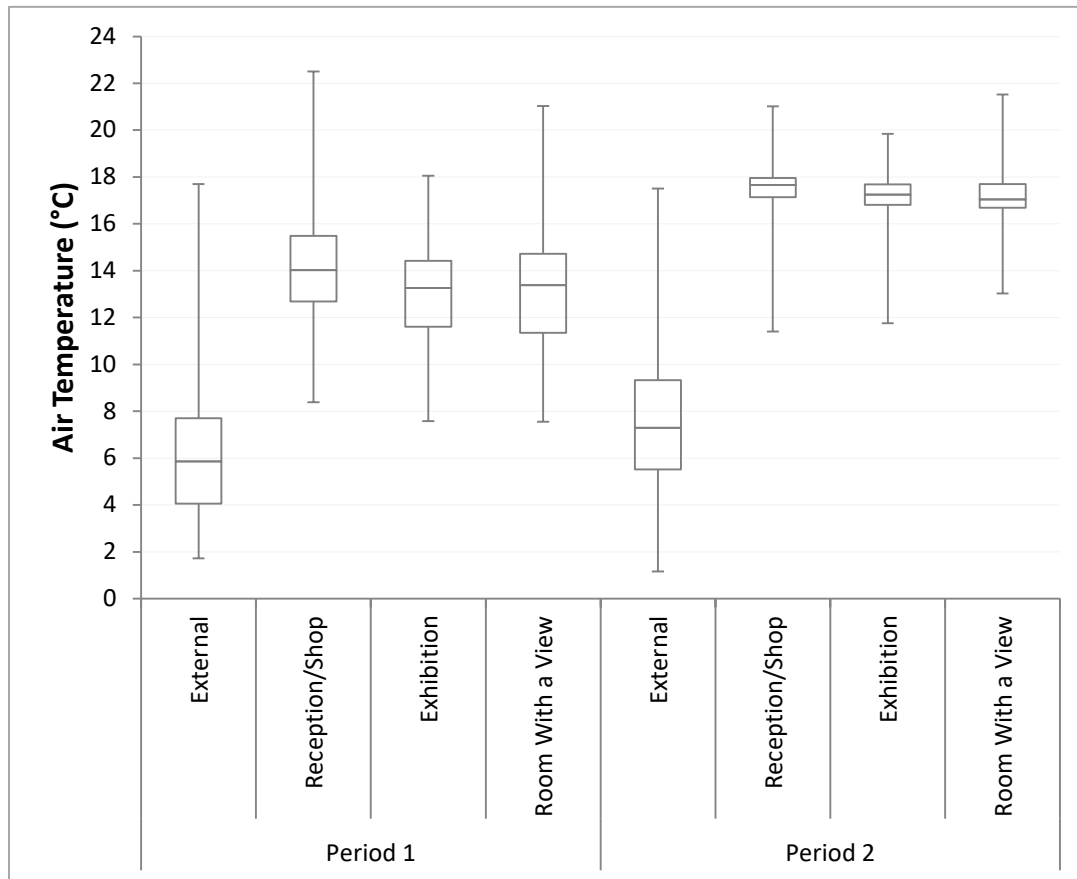
The external temperature throughout both monitoring periods was unseasonably warm for the time of year. Figure 6 presents an overview of the temperature ranges through two monitoring periods where median external air temperature was around 6°C and 7°C for PERIOD 1 and PERIOD 2 respectively. There were similar weather patterns during both of the monitoring periods with unexpected warm days, during which the external temperature rarely fell below 0°C. However, when comparing internal air temperature data for both PERIOD 1 and PERIOD 2 significant differences were observed. In PERIOD 1 the internal temperature distribution is relatively wide with the majority of internal temperatures remaining between 11-15°C. Conversely, the comparison of data between PERIOD 1 and

PERIOD 2 indicates higher internal air temperatures for PERIOD 2 that are relatively stable between 16-18°C in each of the three monitored rooms.

Figure 6. Overview of PERIOD 1 and PERIOD 2 temperature (°C) ranges.

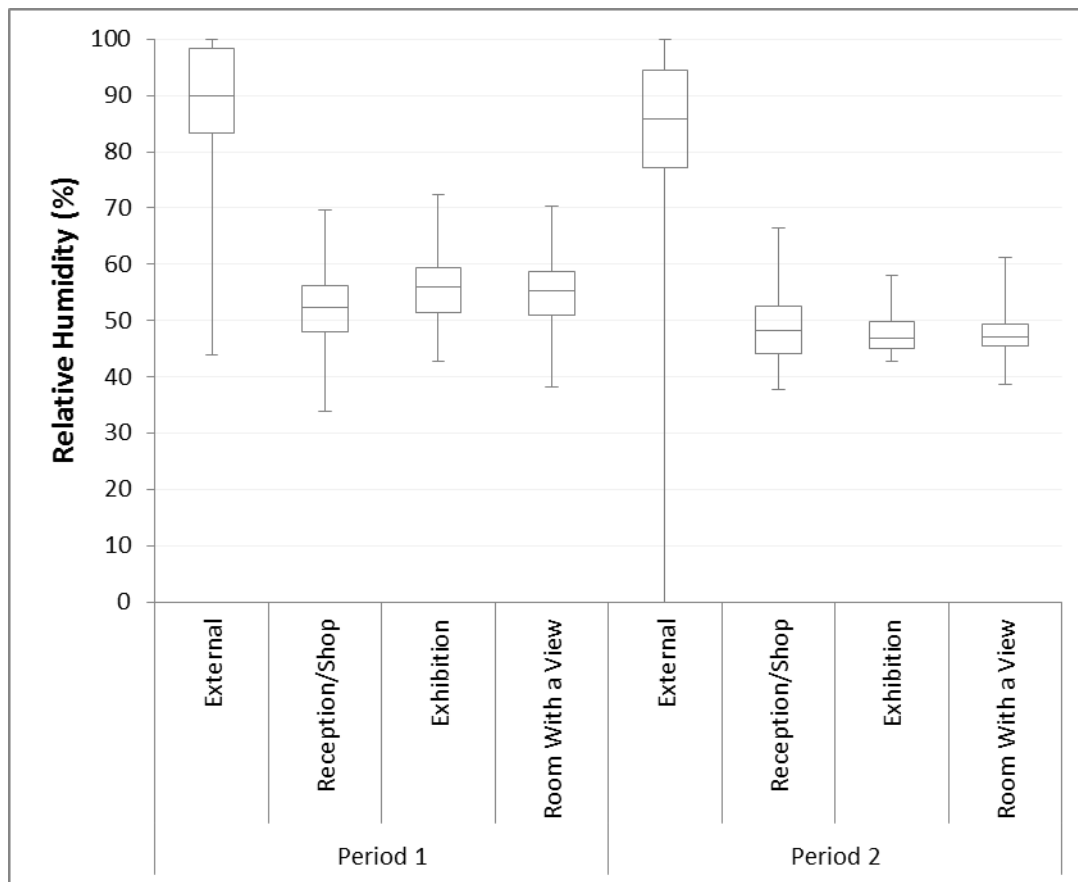
External relative humidity (RH) readings were wide ranging, with the bulk of external data between 75 and 98%. While the RH data in Figure 7 indicates that PERIOD 2 was slightly less humid than PERIOD 1, when correlating between external temperature and RH on a psychrometric chart the external moisture content for both monitoring periods are similar. The indoor monitoring indicated the RH remained between 30-70% with the median

at around 50-55% RH for PERIOD 1. Comparing this data with PERIOD 2 there is a distinct difference where lower RH was recorded and RH conditions were more stable.

Figure 7. Overview of PERIOD 1 and PERIOD 2 relative humidity (%) ranges

The reception has the largest fluctuations; however, this was an expected outcome due to the cosmetic upgrade designed for this area. The exhibition room indicated a narrow RH band showing less of a RH swing. This type of behaviour is favourable for the exhibits on display and aligns well with the recognised RH band for health of buildings and occupants. Furthermore, there were no significant differences in overall internal moisture content, and therefore the more stable conditions could be a result of the quantity of vapour open building materials used in this room.

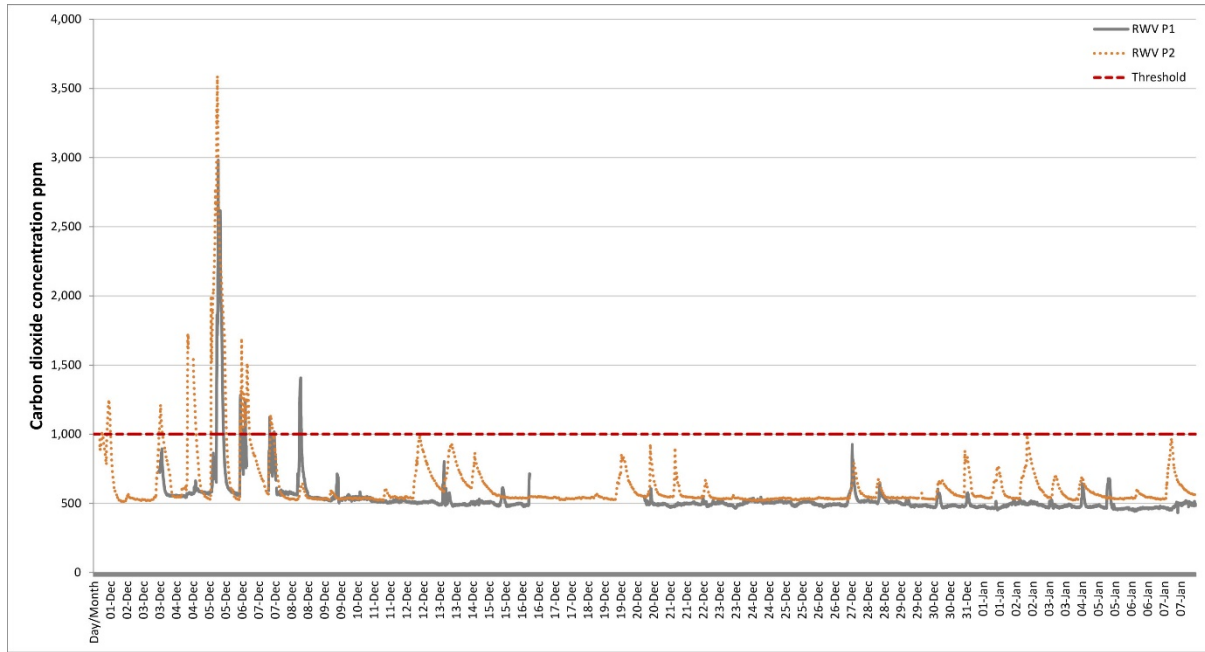
Carbon dioxide concentrations were measured to allow evaluation of the ventilation rates within the building. A comparison of PERIOD 1 and PERIOD 2 concentration rates were made for all three monitored rooms and were additionally compared against established benchmarks. There were unexpected differences in concentration rates where PERIOD 2 had higher peaks than PERIOD 1 in concentrations during the two monitoring periods. The data plotted for the room with a view (RWV) in Figure 8 indicates that there were large peaks and troughs in carbon dioxide concentrations over three consecutive days during both monitoring periods and similarly with the reception/shop area results in Figure 9. These peaks were later associated with Christmas fair events that were well attended by the local community. Aside from this annual event, what is interesting about the data is that there were frequent carbon dioxide concentration increases, most notable during PERIOD 2 monitoring. While these peaks have been taken to be within acceptable carbon dioxide concentration limits, of less than 1,000ppm, for acceptable indoor air quality, a theme is emerging where the building may not be being adequately ventilated when occupied.

Figure 8. Room with a view (RWV) Carbon Dioxide (CO₂) concentrations throughout PERIOD 1 and PERIOD 2.

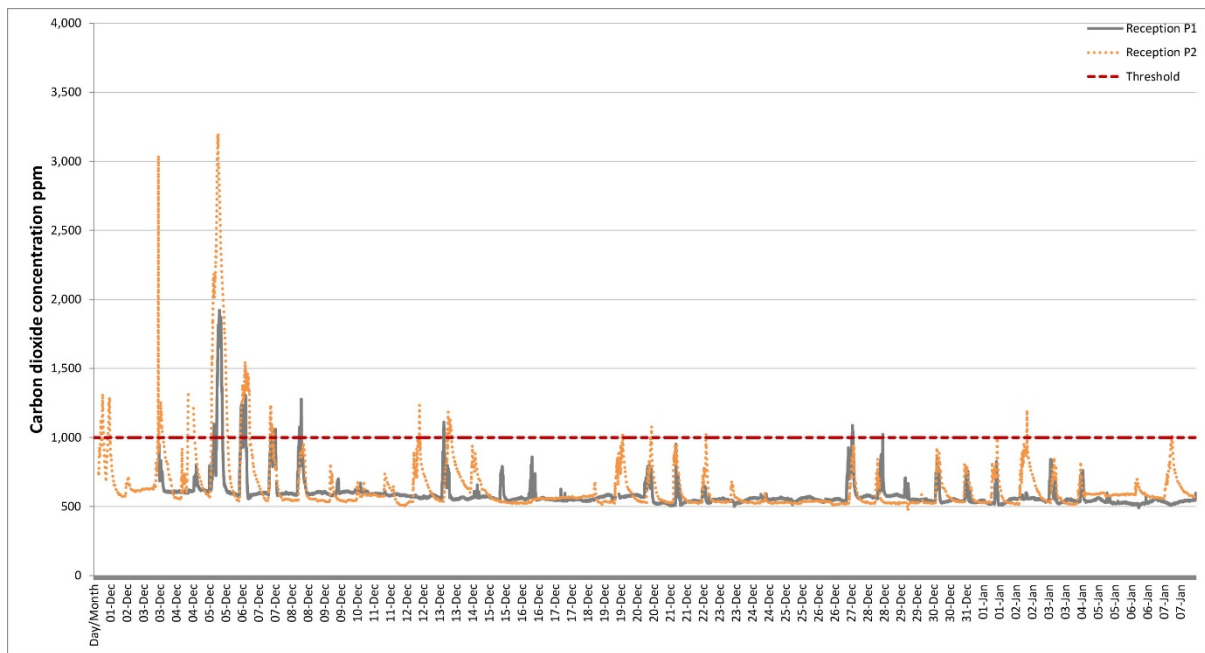
Figure 9. Reception/shop area Carbon Dioxide (CO₂) concentrations throughout PERIOD 1 and PERIOD 2.

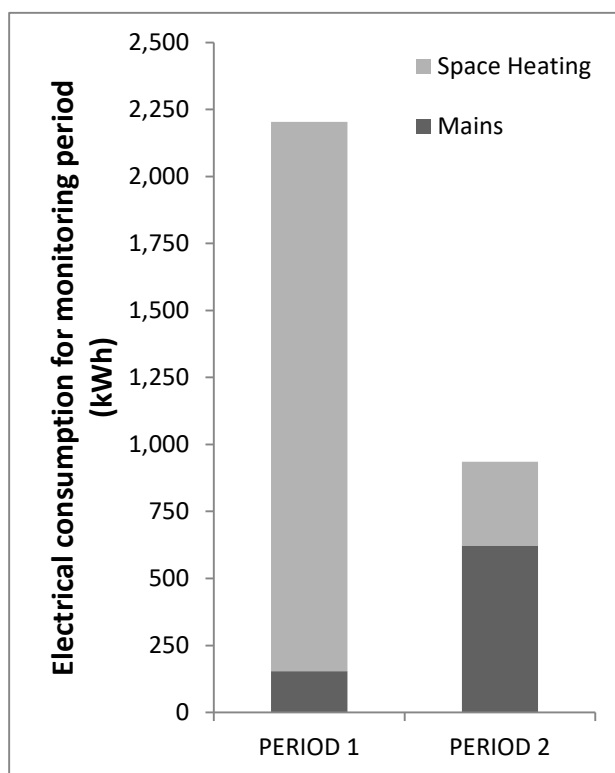
Electrical meter readings were recorded twice each day and this information was used to assess the overall energy reductions in the building. Figure 10 indicates a significant overall energy consumption reduction of 57% between the two monitoring periods. This is 18% less than the 75% prediction. However, the building occupation increased from around six months opening per year before the refurbishment to twelve months opening per year after the refurbishment (PERIOD 2) which affects the overall energy reduction.

Figure 10. Overall energy consumption, space heating and mains, in PERIOD 1 and PERIOD 2.

The most surprising aspect of this data was the unexplained dramatic increase in mains electrical energy consumption between the two monitoring periods. Post PERIOD 2 BPE the LSIC employed the services of an electrician to determine the cause of the unexpected increase in mains power consumption. It was found that two of the electric storage heaters
