# Building Performance Evaluation

Lessons from studies of 26 Scottish low-energy homes

**MEARU: J Foster**

December 2018

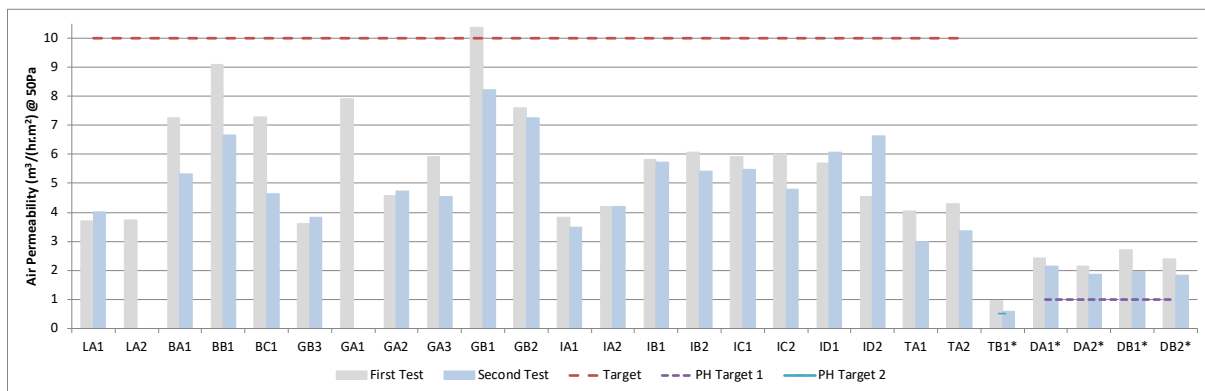
Figure 2: Air permeability (m³/h.m² @ 50Pa) test results for housing subject to BPE.

The results from the air permeability tests, as well as the design targets, for each of the 26 dwellings monitored are shown in Figure 2. This indicates that one dwelling exceeded the 10 m³/h.m² @ 50 Pa design target and all five Passivhaus dwellings (indicated with an asterisk in Figure 2) failed to meet their more stringent air permeability design targets.

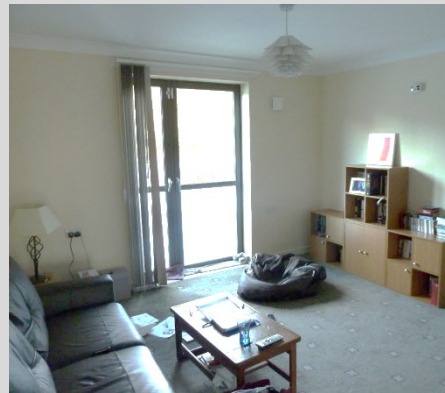
The occupant did not use two rooms in this flat (north-east facing living room and bedroom) during cold, windy periods in winter as the draughts that entered the property caused significant discomfort. It was perceived that the flat was difficult to heat to an even continuous temperature due to the draught being drawn across the living room to be heated by the radiator on the opposite side of the room.

The first air permeability test was recorded at  $10.39 \text{ m}^3/\text{h.m}^2 @ 50\text{Pa}$ , which exceeded the design target of  $10 \text{ m}^3/\text{h.m}^2 @ 50\text{Pa}$ . During this test significant areas of air leakage were identified and the fitted carpet was seen ballooning upwards, highlighting significant air leakage from below the finished floor. At the end of the two-year defects liability period and two years of complaint by the occupant, remedial sealing works were undertaken. These consisted of the contractor applying silicone sealant to the top edge of the skirting boards and beneath the window sills. These sealing works were undertaken a few weeks ahead of the second air permeability test where a result of  $8.23 \text{ m}^3/\text{h.m}^2 @ 50\text{Pa}$  was recorded. The BPE researchers have concerns over the suitability of this method for the remedial works and the longevity of this. In the long-term, the issue of draughts will continue to be present in this property and will impact the occupant’s comfort, health and on-going energy bills.

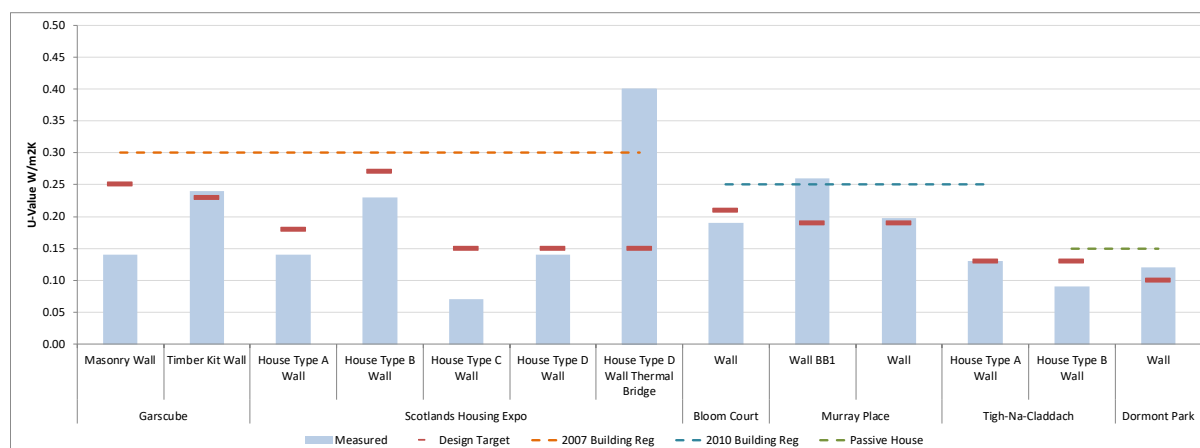
Figure 18: In-situ u-values measurement results for each wall type, compared against the relevant backstop u-values.

Figure 18 indicates the measured u-values for external walls measured in each development and compares these against the design and backstop u-values. Excluding the result of two measurements – one of which was where a thermal bridge was deliberately measured - 58% of wall elements had a lower (better) u-value than their corresponding design targets, while the measured u-values of 33% of wall elements were higher (worse) than the design target. Most were lower (better) than the backstop u-values for the relevant building regulations they were designed to comply with. Five of the houses were certified Passive House dwellings, where all wall elements measured in these houses had in-situ u-value results below (better than) the Passive House design criteria.

Thermography was used by the researchers when positioning the heat flux plates. This ensured that measurements were taken on areas of insulated wall and not on thermal bridges that may have been present. While doing this the researchers discovered a large area of external wall in one flatted property in Scotland's Housing Expo where there appeared to be missing or ill-fitting insulation. As a result the u-value equipment was set up to simultaneously measure two external wall areas, on the same wall, to determine the effect that this 'cold spot' had on the in-situ u-value. The *intended* u-value for the wall was 0.15 W/m²K. While the measured u-value of the insulated area was recorded at 0.14 W/m²K, the 'cold spot' was found to have a measured u-value of 0.40 W/m²K - nearly three times the rate of heat loss of the rest of the wall. This will have a significant risk of localised lower surface

temperatures, potentially leading to condensation, mould growth and damage to the building fabric and finishes.

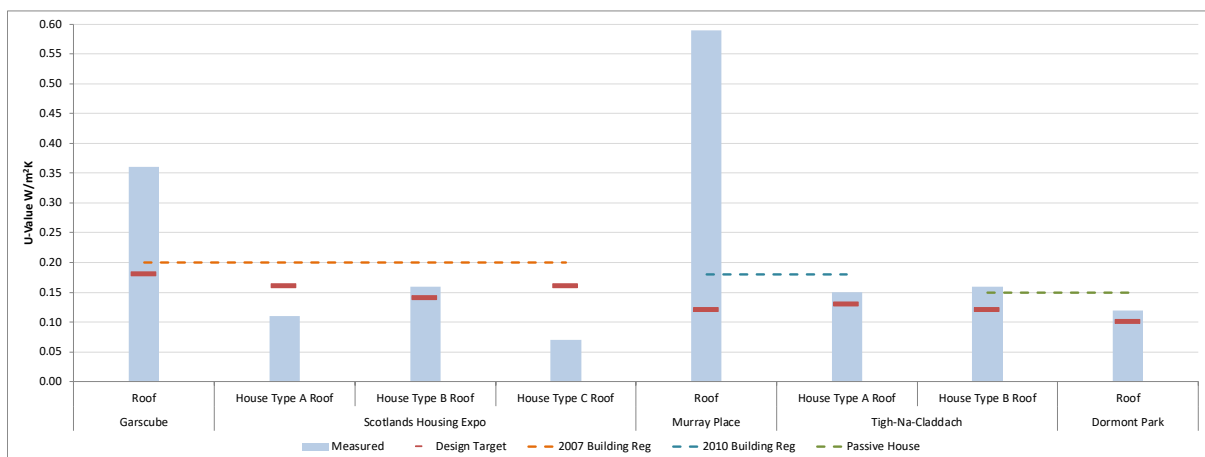
Figure 19: In-situ u-values measurement results for each roof type, compared against the relevant backstop u-values.

Design u-value targets for all roofs were lower than (better) the Building Regulation backstop values. 25% of roof measurements were better than their corresponding design target, while the remaining 75% of roofs failed to meet the design targets (Figure 19). In two developments heat loss from the roofs was significantly greater than expected. In one development, Barrhead, the in-situ result prompted investigation by the Housing Association. They found the insulation to be very poorly installed, which led to remedial works to improve the situation. Two Passive House dwellings on separate developments were included in the in-situ u-value testing. This revealed that while the roofs of neither achieved the design u-values, one exceeded (was better than) the backstop Passive House u-value target of 0.15 W/m<sup>2</sup>K.

For compliance with the Building Regulations the design u-value is used for the dwellings' carbon dioxide emission calculation and subsequent Energy Performance Certificate (EPC). In turn this informs home occupiers and owners of the energy efficiency of their homes. The negative results highlighted by the in-situ testing may increase the actual carbon dioxide emission and costs for space heating for the occupants. This suggests that the EPC may give homeowners and tenants a misleading picture of the energy performance and running costs of their house.

These in-situ u-value measurements show that the majority of external walls and roofs met the Building Regulation backstop values of the time. However, some design targets were not met, particularly for the roof elements.

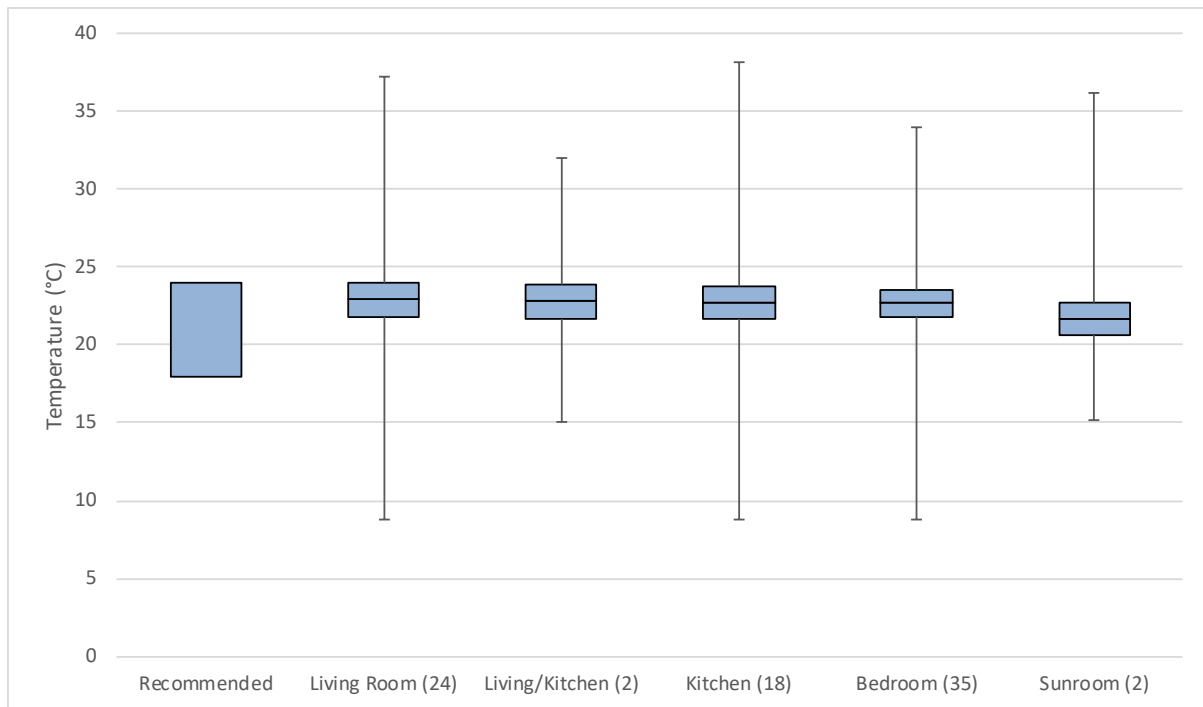
**Figure 21: Summary of annual minimum, maximum and mean temperature from a range of rooms within 26 monitored homes plotted against World Health Organisation thermal comfort range for non-vulnerable groups.**

Temperature data for one year (2013) has been plotted in Figure 21 and indicates an average internal temperature of 22°C for each monitored room type. The range and extremes of temperatures recorded are concerning as sustained high or low heating extremes could pose health risks for occupants, in particular those considered most vulnerable.

The data illustrates that temperatures in some of the monitored rooms did not meet the World Health Organisation's (WHO) minimum thermal comfort benchmark of 18°C for non-vulnerable households. The lowest recorded internal temperature fell below 12°C in 7 (8%) of monitored rooms. While the data were not analysed in detail against occupancy profiles the low internal temperatures recorded may have occurred at times on no occupancy. It is also of note that low internal temperatures, particularly those below 12°C, are known to increase respiratory and cardiovascular risk for occupants.

This is concerning as the homes monitored were all designed as new, energy efficient homes. The low temperatures recorded in some of the dwellings suggests that fuel poverty remains a risk in new low-energy homes.

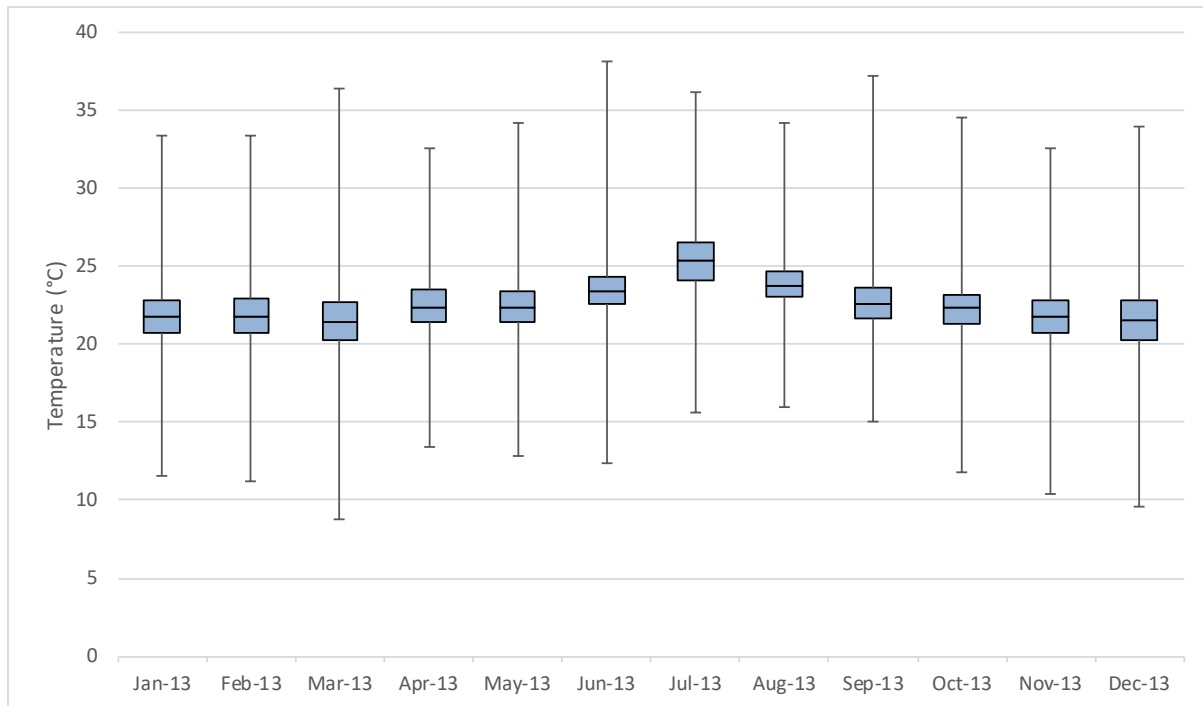
**Figure 22: Summary of monthly minimum, maximum and mean temperature from monitored rooms within 26 homes.**

At the opposite end of the scale, temperatures as high as 38°C were recorded inside some of the dwellings. While this was a peak, temperatures over 25°C were frequently recorded<sup>2</sup>. The data plotted in Figure 22 suggest that some occupants are heating their homes more than they need to during the winter months and that they may have become accustomed to higher internal air temperatures. High temperatures are associated with heat stress, heat stroke and mental health issues.

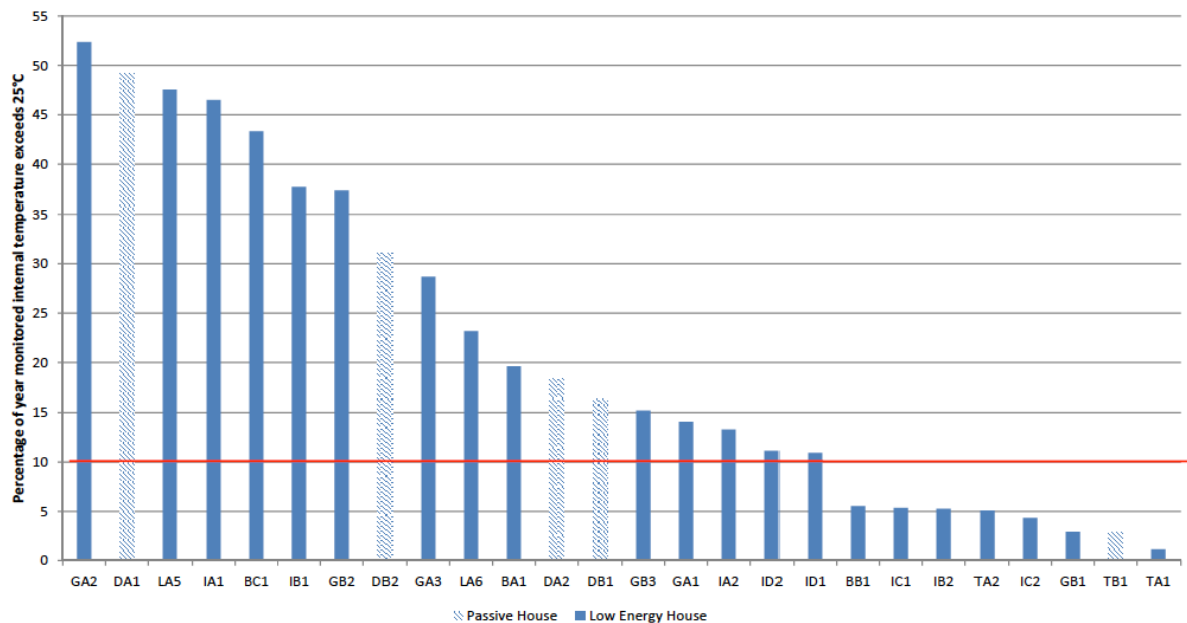
**Figure 23: Percentage of year monitored internal temperature exceeds 25°C in Passive House and Low Energy Homes. The Passive House 10% of year over 25°C was used as the overheating threshold.**

Uncontrolled heat gains within some homes were identified through thermography. These include heat gains from kitchen appliances, un-insulated pipework, solar thermal systems, domestic hot water storage and heat interface units. These gains are often mistakenly considered as 'free' heat during the winter. However, as they are also present during the warmer months, they can contribute to overheating and cause significant thermal discomfort. This phenomenon was identified through the monitoring. Using the Passivhaus overheating threshold of 10% of year over 25°C it was found that 70% of monitored homes exceeded this benchmark. It was also of note that temperatures were high in all houses through July. 23% of the homes exhibited high temperatures for more than 10% of every month of the year. See Figure 23.

Overheating was found to be caused by a variety of contributing factors including lack of designed ventilation. MVHR systems in two of the Passive House dwellings were found to be lacking ‘summer bypass’ (where the heat from exhaust air is not used to preheat incoming fresh air), contributing to high internal temperatures. Occupants were generally unaware of how to effectively cool their houses during warm periods. Details of when occupants opened and closed windows can be found in Section 4.2

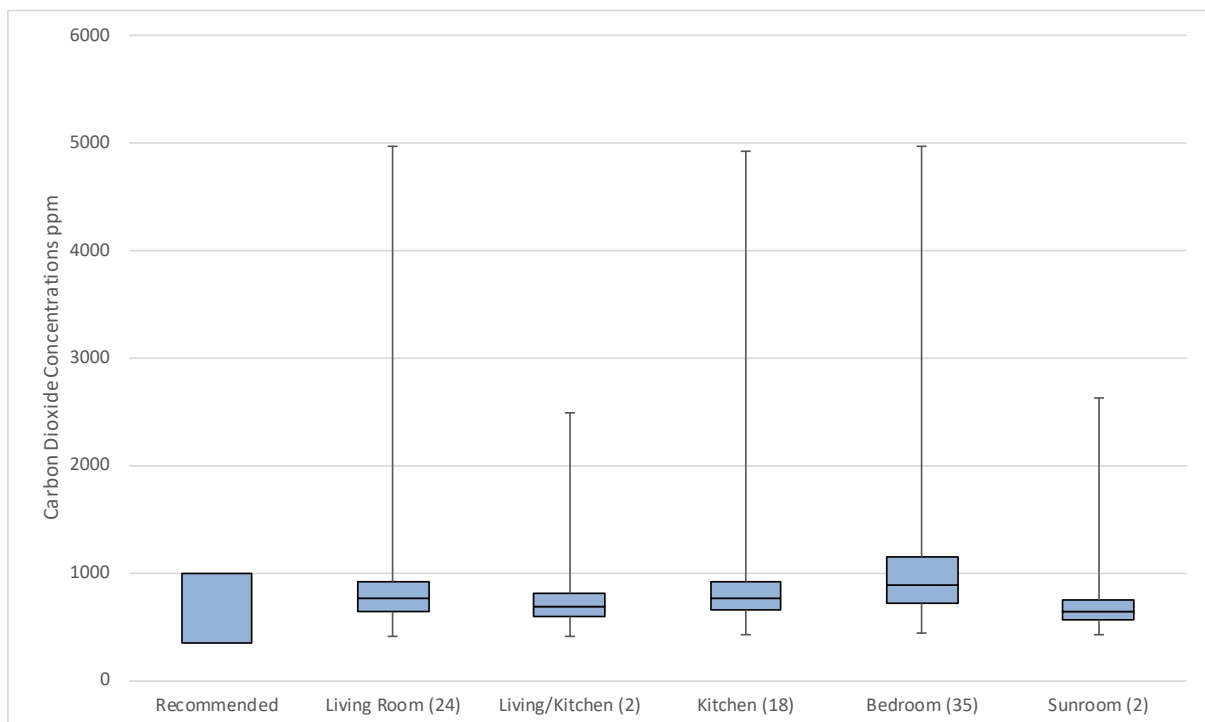
**Figure 24: Summary of annual minimum, maximum and mean carbon dioxide concentrations measured in a range of rooms within 26 monitored homes plotted against recommended levels.**

The benchmark maximum CO<sub>2</sub> concentration for an adequately ventilated house is 1,000 parts per million (ppm). Figure 24 illustrates the maximum, minimum and mean CO<sub>2</sub> concentrations of all of the monitored dwellings. It shows that all monitored rooms exceeded the recommended benchmark, suggesting occupant ventilation regimes were poor at times. The monitoring equipment had a high range of 5,000ppm, which was reached in most spaces.

Mean CO<sub>2</sub> values of all rooms were below 1,000ppm except for the bedrooms, which indicates that ventilation provision in bedrooms requires more consideration. The building regulations now require

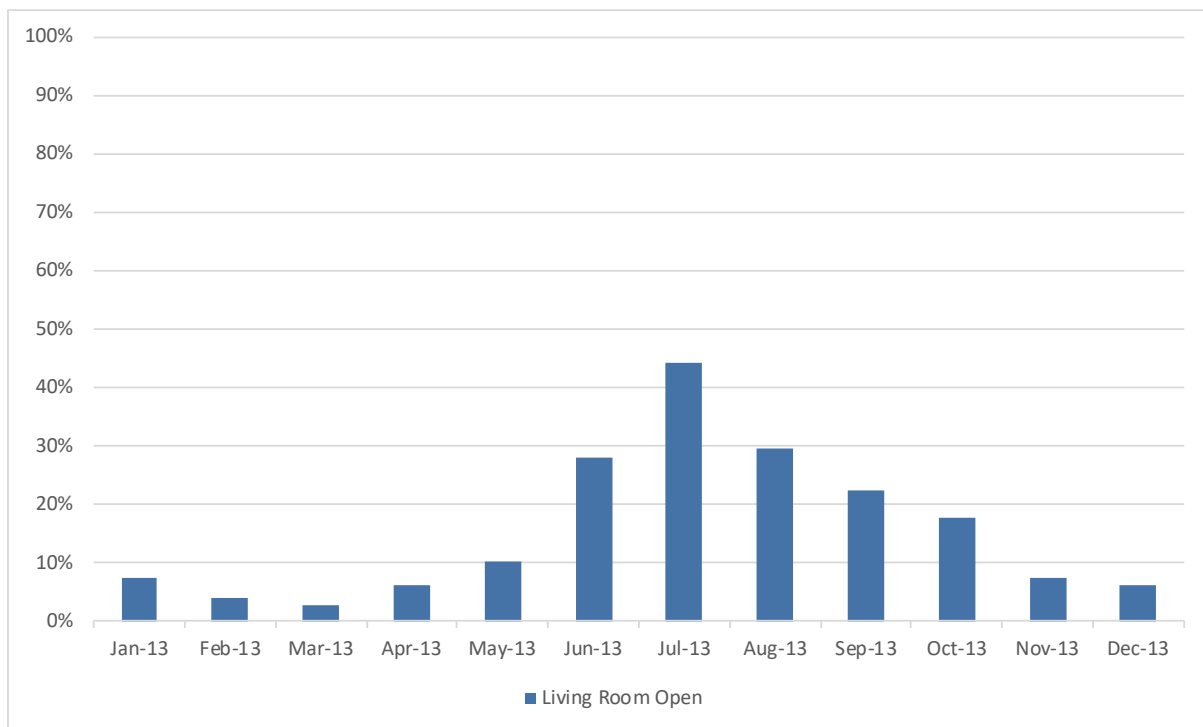
There was a clear pattern for window opening occurrences in living rooms (Figure 25), bedrooms (Figure 26) and kitchens (Figure 27). Windows were opened more frequently between the months of May and October with opening becoming more frequent during June, July and August. Windows were opened most frequently during the summer, and kitchen windows were opened more often than other rooms during the colder months.

**Figure 25: Annual window opening in living rooms across 24 homes.**

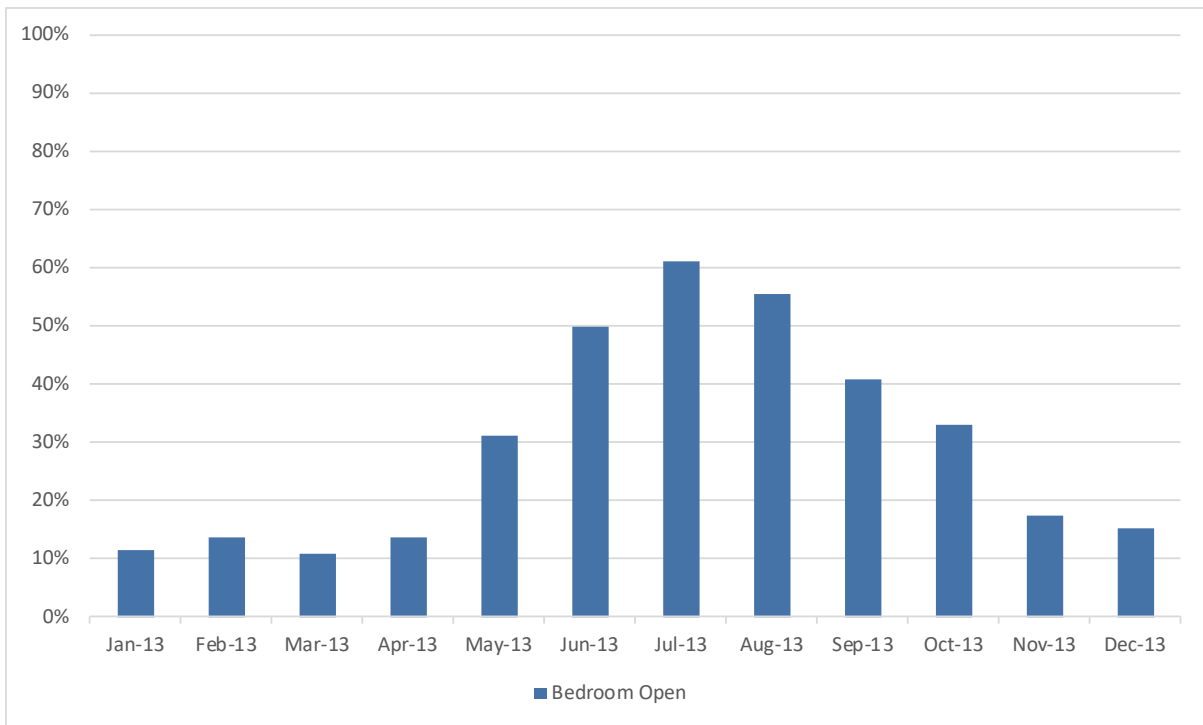
**Figure 26: Annual window opening in 33 bedrooms across 25 homes.**

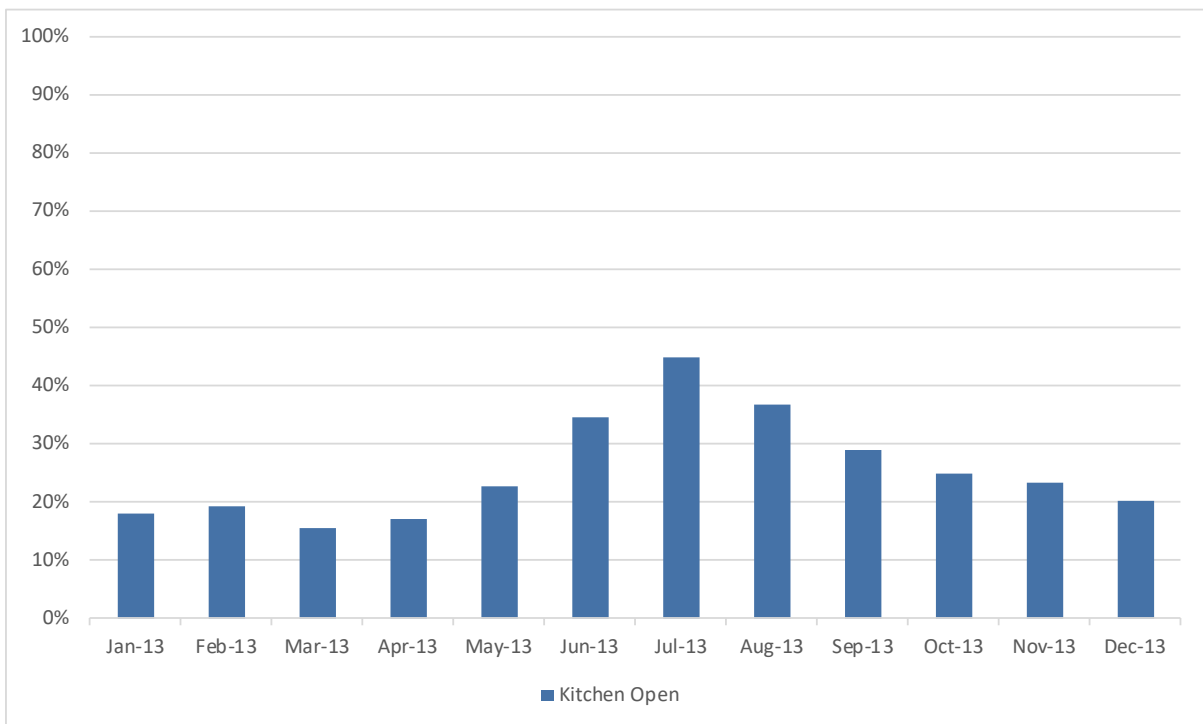
**Figure 27: Annual window opening in kitchens across 13 homes.**

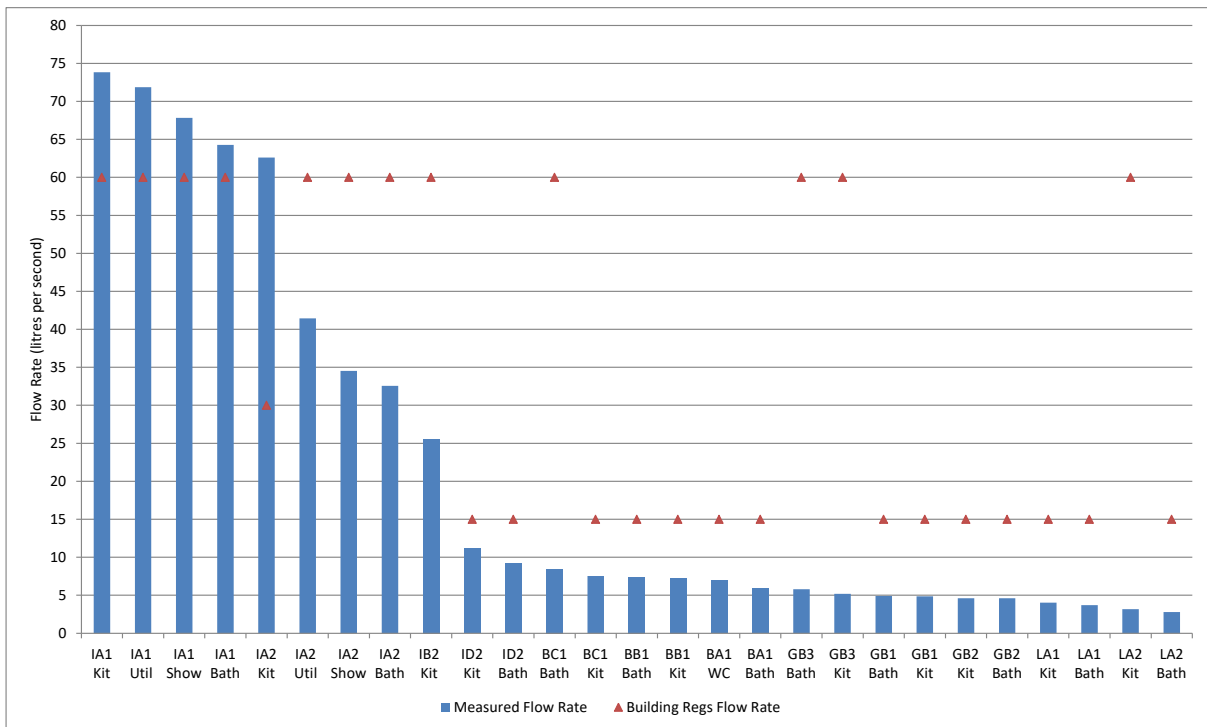
Some occupants made complaints about under performance of extract fans. In one bathroom extensive mould growth was observed on the ceiling surface, walls and the tile grout. Airflow measurements indicated that the extract fan was operating at five litres per second (l/s) - well below the 15 l/s specified in the building regulations for moisture control in bathrooms. This instigated testing of airflow rates for all intermittent extract fans installed in the monitored buildings, excluding the Passive Houses. Twenty-seven intermittent extract fans were tested, of which only 20% (5no.) were found to achieve their intended flow rate (Figure 28).

The fans tested were all fixed speed and were most likely selected on the basis of meeting the building regulations guidance. This demands extraction flow rates of: Kitchen, 30 l/s above a hob or 60 l/s if fan is located elsewhere; Utility 30 l/s; and Bathroom or Shower room 15 l/s. Some landlords replaced defective units with new units. However, in a dwelling in Inverness (IA1), the replacement fan was disabled by the occupants due to the high noise levels, resulting in the purpose of the extract fan being overridden by occupant comfort demands.

**Figure 28: Measured airflow rates of kitchens and bathrooms compared with Building (Scotland) Regulation minimum airflow rates.**

This testing clearly indicates that extract fans need to be appropriately selected, carefully installed and properly commissioned to ensure they meet the minimum ventilation requirements of the building regulations. In addition to this ducted exhausts should have calculations made for the additional pressure drop associated with the duct runs to ensure there is enough fan power to exhaust the moisture laden air to outside. In all cases noise criteria should form part of the specification rather than a selection being made on capital cost alone: occupants will not use fans that are noisy and also perceive noisy fans to cost more to run.

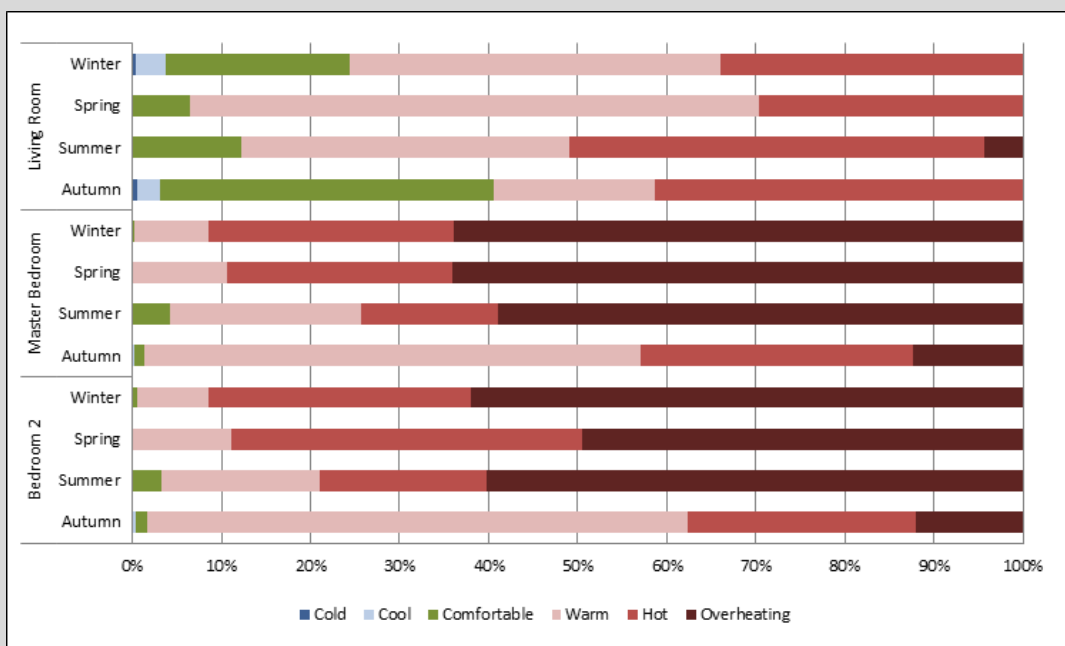
Temperature measurements in the Passive Houses in Dormont Park identified that all exceeded the Passive House overheating threshold of 25 °C for more than 10% of the year. The Passive House Planning Package (PHPP) predicted that there would be 0.2% overheating throughout the year. In home DA1, high temperatures were recorded for almost 50% of the year. See Figure 30. In the south facing master bedroom temperatures were generally within the 25-30 °C band (dark red) during summer 2013, sometimes peaking at 32 °C or above. Both bedrooms experienced significant high temperatures throughout the year with temperatures generally above 23 °C and exceeding 26 °C in all four seasons. The BPE found that the occupant would heat the home to high temperatures to ensure their baby was warm enough. This is reflected in the annual energy use of the dwelling, which is significantly higher than the other Passive House dwellings at Dormont Park. Refer section 5.

Figure 30: Chart indicating temperature range in dwelling DA1 for 2013. Dark red indicates temperatures above 25°C.

Window opening was monitored and had a minimal impact on the high temperatures. External solar shading could have helped to reduce the effect of solar gain and the timing of window opening could also have an impact on internal temperatures. In the UK occupants are unaccustomed to closing windows during the day and opening windows at night when it is cooler.

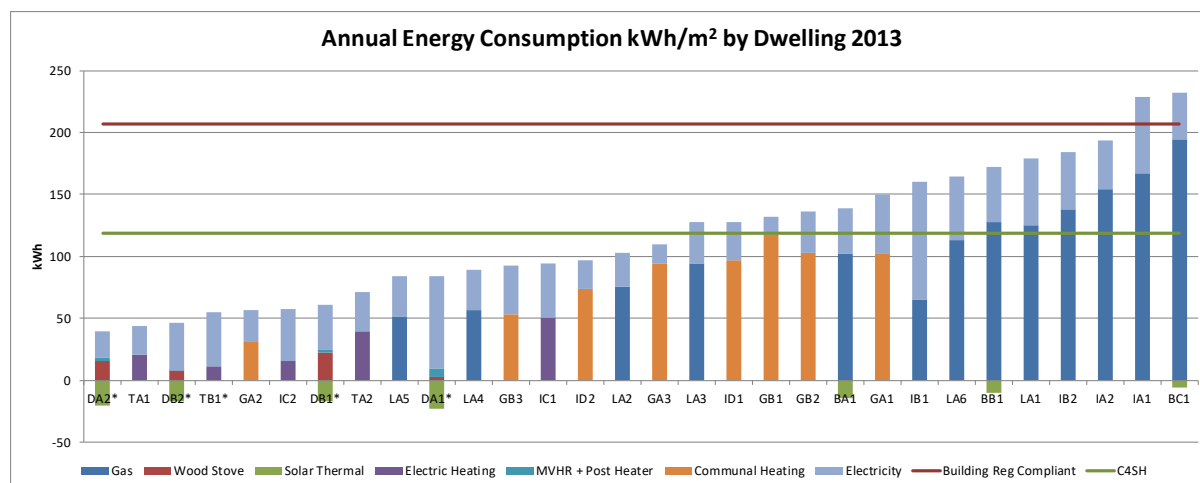
Figure 31: Annual Energy Consumption kWh/m<sup>2</sup> by dwelling 2013.

The chart identifies that two homes consumed more energy than the maximum permitted by building regulations and just over 50% (16, including all five Passive House dwellings) used less energy than permitted by the Code for Sustainable Homes. The data additionally identify that in all but two homes the greatest proportion of energy consumption was attributed to space heating (denoted by proportion of gas, wood stove, electric heating and communal heating in each column).

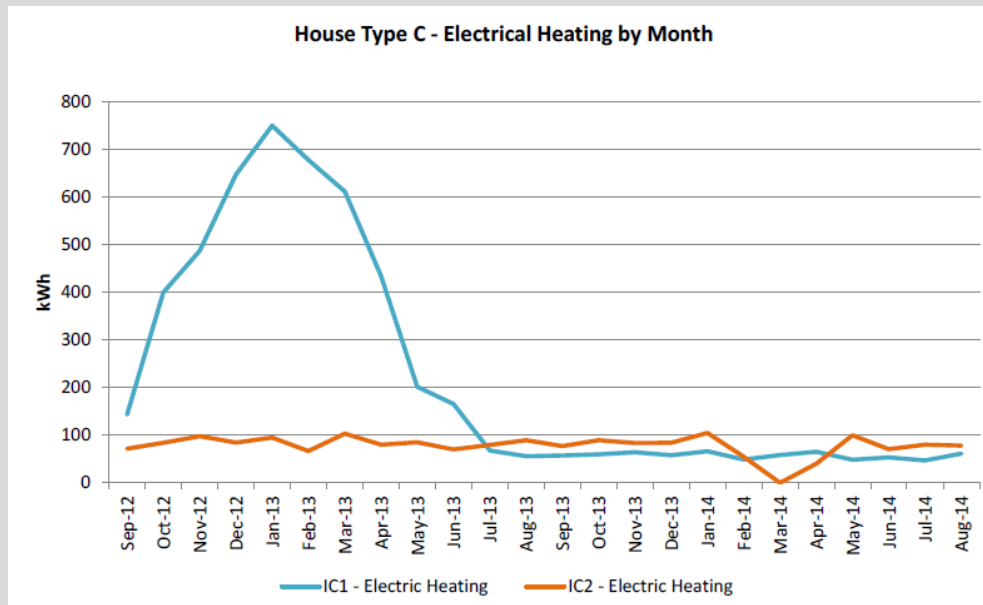
Occupant habits play an important part in energy consumption and the performance of a home. House IC1 in Inverness was excessively using the electric heating. The graph below shows the difference in energy consumption between IC1 and IC2, there is also a significant change in electrical consumption before and after July 2013 when there was change in occupancy. The consumption is now similar to neighbouring IC2 where both occupants prefer to use their wood burning stoves more frequently to reduce running costs of the electric heating. See Figure 32.

Figure 32: Graph showing the electrical heating profile by month for two years in House Type C in Inverness.
