# In case of Emergency:

# What do the 2014 and 2018 fires in the Mackintosh Building tell us about how we manage our built heritage?

Submitted in fulfilment of the requirements for the Degree of PHD School of Design Glasgow School of Art September 2020

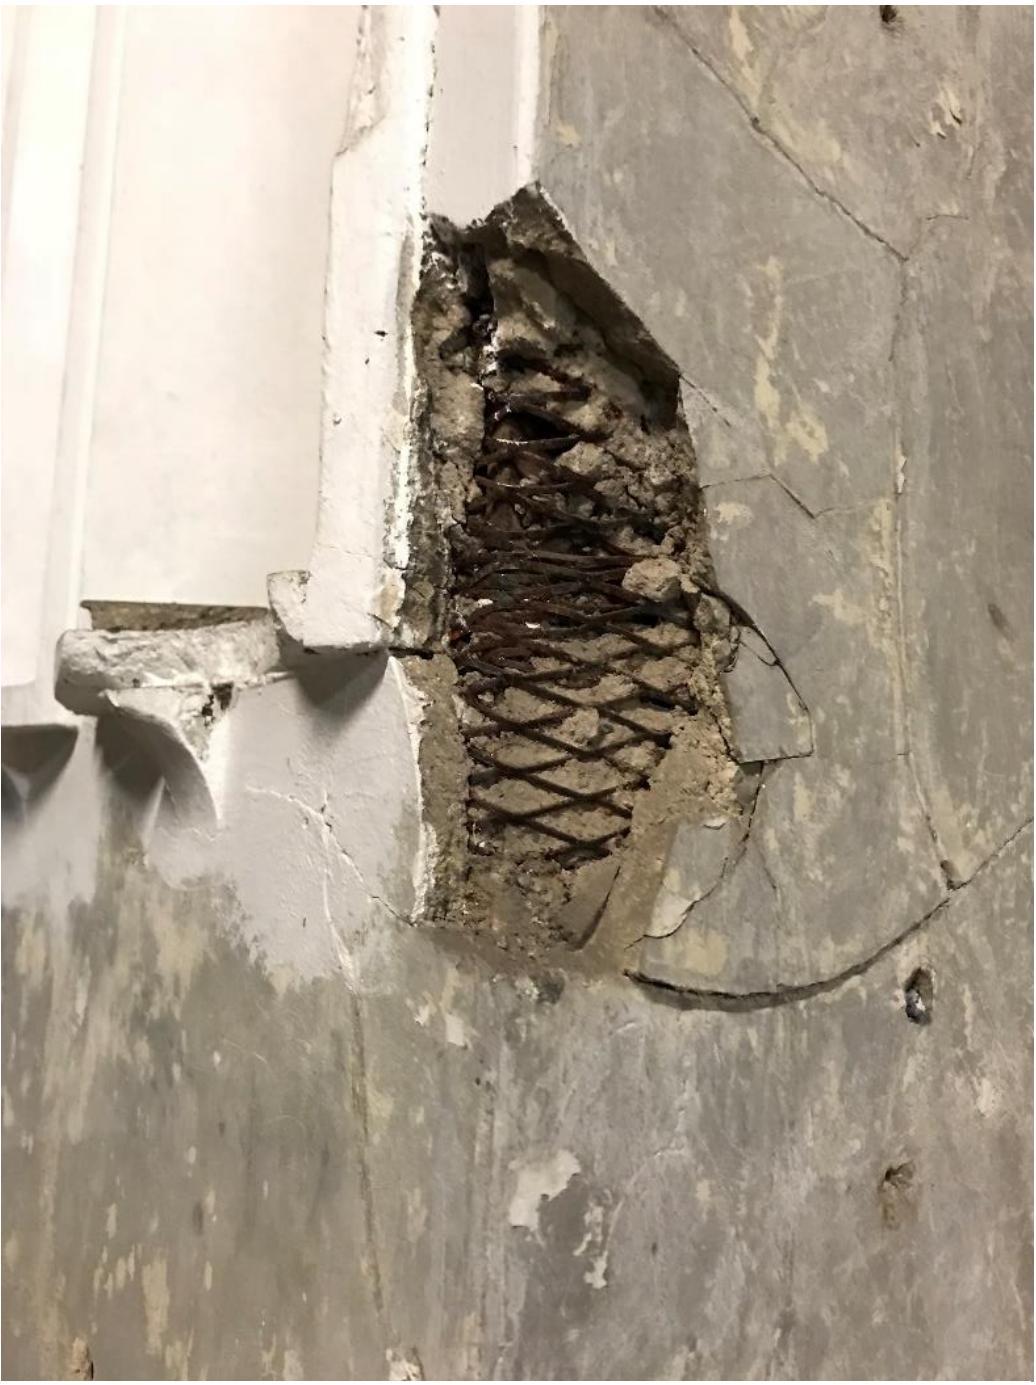
Figure 3.2: Photograph of the expanded metal lath and plaster in Studio 19, revealed during the restoration process. Taken by Rachael Purse, February 2018.

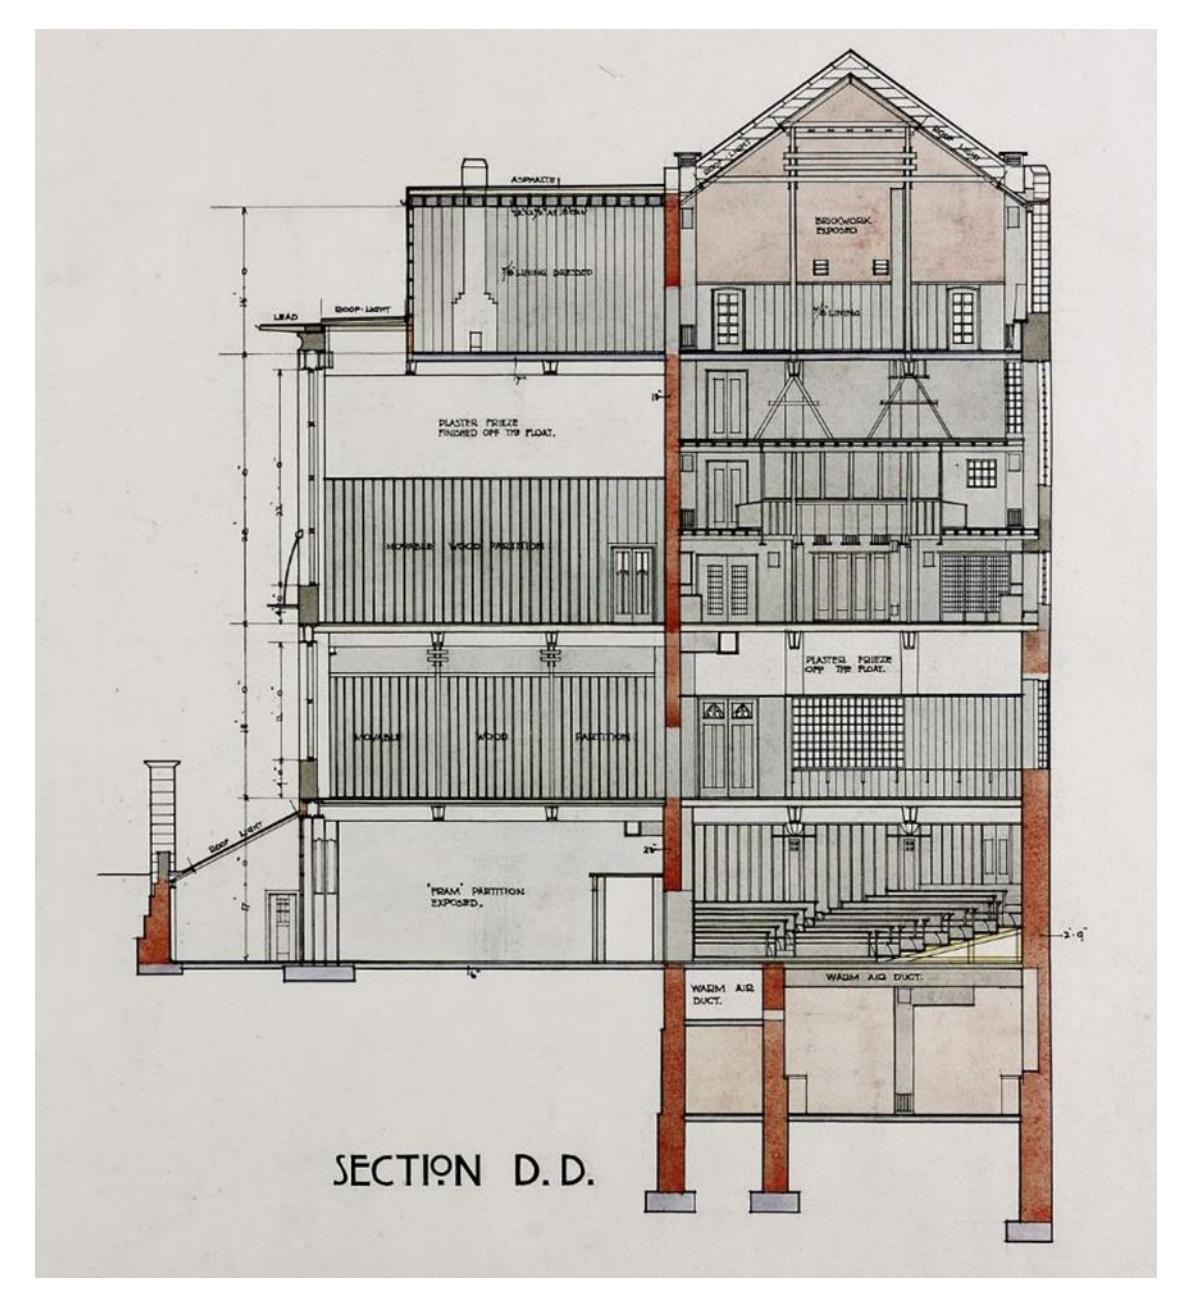
Figure 3.3: Cross-section of West Side of Mackintosh Building, ink and wash, 1910. Ducts running vertically through the building are highlighted in red. Copyright Glasgow School of Art Archives and Collections.

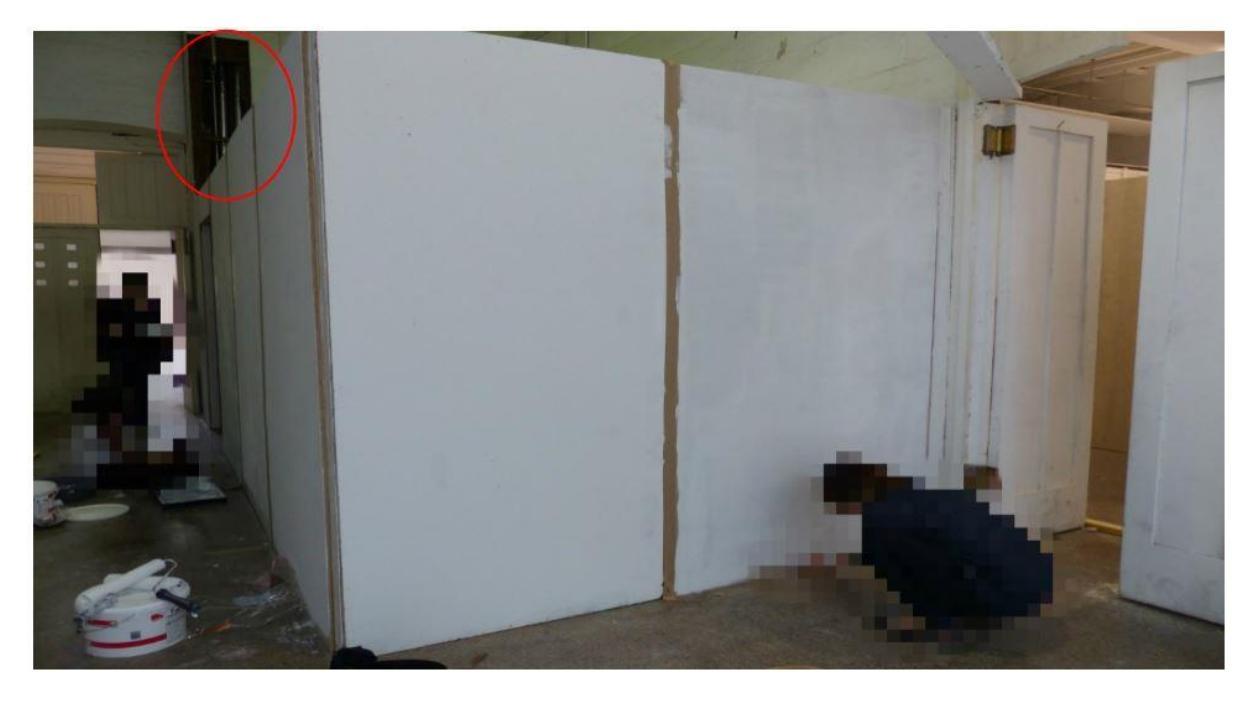
Figure 3.5: An image of the student display area in studio 19. This was taken two to three days prior to the fire. Note the area circled is the pipe void with panels removed. Image courtesy of Police Scotland, 2014.

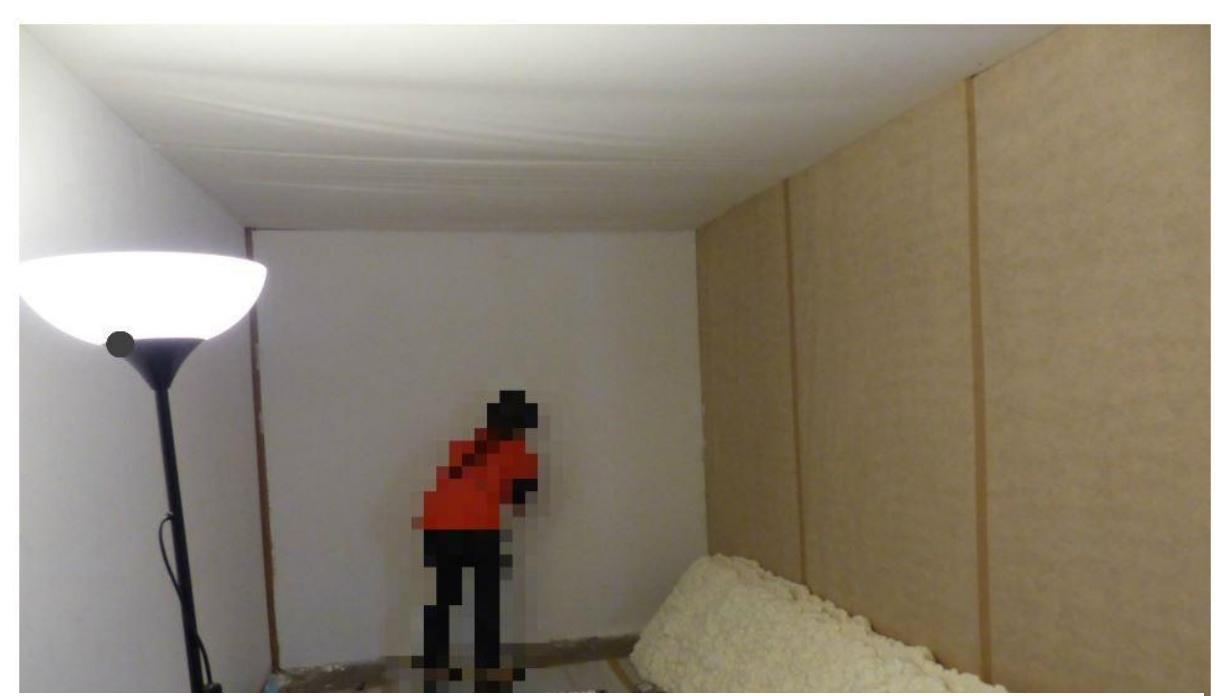
Figure 3.4: An image of the student display area prior to the foam panels (seen on the right-hand side) being located on the walls in Studio 19. Image courtesy of Police Scotland, 2014.

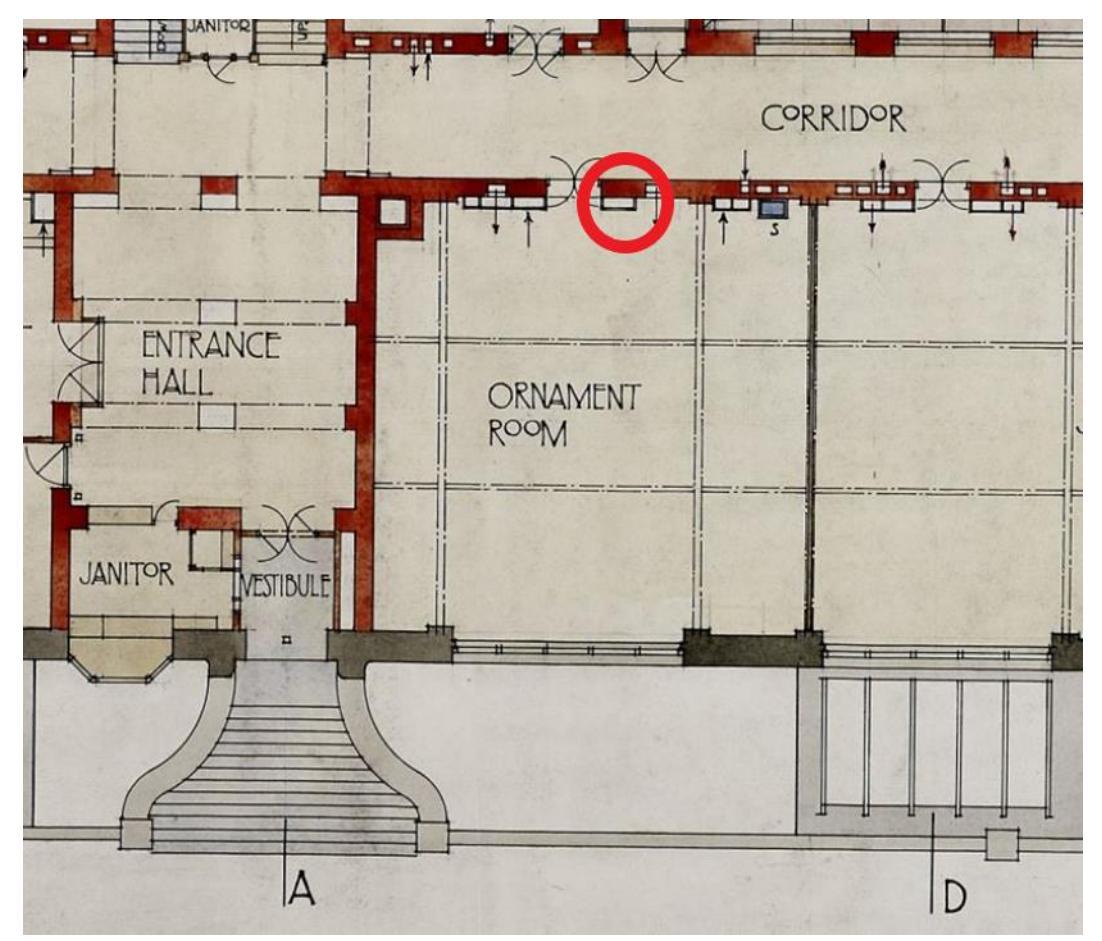
Figure 3.6: Ground Floor Plan of the Mackintosh Building, ink and wash, 1910. Location of the projector in 2014 encircled, air duct can be seen. Copyright Glasgow School of Art Archives and Collections.

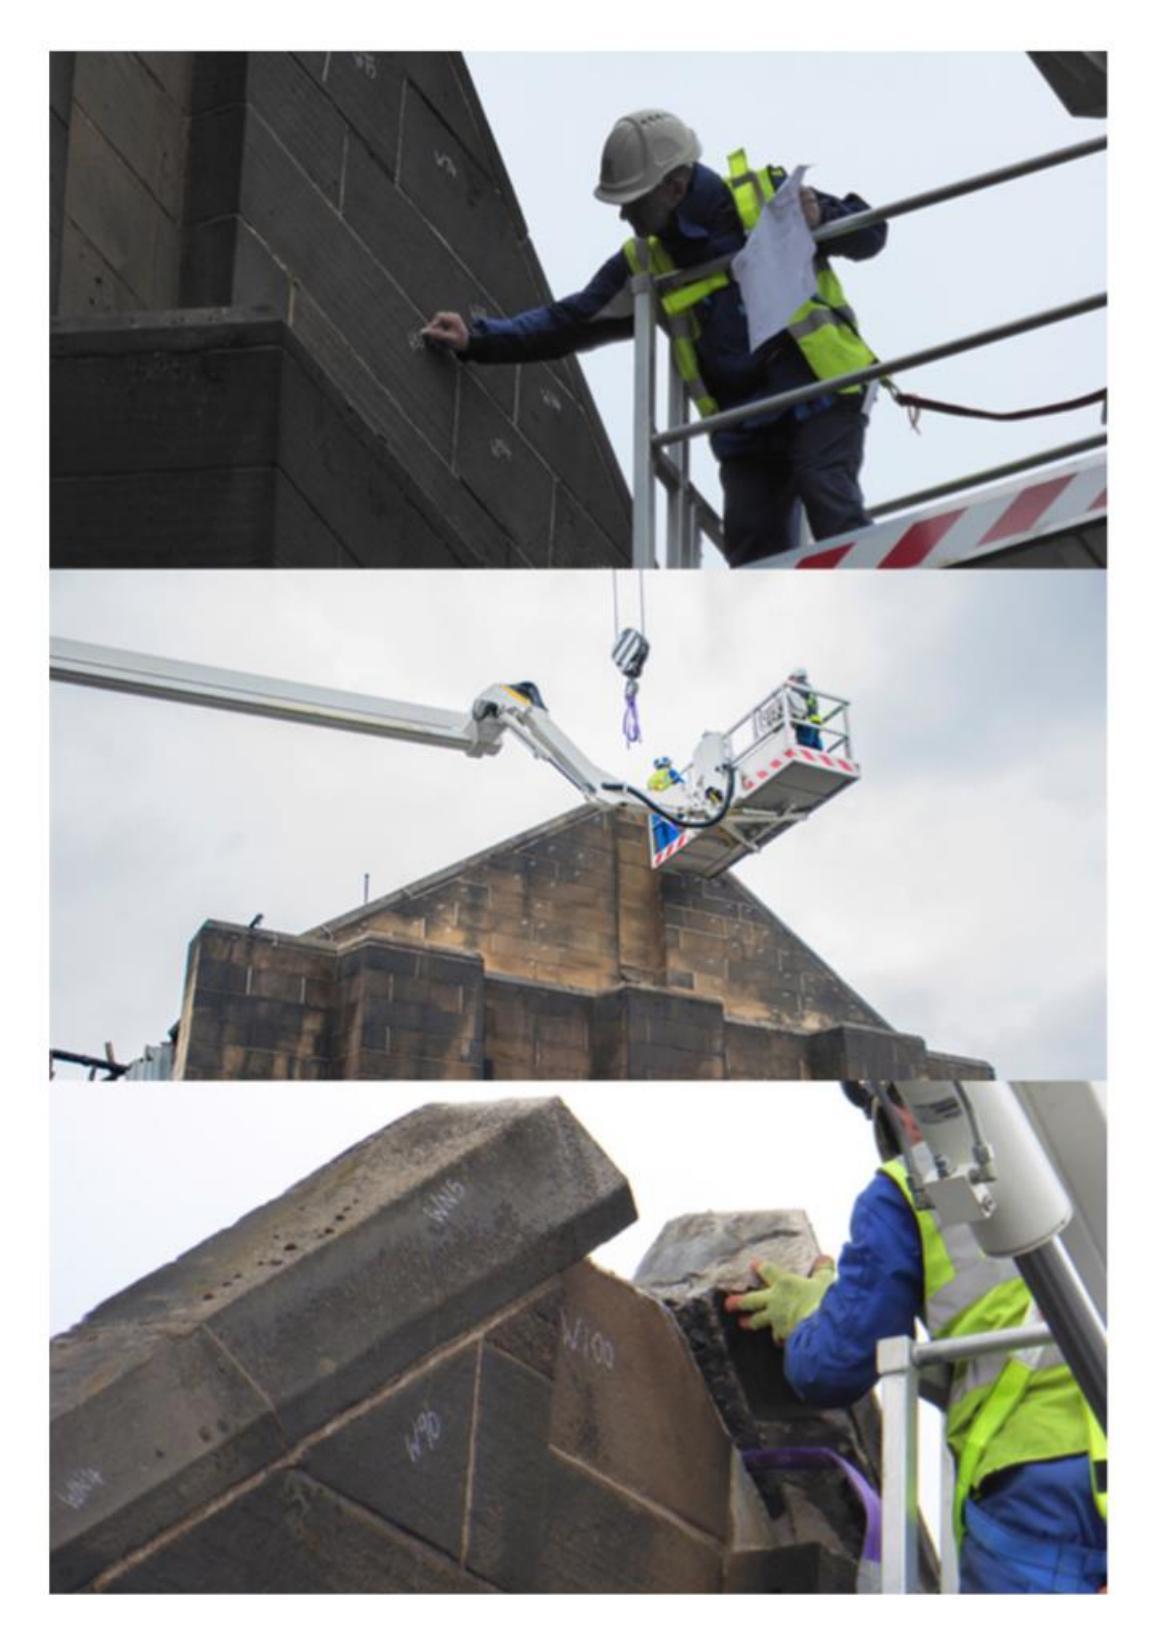
Figure 4.10: Stones in the West Gable, or Library Tower, are numbered and the removed following the fire of 2014. Images from '3D documentation for disaster management in historic buildings: Applications following fire damage at the Mackintosh building, The Glasgow School of Art'. Copyright HES.

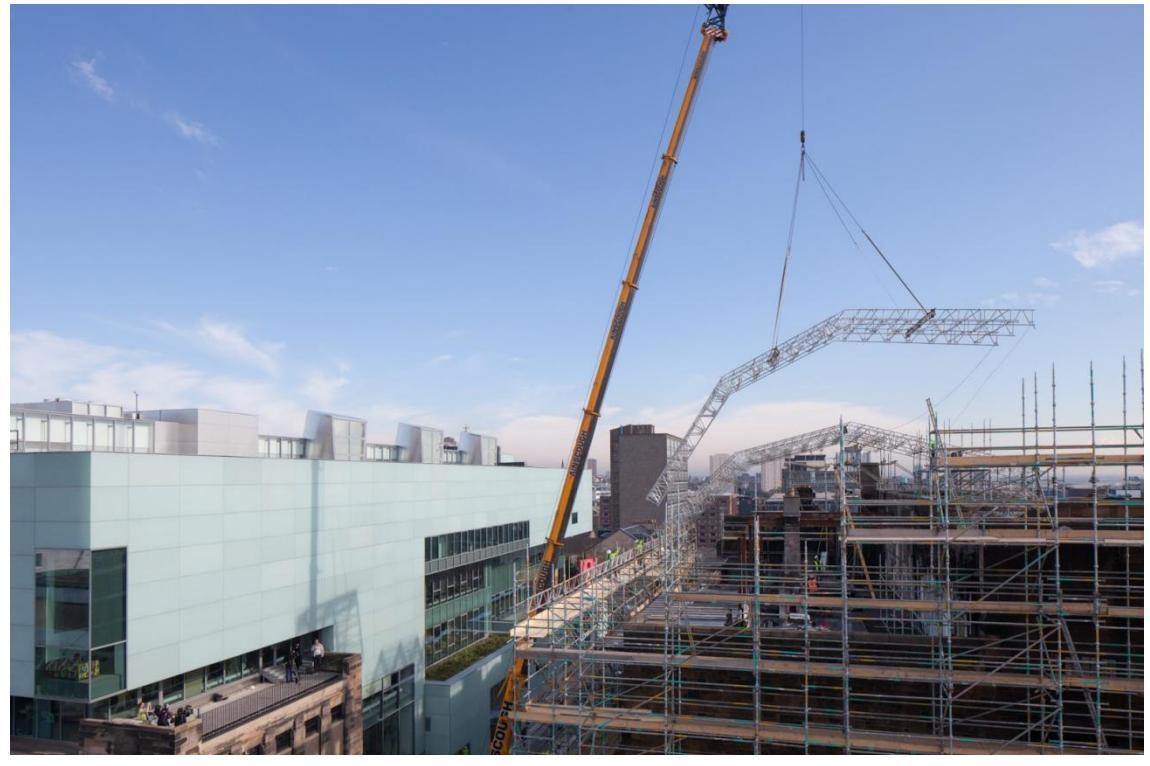
Figure 4.11: The Frame of the temporary roof, designed by SGB Roofing, is lowered into position via a crane, October 2014. Image copyright GSA.

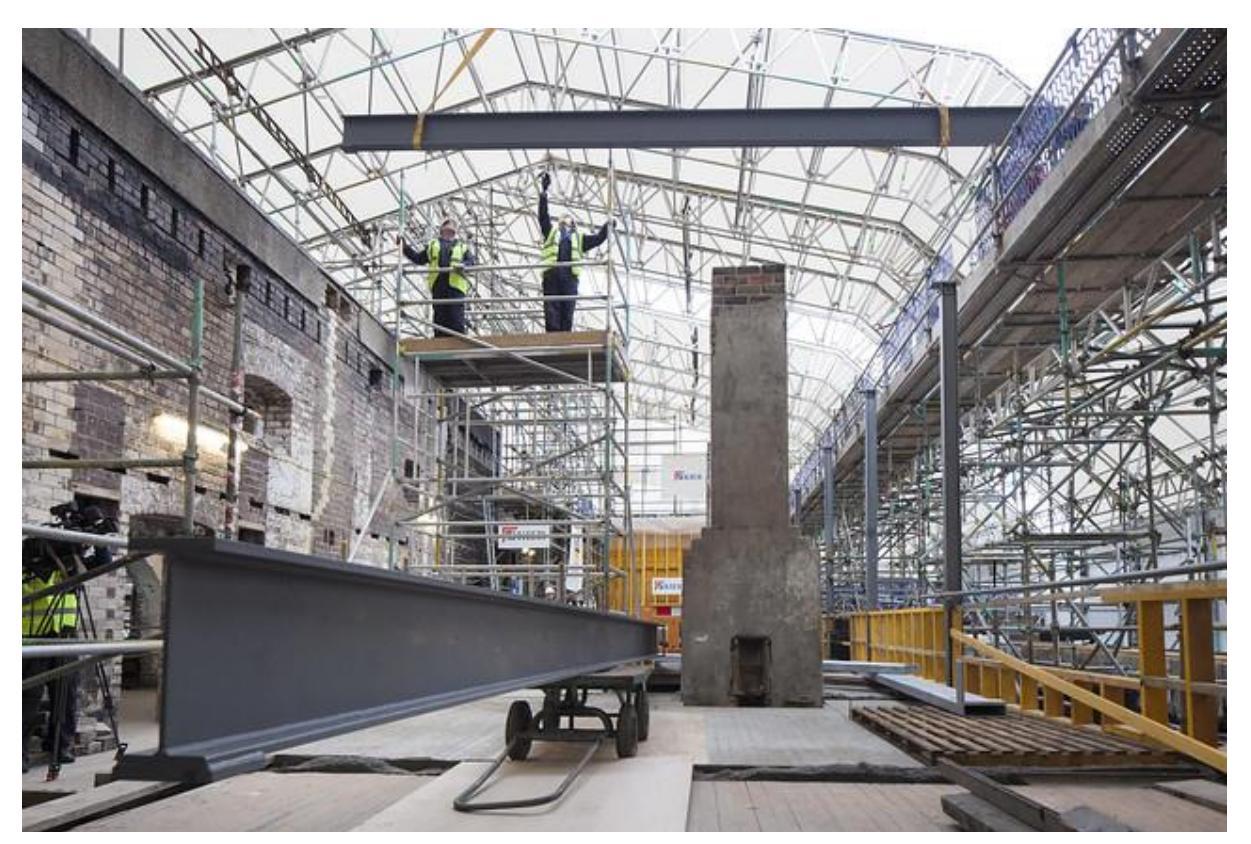
Figure 4.12: The temporary roof two years after its initial installation, image taken when the roof of the Mackintosh Building was being rebuilt, 2016. Image copyright McAteer.

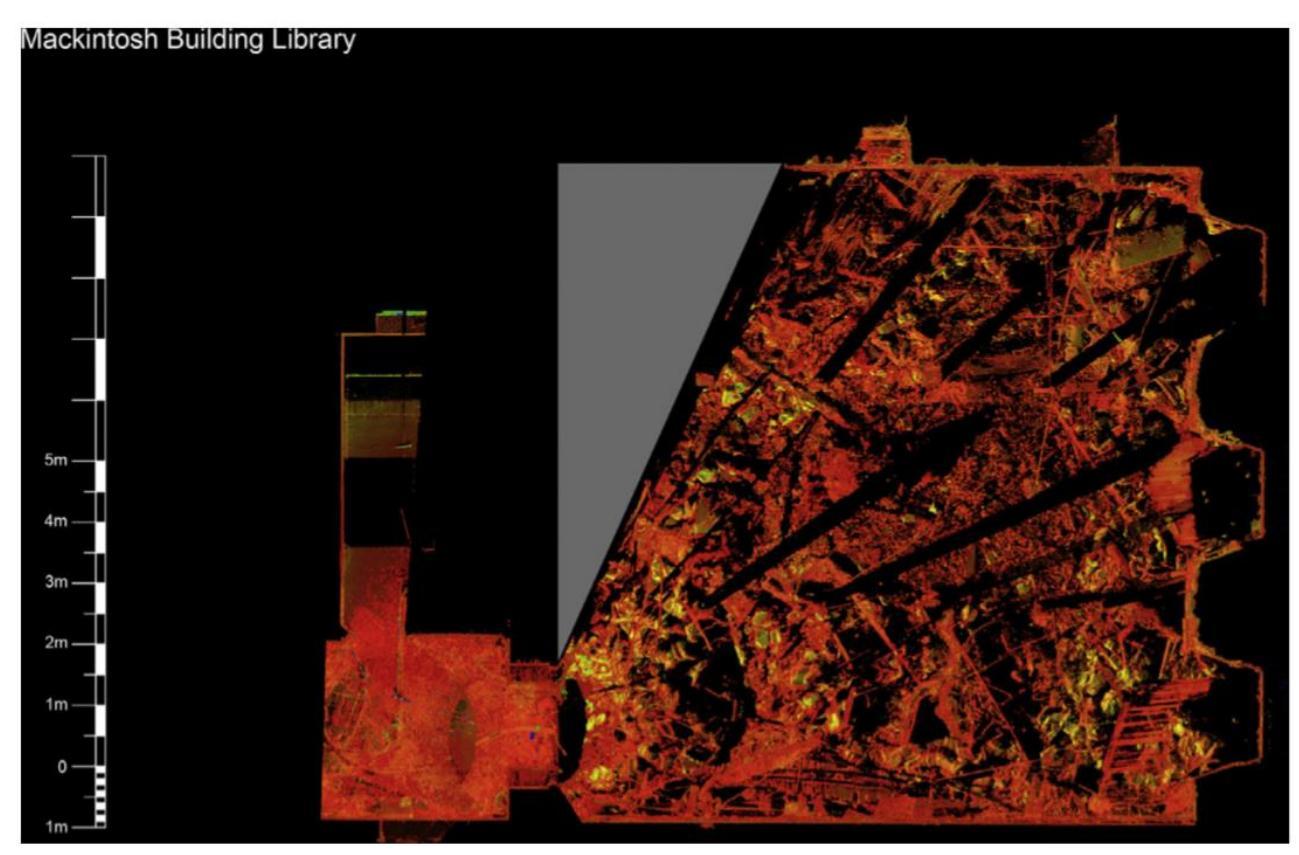
Figure 4.13: Lasserscan data of the debris on the Library floor. Images from '3D documentation for disaster management in historic buildings: Applications following fire damage at the Mackintosh building, The Glasgow School of Art'. Copyright HES.

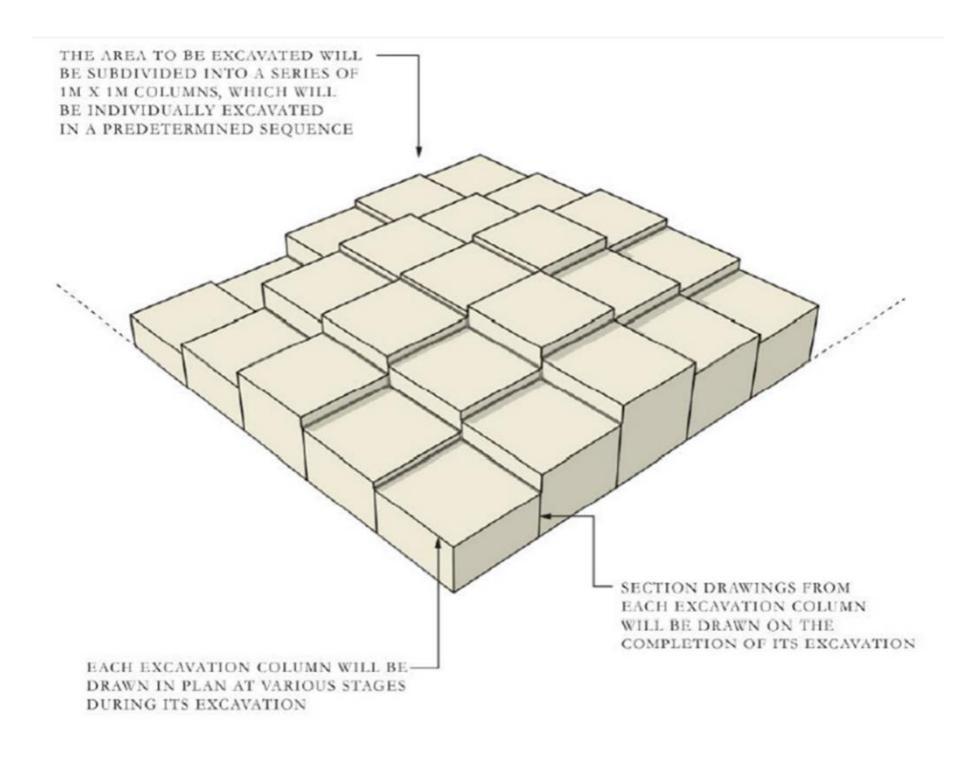
*Figure 4.14: Image of planned excavation grids, in 3D, of the Mackintosh Building Library, 2014. Copyright Kirkdale Archaeology.*

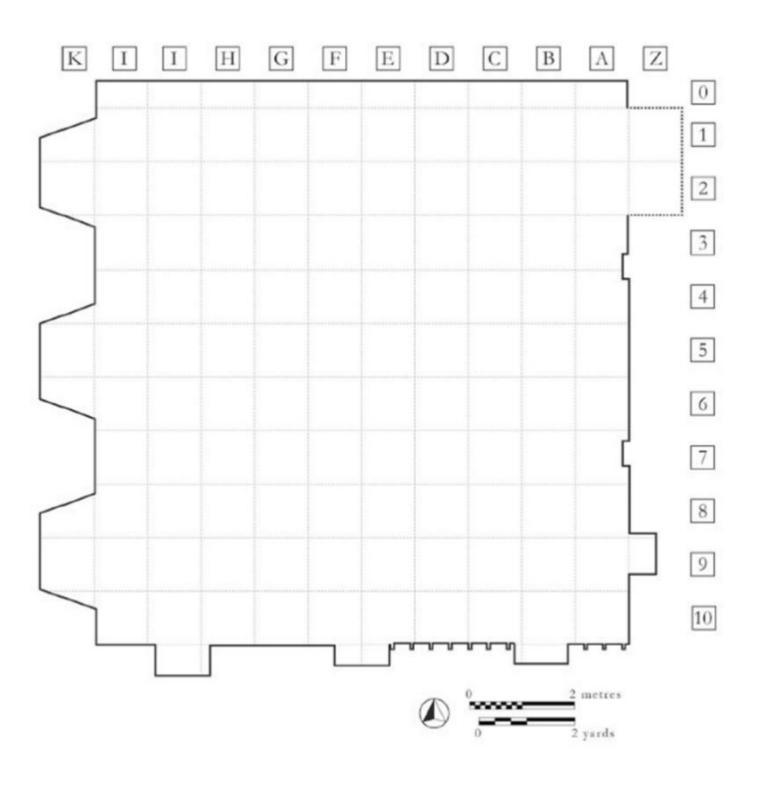
Figure 4.15: Plan of the gridded floor of the Mackintosh Building Library, the window bays can be seen on the left of the plan, 2014. Copyright Kirkdale Archaeology.

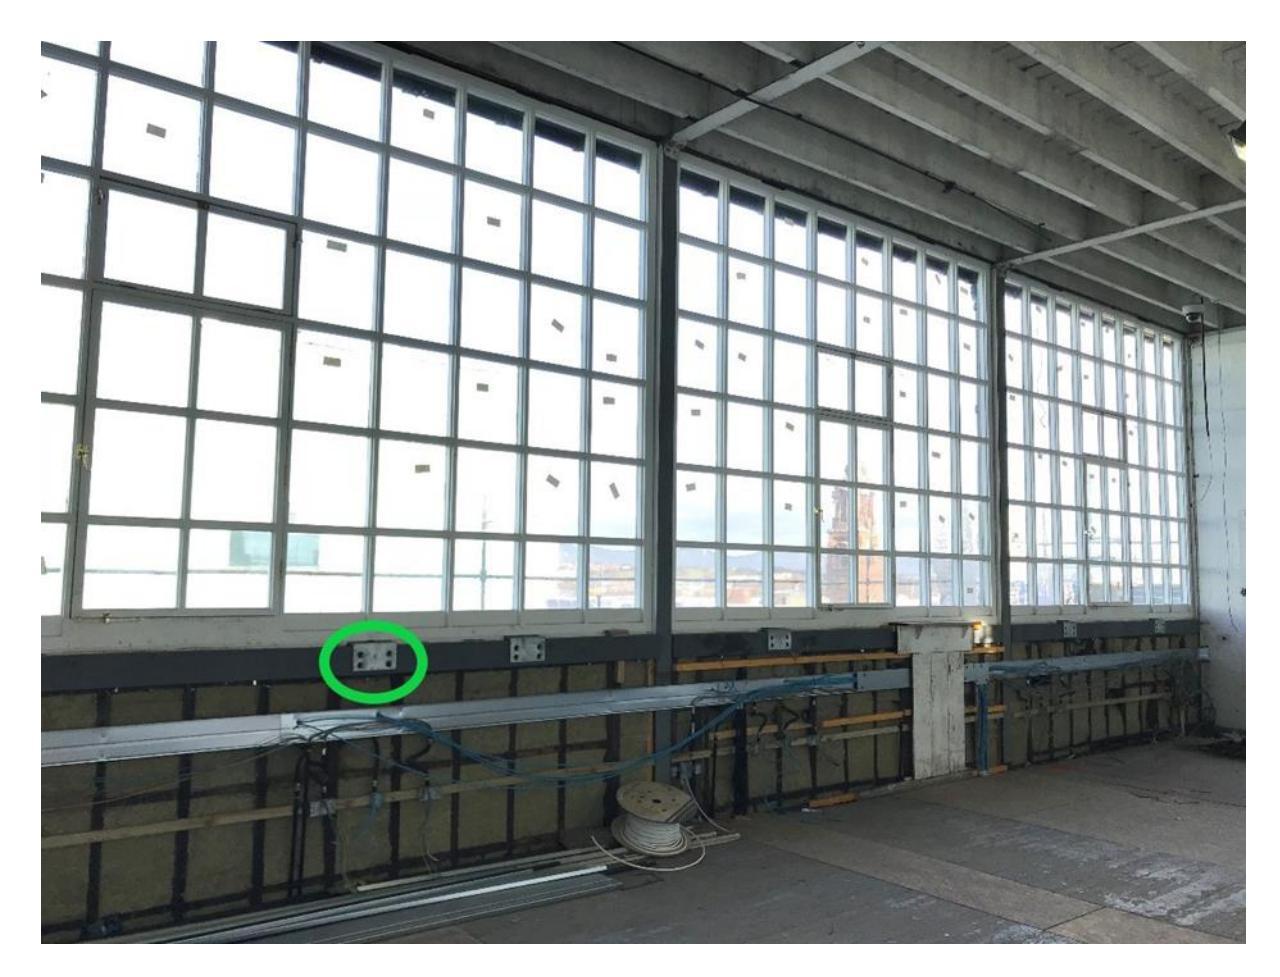
Figure 5.3: The steel flanges had been inserted into new the window frames to provide strength. The metal bosses can still be seen, they would have been covered by wooden panelling. The bottom sill has been raised slightly to accommodate the steel flanges. Image taken by Rachael Purse, February 2018.

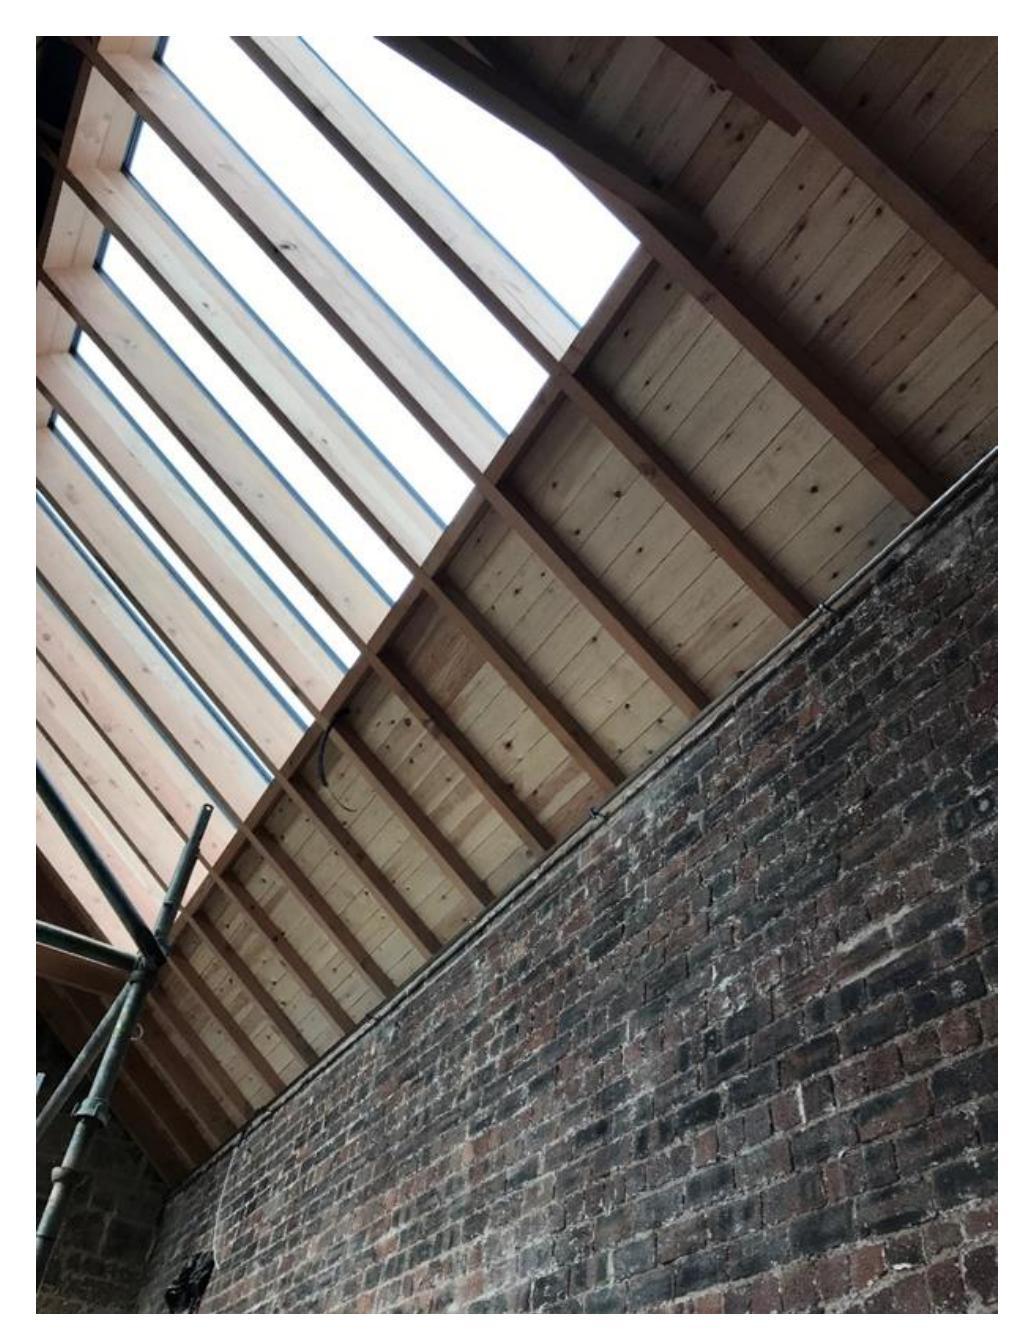
Figure 5.4: The new, lower, timber roof of Studio 58, with insulation concealed behind the sarking. Photograph taken by Rachael Purse, February 2018.

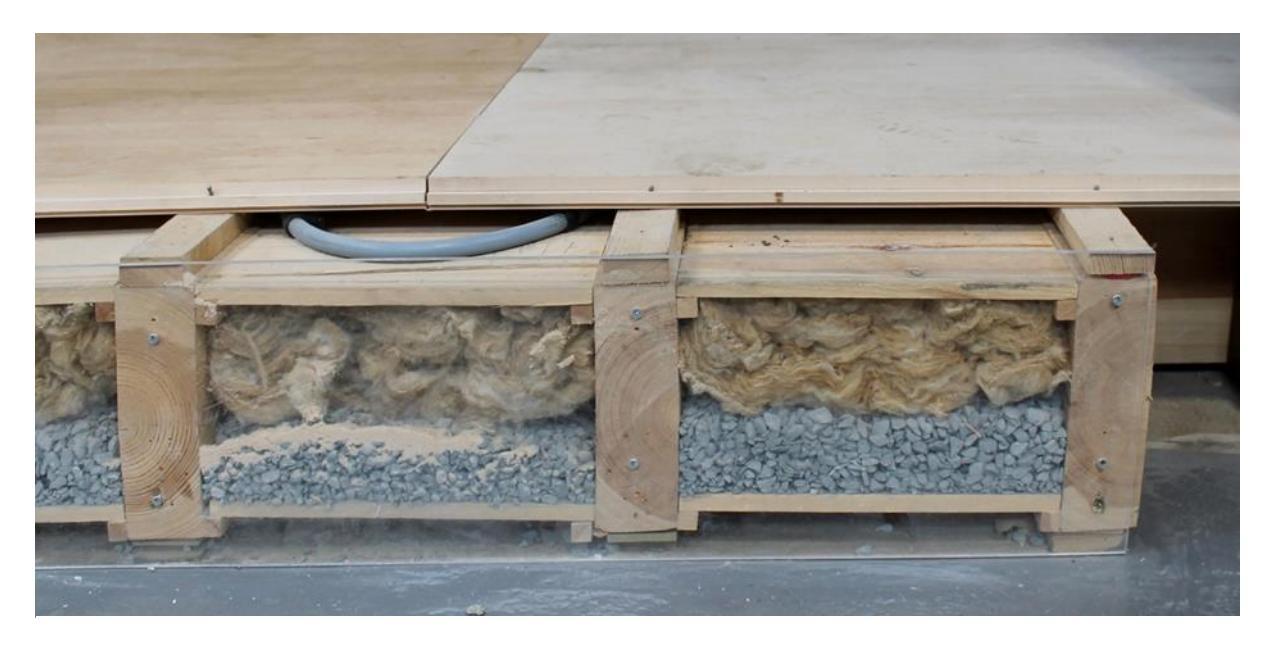
Figure 5.6: Laurence Macintosh, the joiners who were tasked with re-creating a bay of the Library, created this cross-section of potential underfloor heating and insulation materials Rock wool and sound-deadening. Taken by Rachael Purse, October 2017.

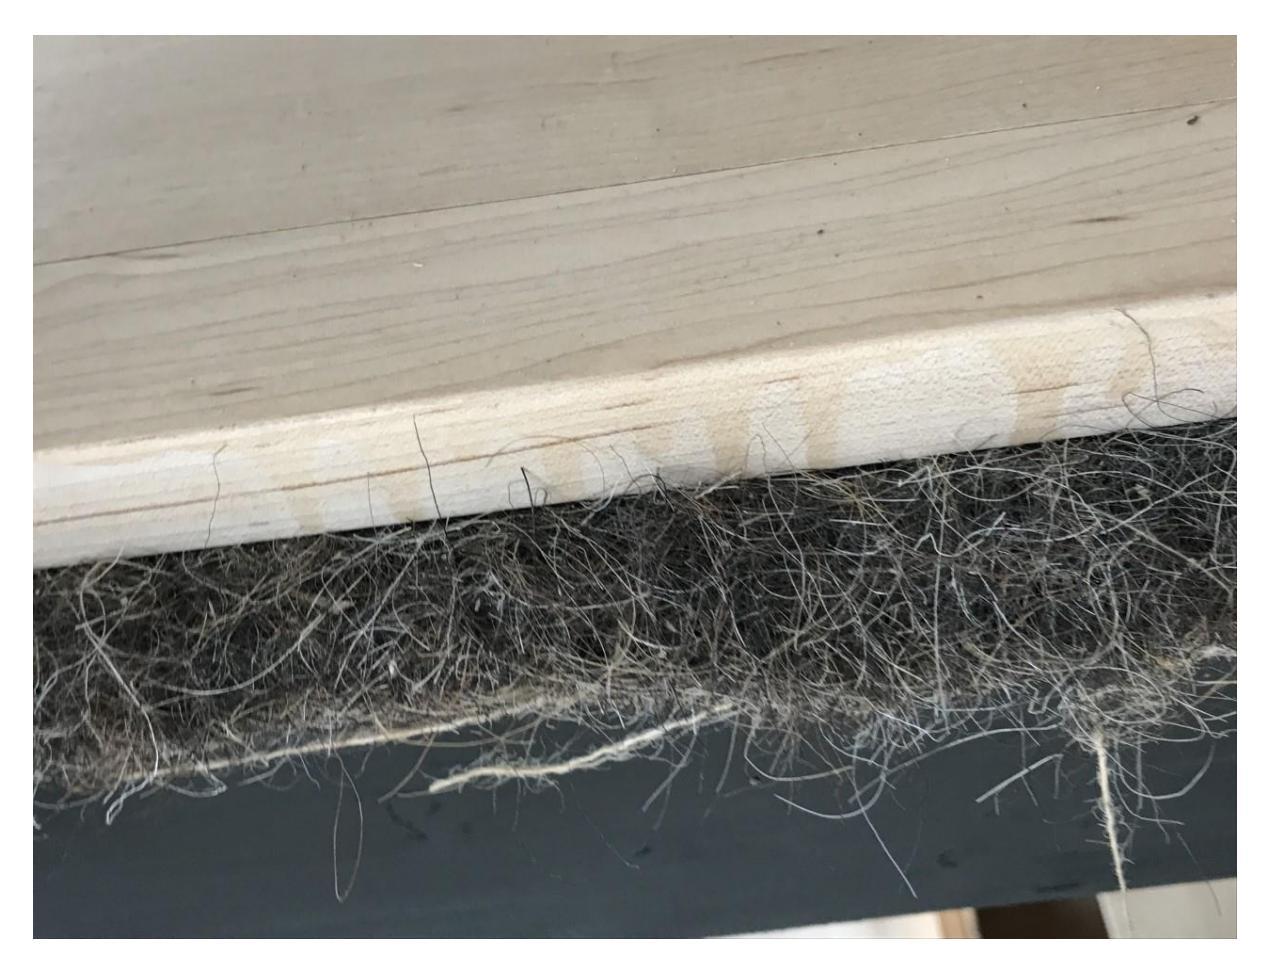
Figure 5.7: Horsehair matting used in the Laurence Macintosh Library Bay prototype, seen here under the floorboards of the balcony level. Taken by Rachael Purse, October 2017.

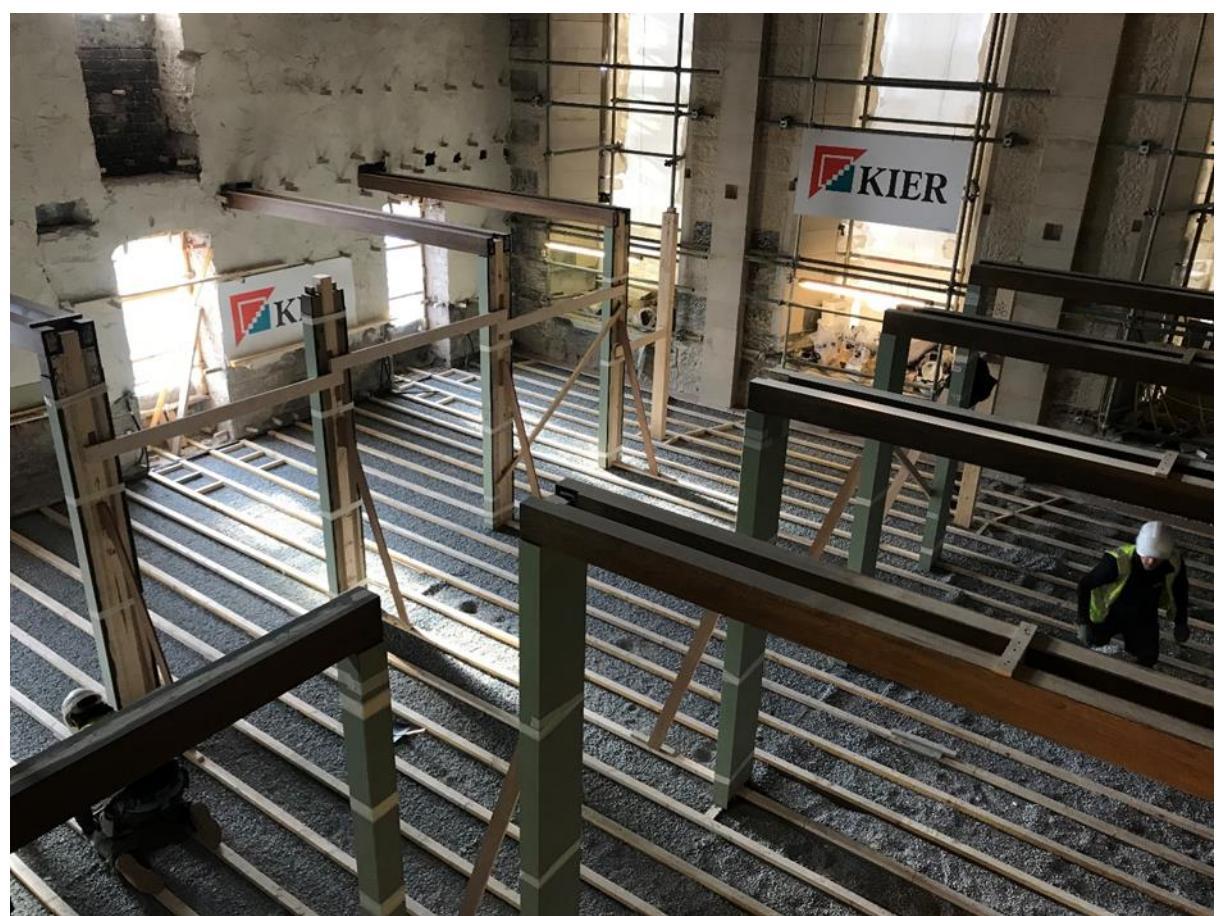
Figure 5.8: The Library being constructed, the sound-deadening stone can be seen as the underfloor heating is laid. Taken by Rachael Purse February 2018.

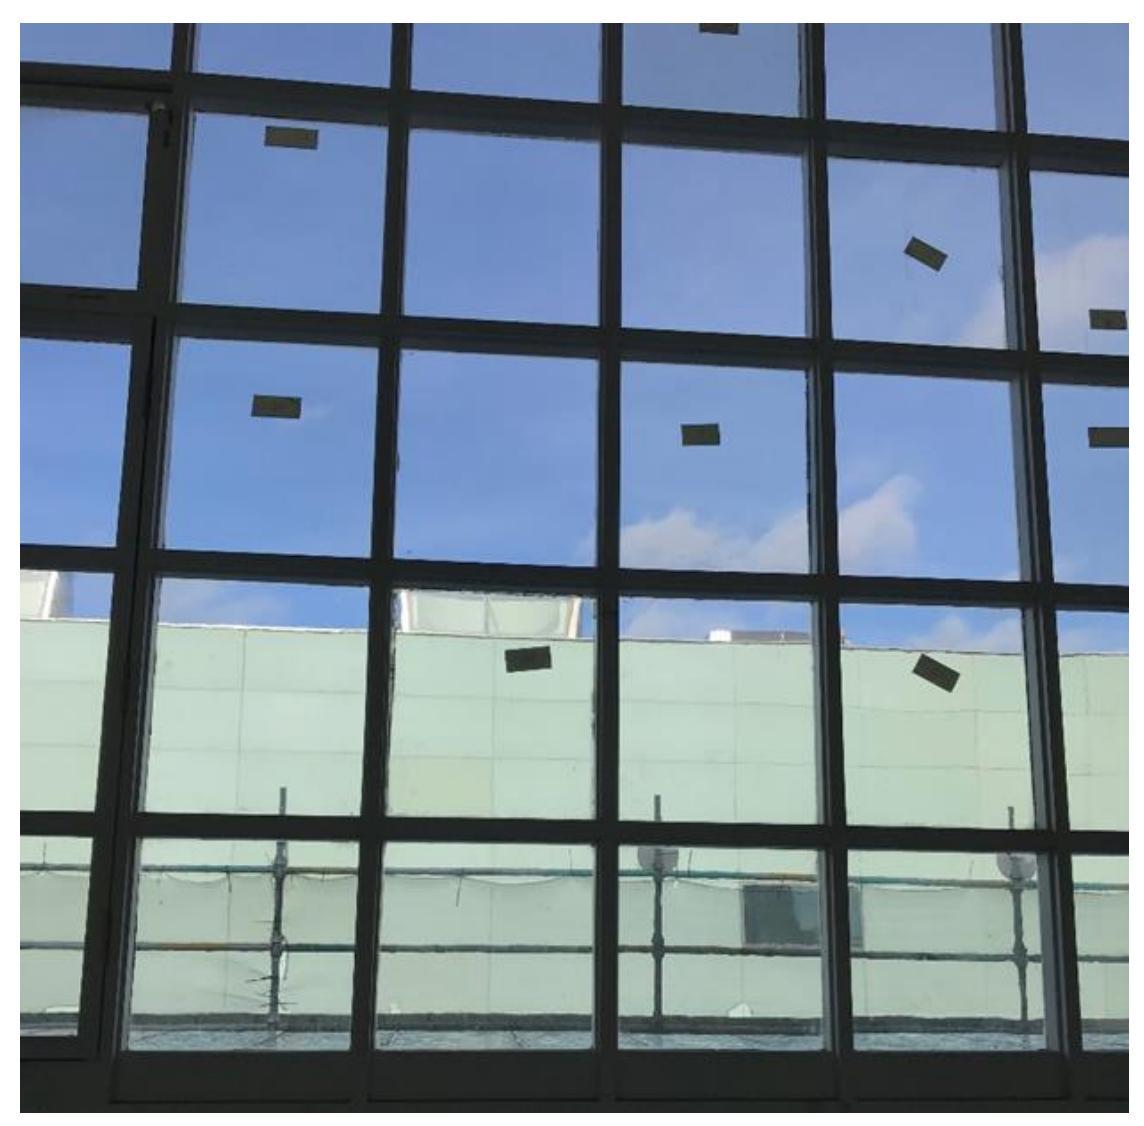
Figure 3: New slimline double-glazed panes and original panes of glass installed in the Embroidery Studio's windows. Taken by Rachael Purse, February 2018.

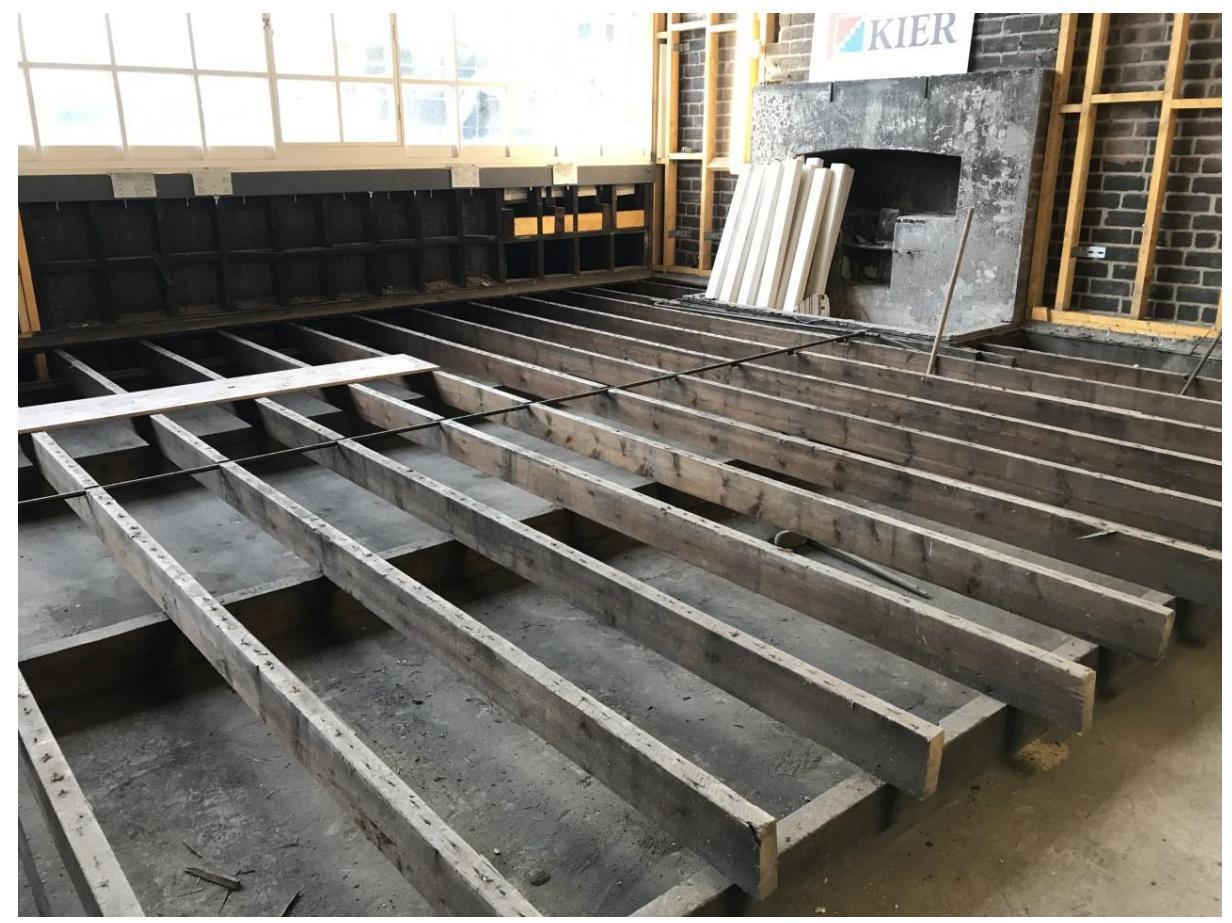
Figure 5.11: This image shows the Professors Studios as the floors were being reconstructed using de-charred roof beams from the Building as underfloor beams. Taken by Rachael Purse. September 2017.

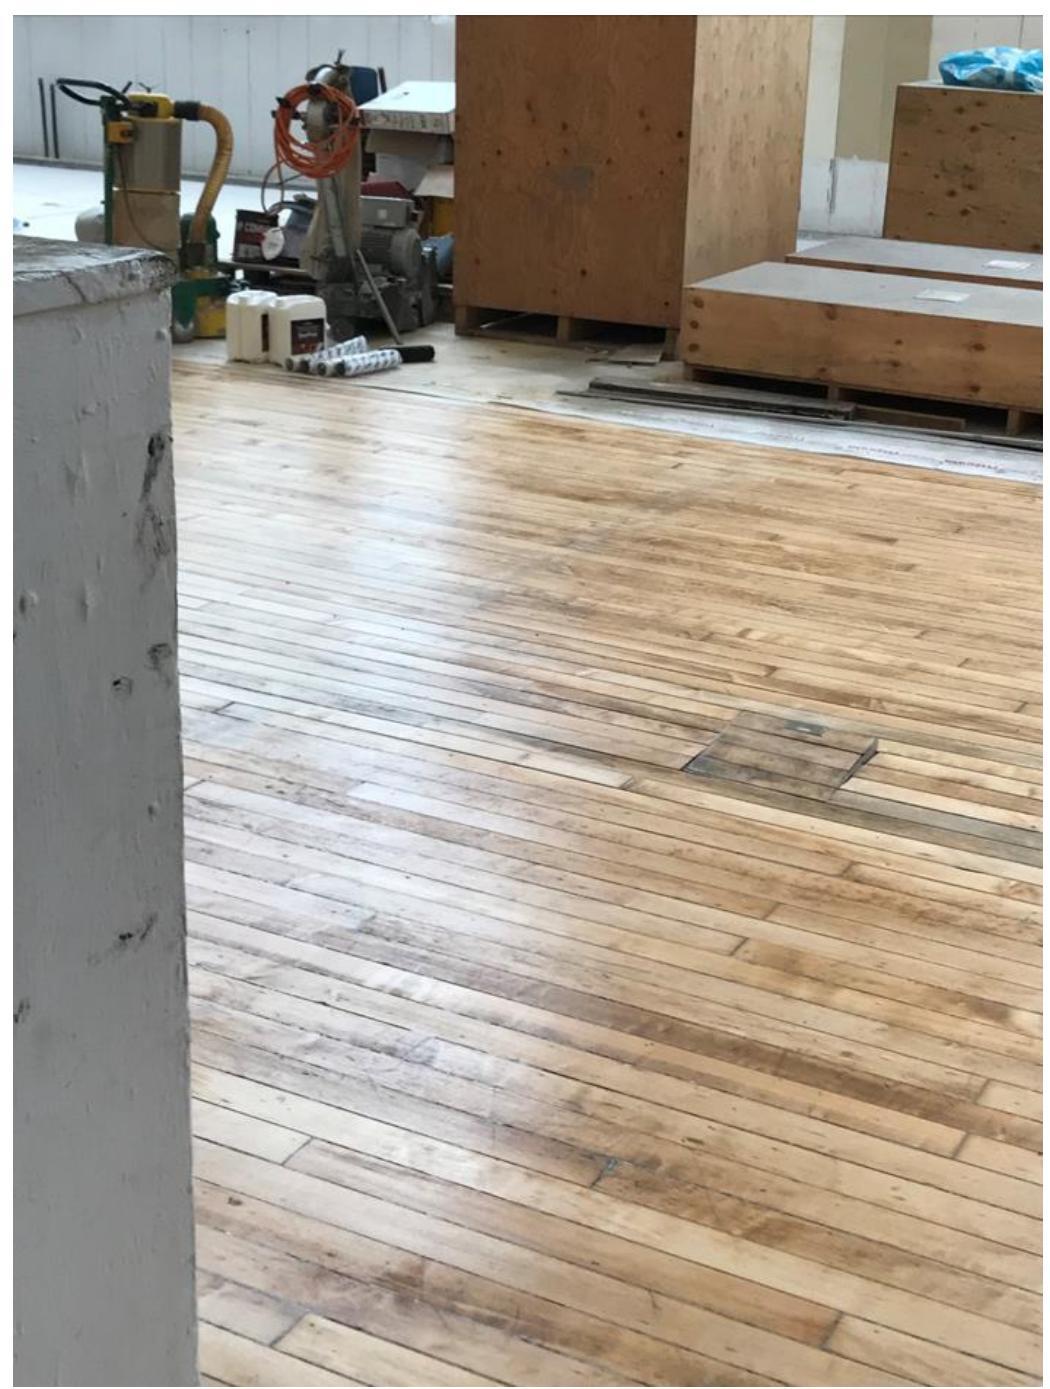
Figure 5.12: The floor in the Studio's is re-laid using floorboards from across the site, sanded-down and re-varnished. Taken by Rachael Purse June 2018.
