# In case of Emergency:

# What do the 2014 and 2018 fires in the Mackintosh Building tell us about how we manage our built heritage?

Submitted in fulfilment of the requirements for the Degree of PHD School of Design Glasgow School of Art September 2020

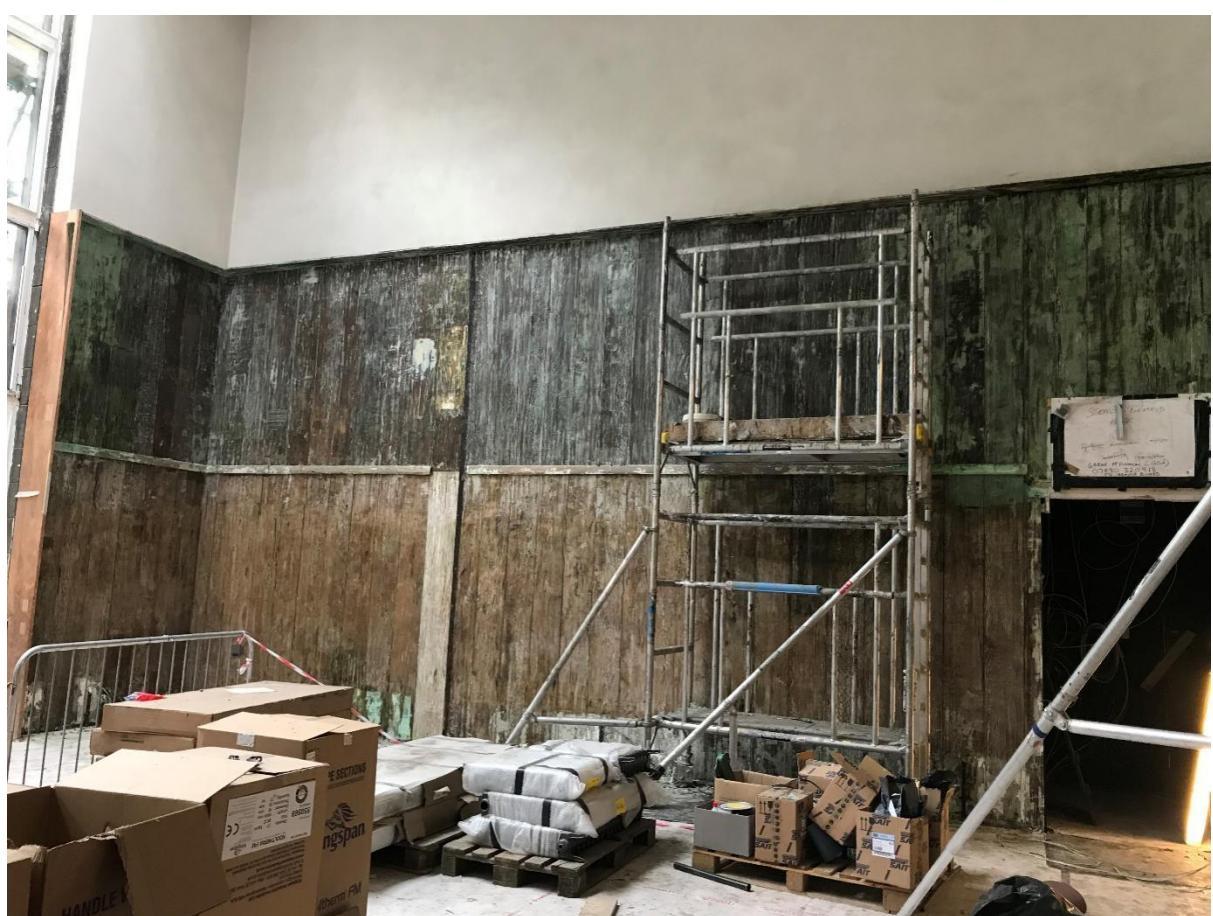
Figure 5.13: Tavec being used on the wooden panels in Studios throughout the Mackintosh Building to remove lead paint. Taken by Rachael Purse June 2018.

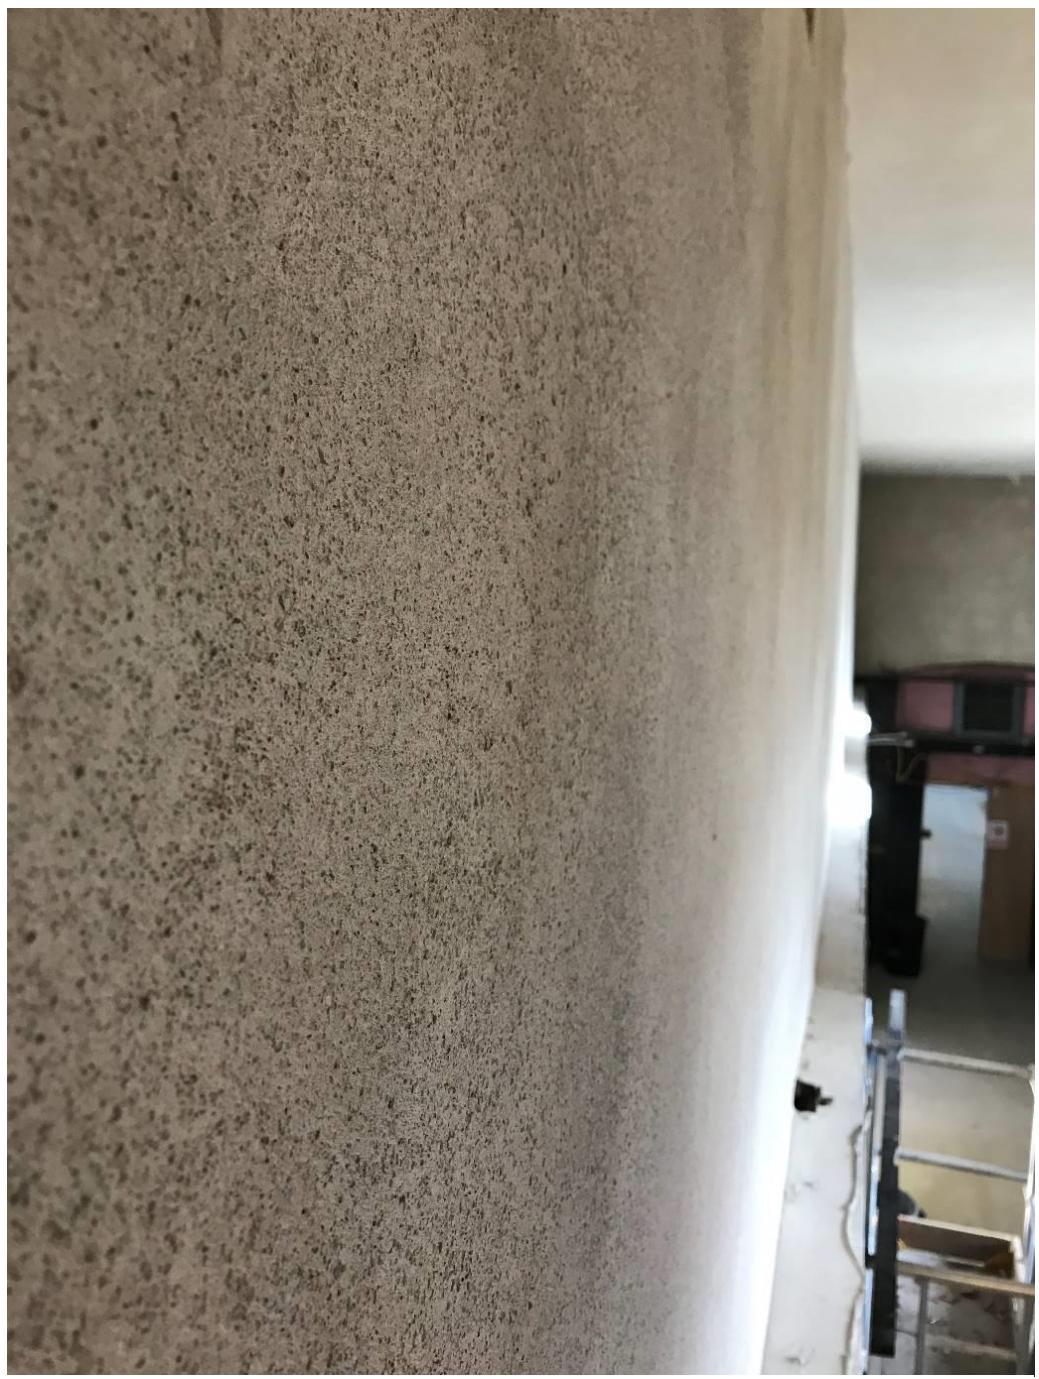
Figure 5.18: A close-up image of the plasterwork in the corridor outside the Library. A piece of cloth was used on the float to bring the aggregate in the plaster out, creating a 'natural' texture. Image taken by Rachael Purse, February 2018.

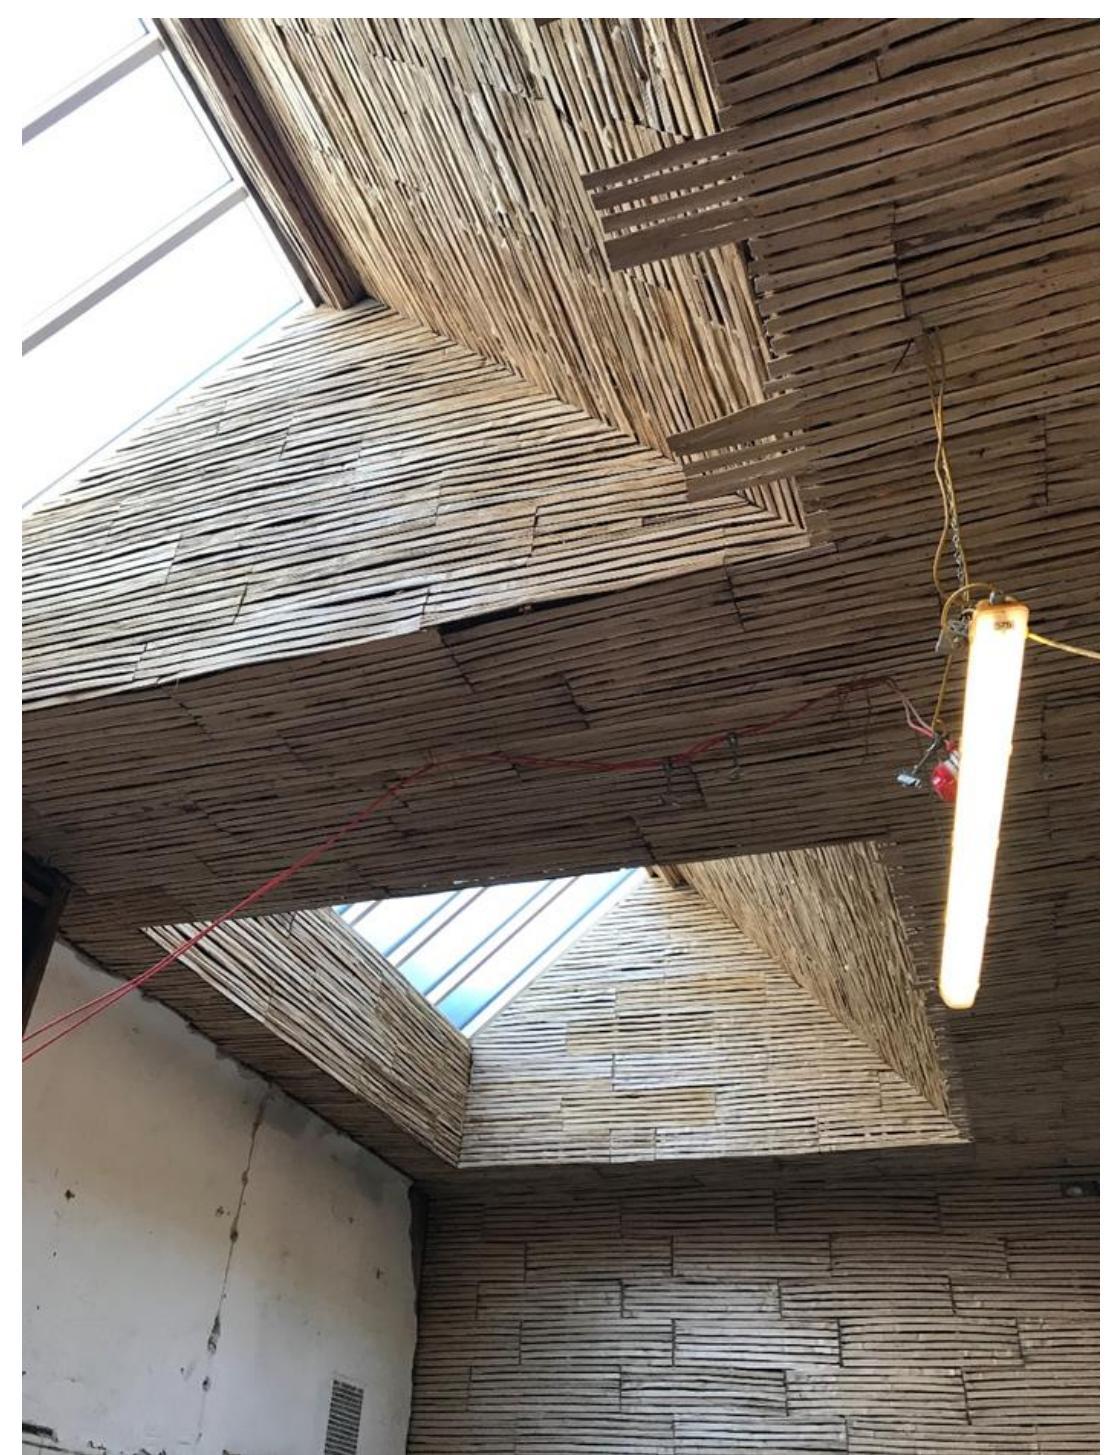
Figure 5.195: Hazel laths in the Mackintosh Building, prior to the application of plaster. Image taken by Rachael Purse, February 2018.

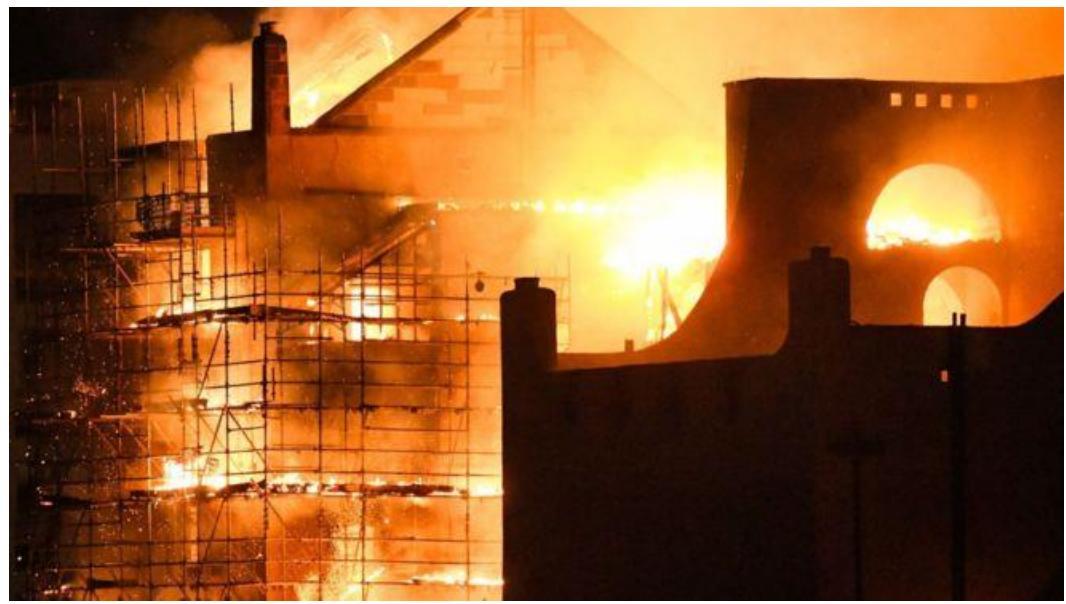
Figure 6.2: The damage done by the fire to the interior of the Mackintosh Building can clearly be seen. The Hen Run has been destroyed and Studio 58 has no roof. Image copyright Getty Images, 2018.

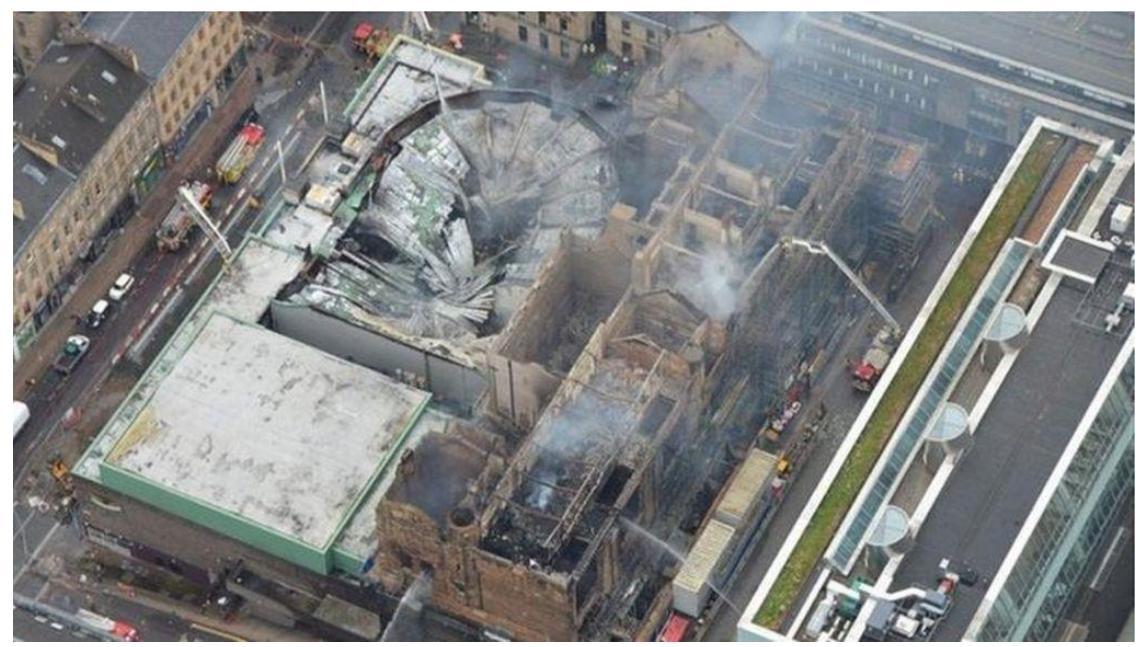
Figure 6.3: Aerial image taken after the fire was put out by SFRS, who were still dousing hotspots. The collapsed roof of the O2 ABC is seen to the left of the Mackintosh Building. Image copyright Police Scotland, 2018.

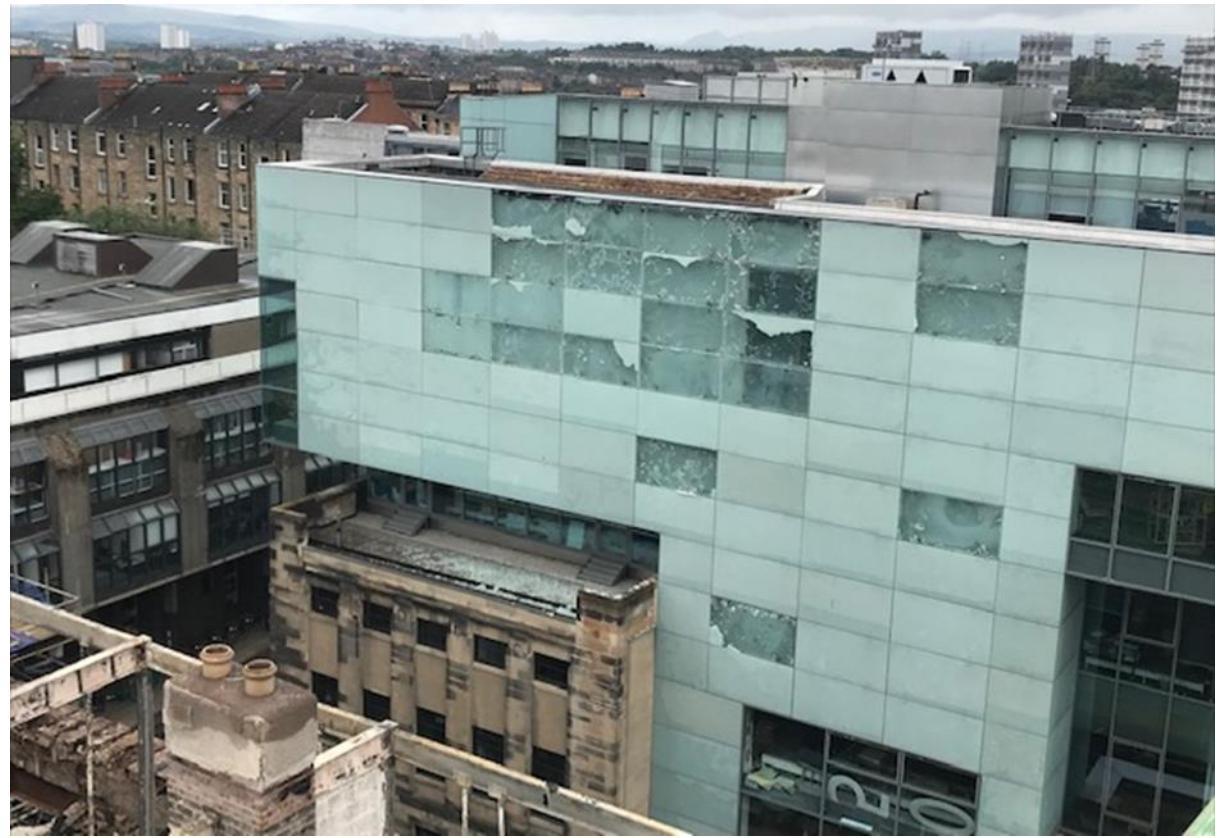
Figure 6.4: The Reid Building's smashed glass panelling, broken during the fire in the Mackintosh Building. Image taken by Rachael Purse, July 2018.

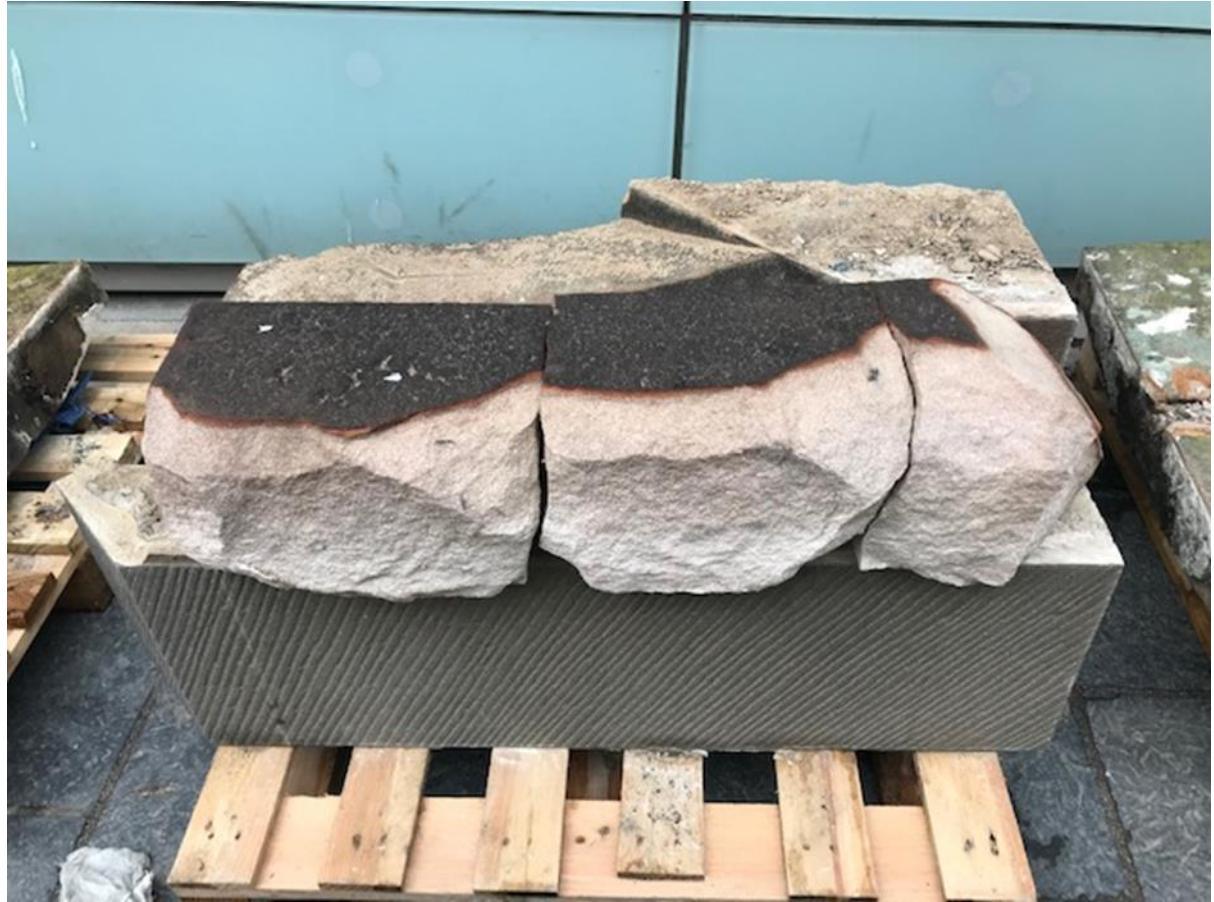
Figure 6.5: Damaged masonry from the Mackintosh Building, removed from the Building during the downtaking works. Image taken by Rachael Purse, 2018.

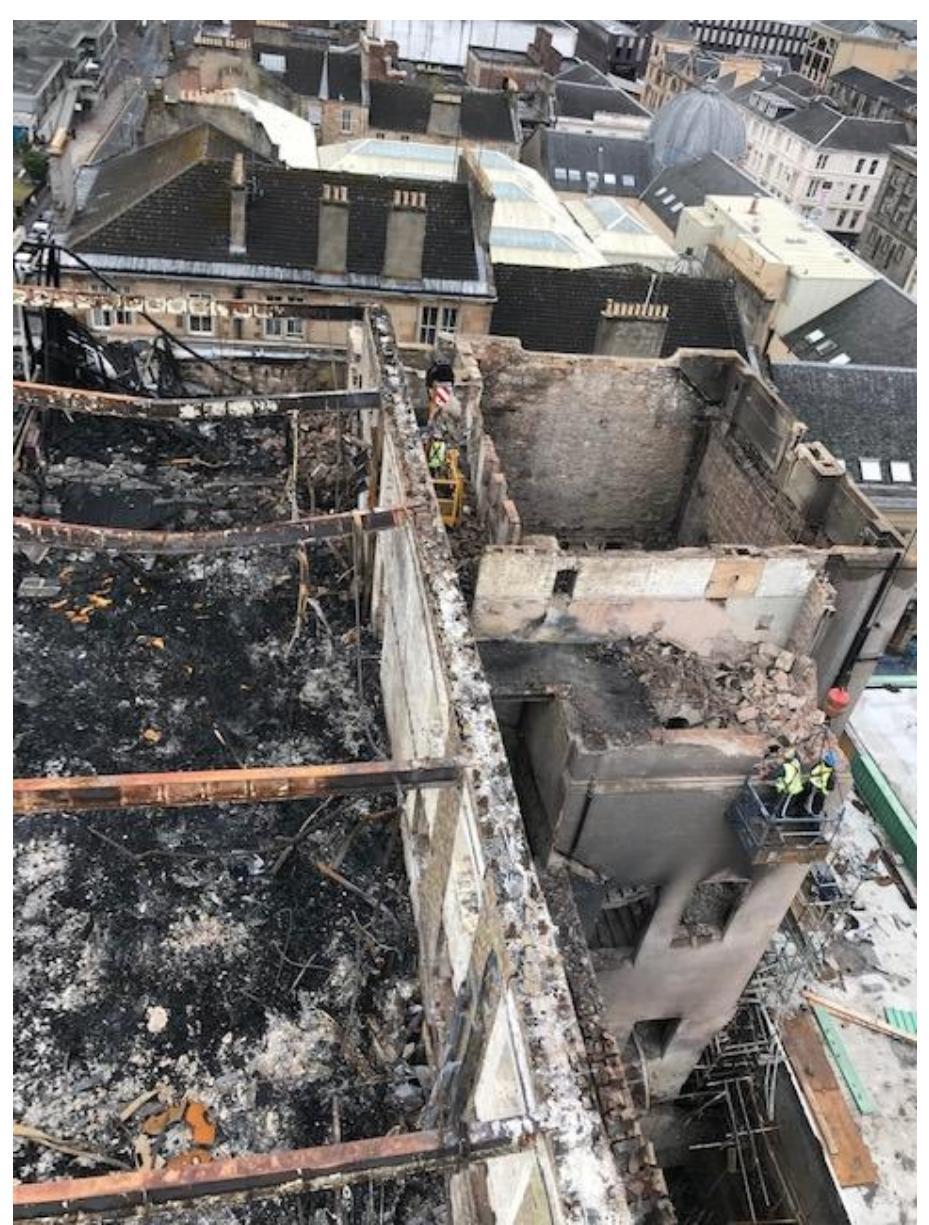
Figure 6.6: Above The East Gable, the remains of the Embroidery Studio can be seen on the left. On the right of the image, Reigart employees working from a basket remove dangerous debris from the staircase on the South Facade. Image taken by Rachael Purse, 2018.

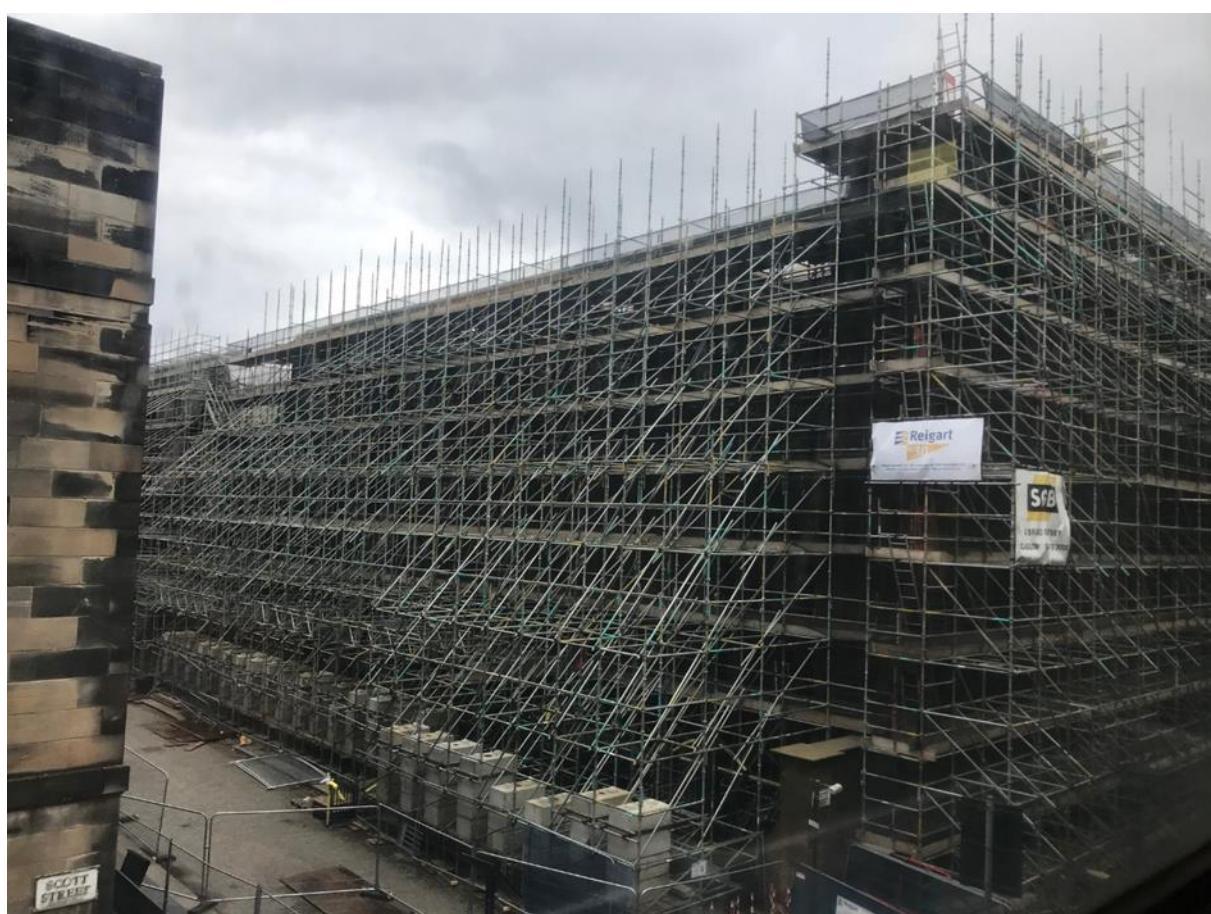
Figure 6.8: The scaffolding-clad Mackintosh Building after all dismantling and stabilisation works were completed. Image taken by Rachael Purse, 2019.

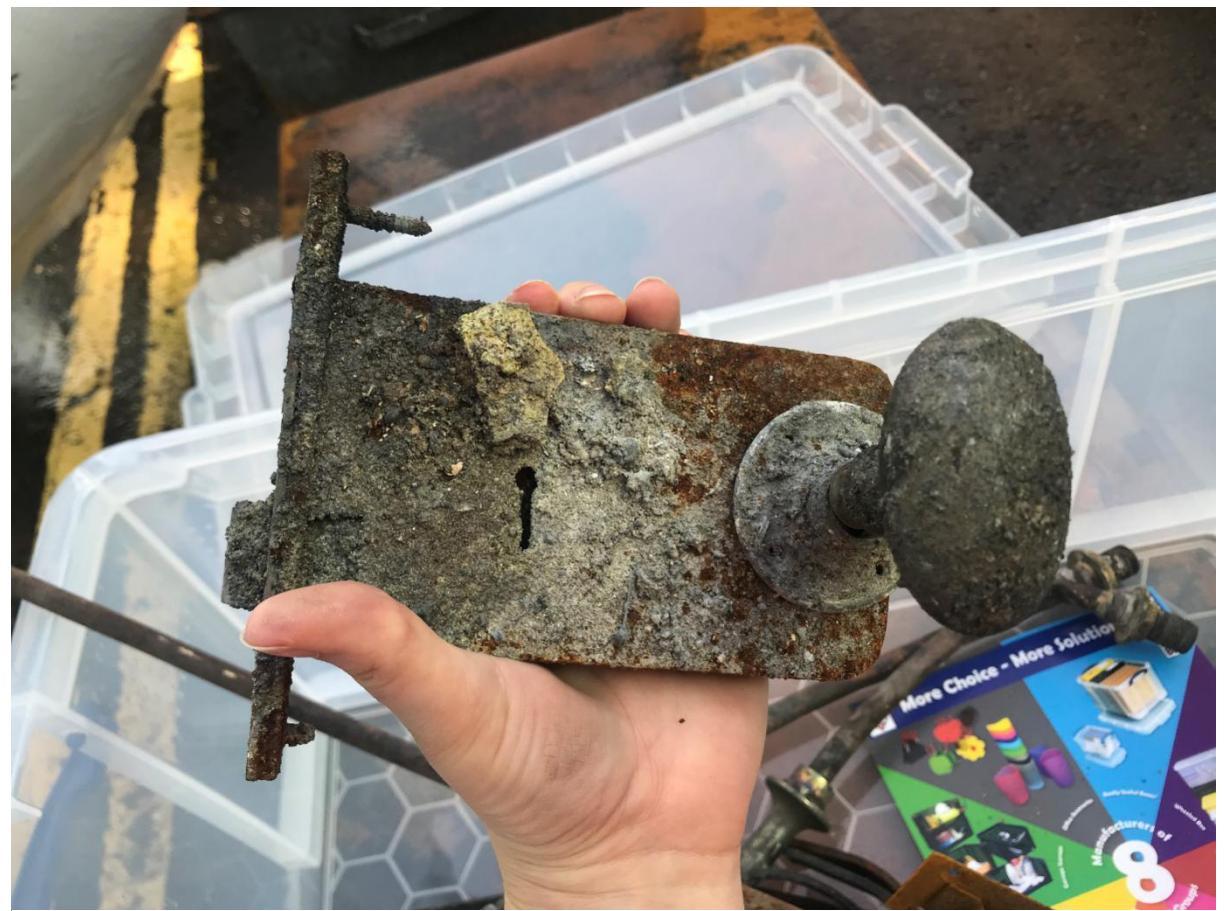
Figure 6.13: Door lock, casing and doorknob which had been removed from the accessible debris in the Mackintosh Building by Reigart operatives. Note the corroded and damaged surface. Image taken by Rachael Purse, September 2018.
