Gulf Organisation for Research and Development
International Journal of Sustainable Built Environment

Original Article/Research

Case study investigation of indoor air quality in mechanically ventilated and naturally ventilated UK social housing

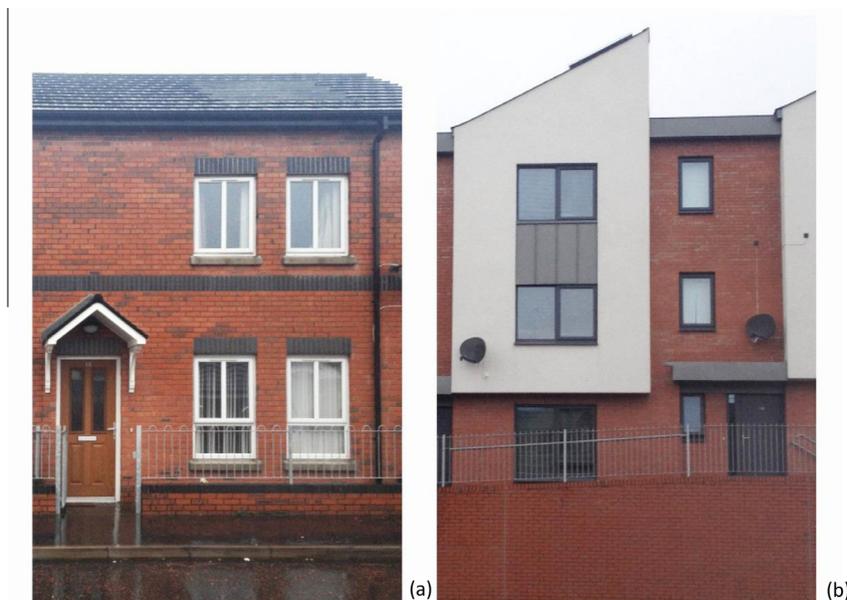
Figure 1. (a) Code 3 dwelling, (b) Code 4 dwelling.

Code 3 (C3) and Code 4 (C4) homes are both located in Northern Ireland, within 0.3 miles of each other. The homes are all 2/3 bedroom terraced houses, heated primarily with gas. Code 4 homes (Fig. 1b) are three storied and utilise Mechanical Ventilation with Heat Recovery (MVHR) systems for ventilation, where-as Code 3 homes (Fig. 1a) are two storied and naturally ventilated with trickle vents. The dwellings are part of two new-build social

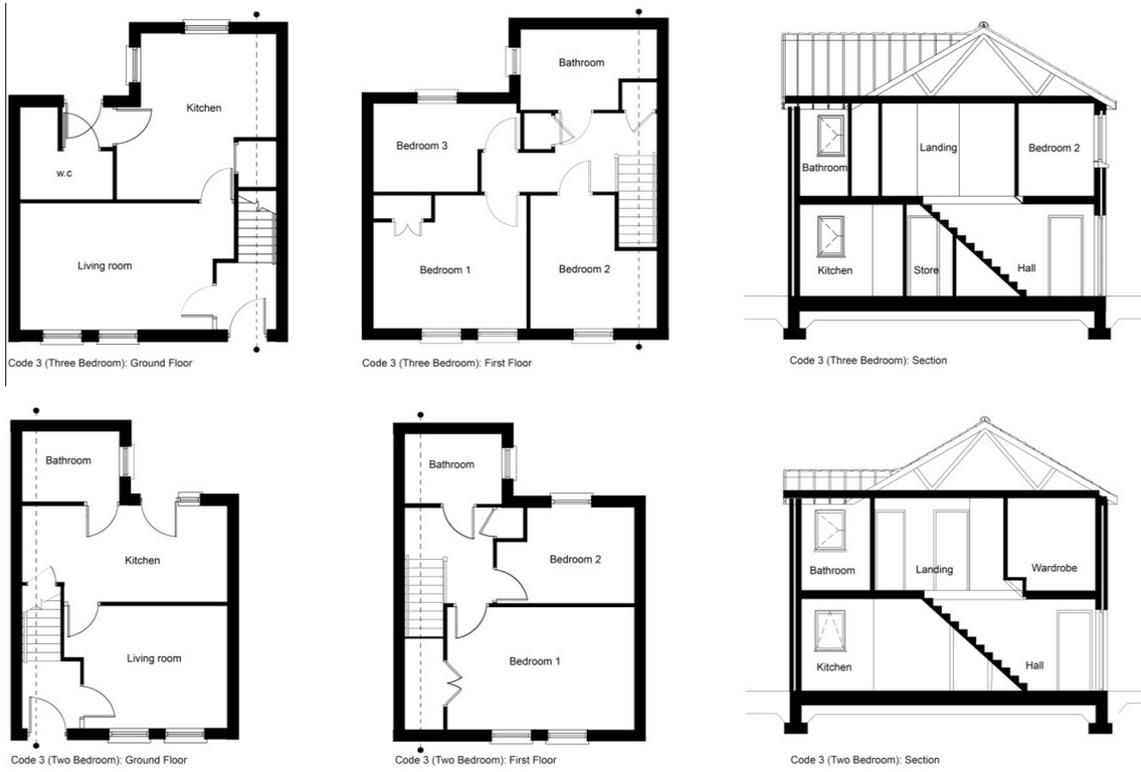
Figure 2. Plans and sections of Code 3 dwellings (Two and three bedroom).

Three of the case study dwellings are end terraces (C4:No.1, C3:No.1, C3:No.4); the remaining are mid-terraces. The dwellings are located in a residential area of moderate to high traffic flow. Dwelling construction and energy efficiency information is presented in Tables 2 and 3.
