Characteristics and performance of MVHR systems

A meta study of MVHR systems used in the Innovate UK Building Performance Evaluation Programme

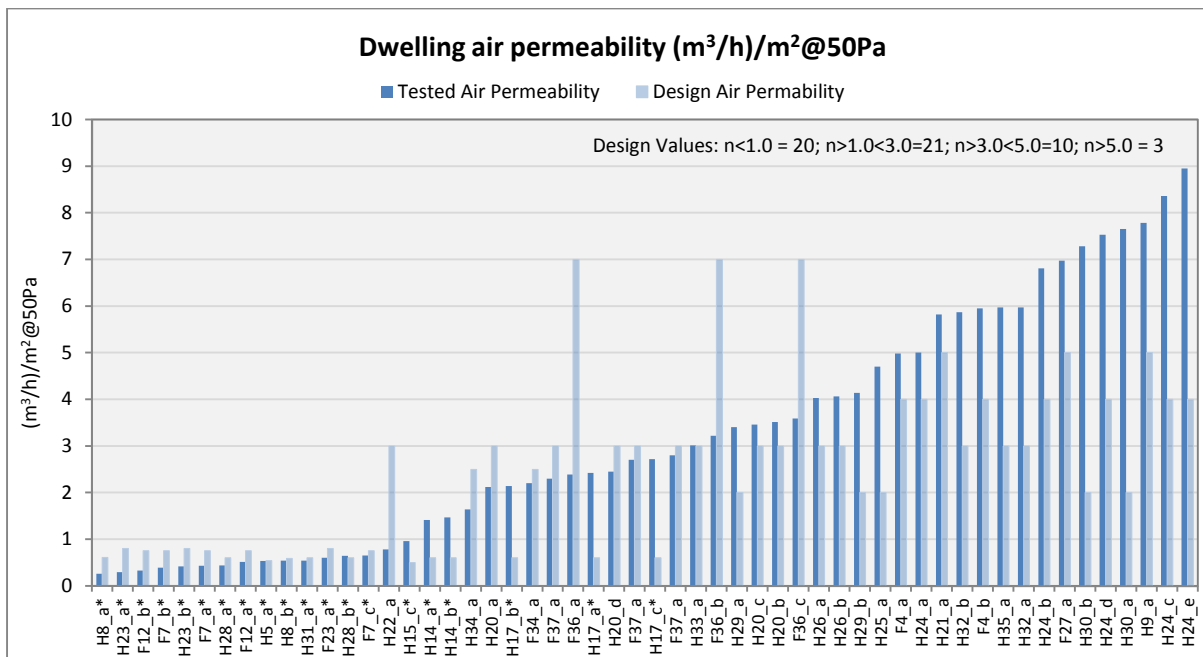
Figure 2.2a. Dwelling air permeability characteristics – design and tested
* against dwelling reference denotes Passivhaus

The design air permeability target is important in the context of MVHR installations as any leakage through the dwelling envelope will have an impact on the efficiency of the heat recovery component. Figure 2.2a illustrates the design and tested air permeability across 54 dwellings.

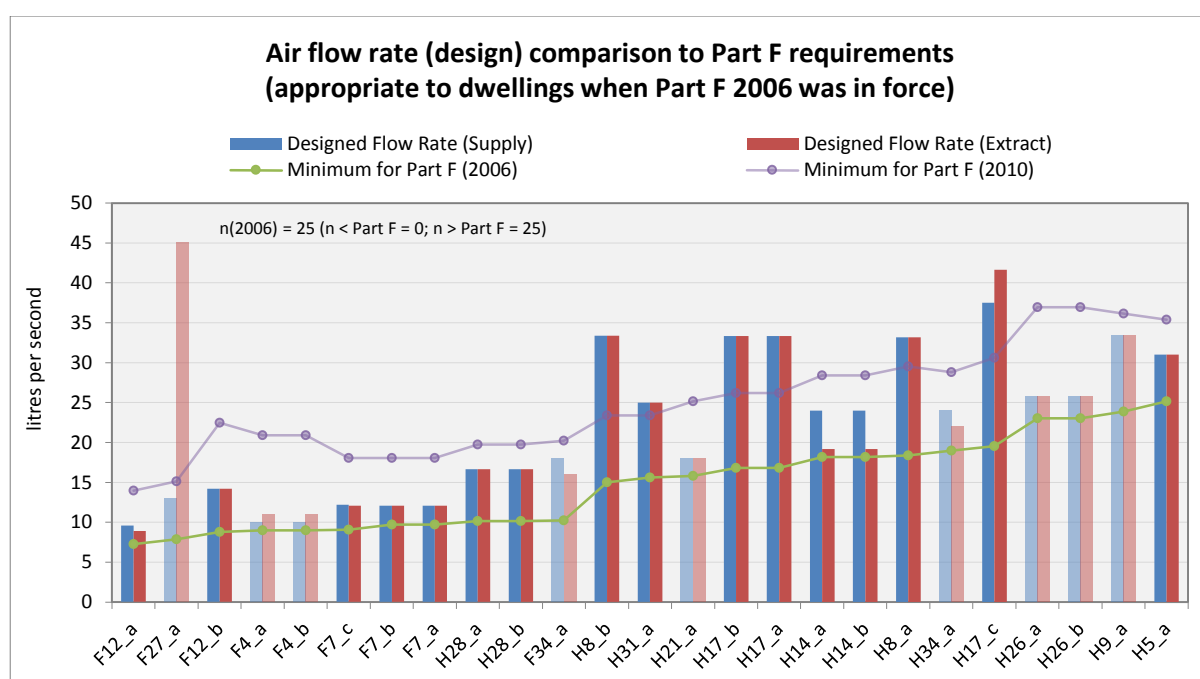
Figure 3.1a. Design stage air flow rates compared to AD F (2006)
Bold bars denote Passivhaus dwellings

Figure 3.1a shows the properties that were completed under the 2006 revision of AD F. The minimum whole-house ventilation rate required, shown by the green line, is based upon the requirement of 0.3 l/s per m² of internal floor area with an allowance for infiltration by subtracting 3% (single-storey) or 4% (multi-storey) internal volume of air from the whole dwelling ventilation rate, according to dwelling type.

The chart (Figure 3.1a) shows that, in all 25 submitted cases, the ventilation designs meet the minimum air flow specification given AD F (2006). However, the guidance published in this revision of AD F was designed to cope with air permeability levels down to around 3-4 (m³/h)/m² @50Pa, and it suggested that additional ventilation provisions (air flow) should be considered for more airtight properties. It would be reasonable to consider that the allowance for additional provision would be to remove the infiltration allowance, thereby the provision of all air flow is via the ventilation system (i.e. not relying upon infiltration to account for a proportion of the total ventilation). The purple line shows the 0.3 l/s per m² (without infiltration allowance), and this is the revised specification for minimum ventilation rates as required by AD F (2010).

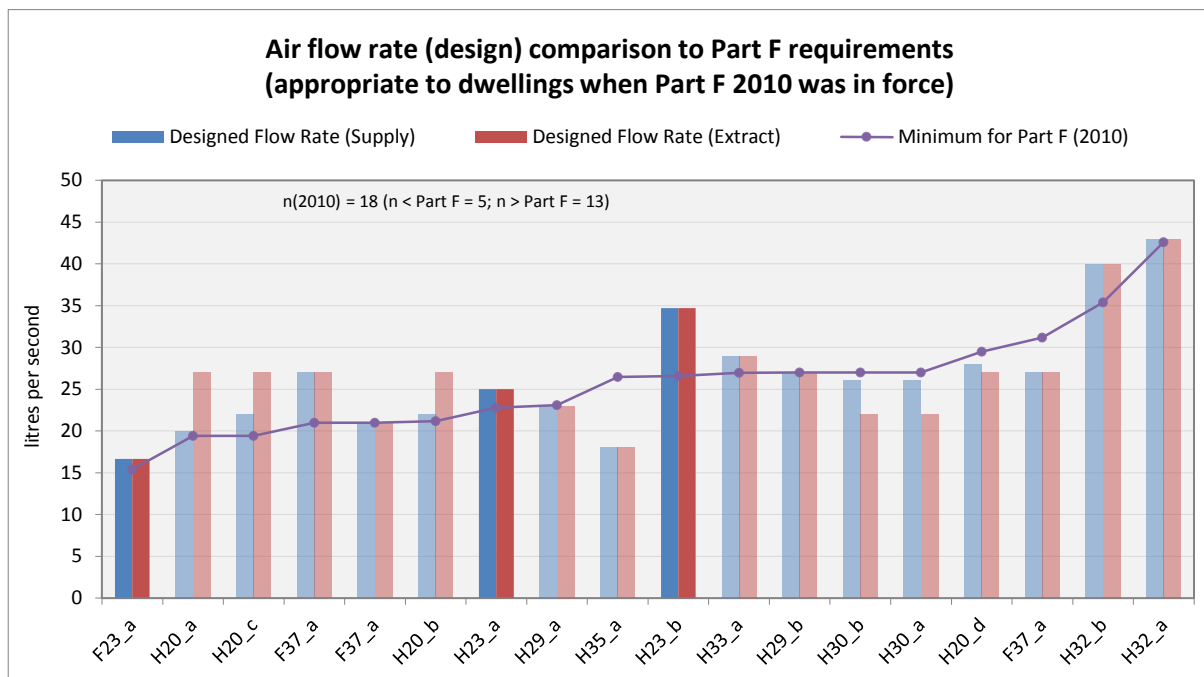
Figure 3.1b. Design stage air flow rates compared to AD F (2010)
Bold bars denote Passivhaus dwellings

Figure 3.1b shows a further 18 properties that were completed to meet AD F (2010) revision. The purple line in the chart shows the minimum design flow rate for each property to meet the AD F (2010) specification. In the majority of cases (72%), the original design values are equal, or greater than the minimum value. However, the design for 5 properties do not meet the minimum specification. Given the period during which the BPE programme spanned, it is probable that these properties fell during the transition between 2006 and 2010 revision of AD F coming into force.

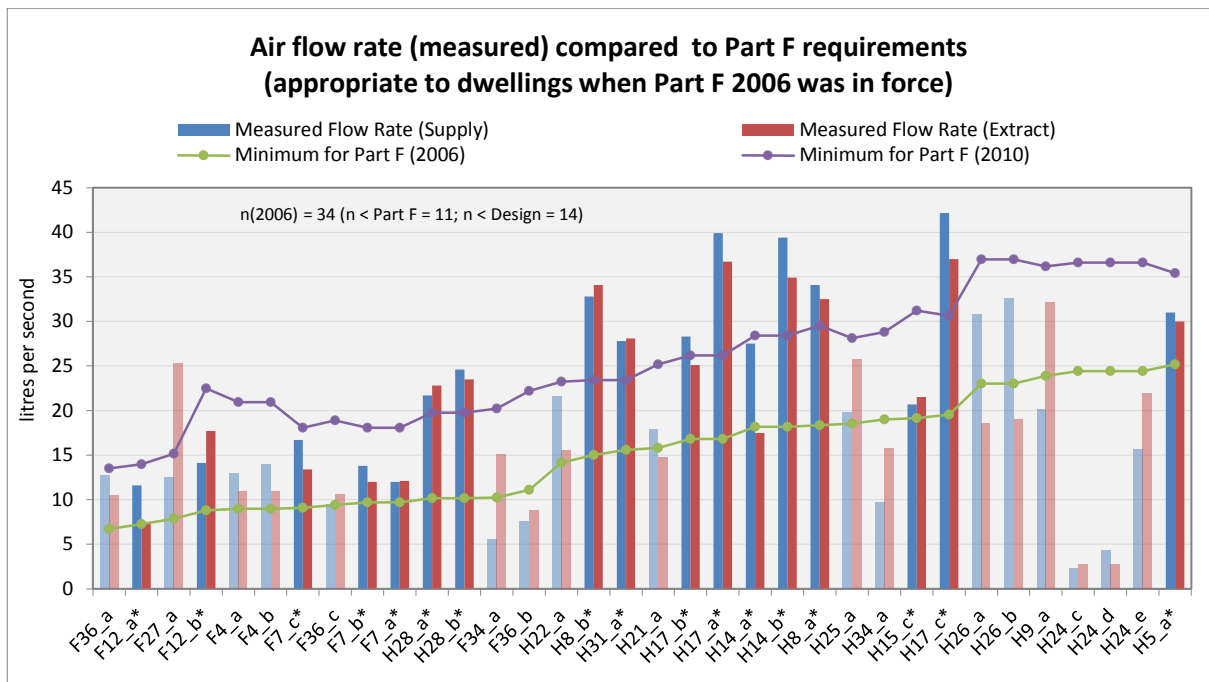
Figure 3.3a. Measured air flow rates compared to AD F (2006)
Bold bars denote Passivhaus dwellings.

Out of the 34 systems, the minimum air flow requirement is met in 23 systems (68%), with two systems (H24_c and H24_d) failing significantly. A number of systems were commissioned to have higher air flow rates, meeting or exceeding the AD F (2010) air flow rates. In most cases, these are the more airtight dwellings (<3.0 (m³/h)/m²), as summarised later.

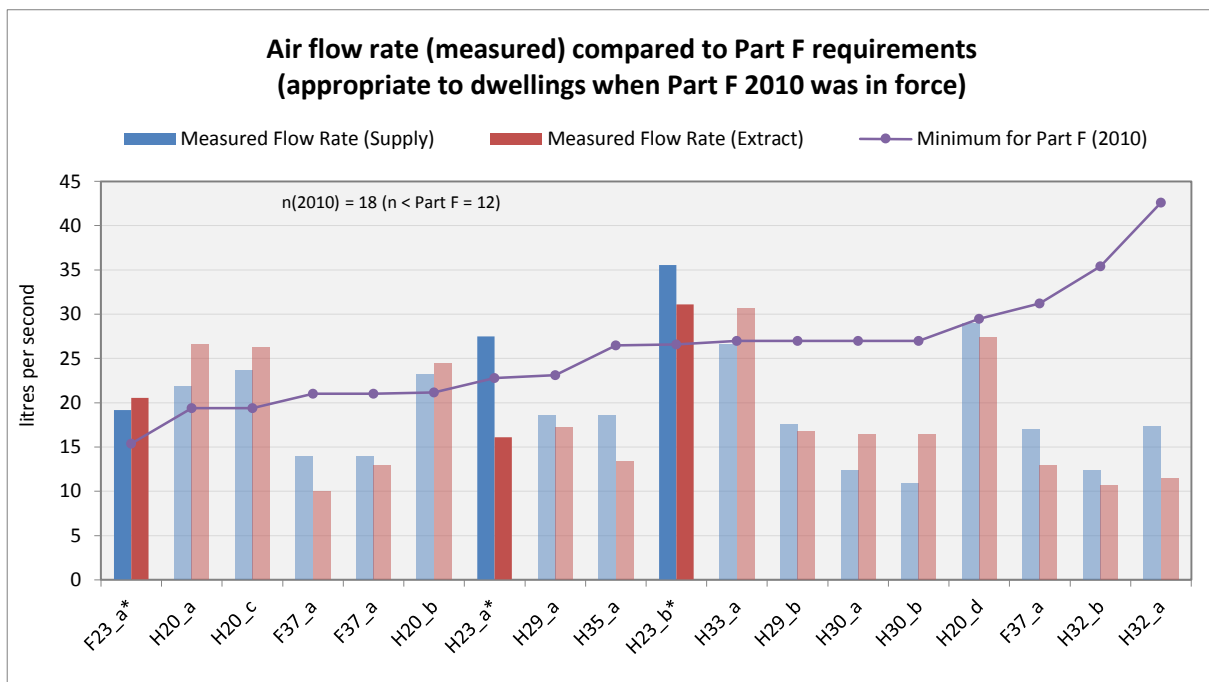
Figure 3.3b. Measured air flow rates compared to AD F (2010)
Bold bars denote Passivhaus dwellings

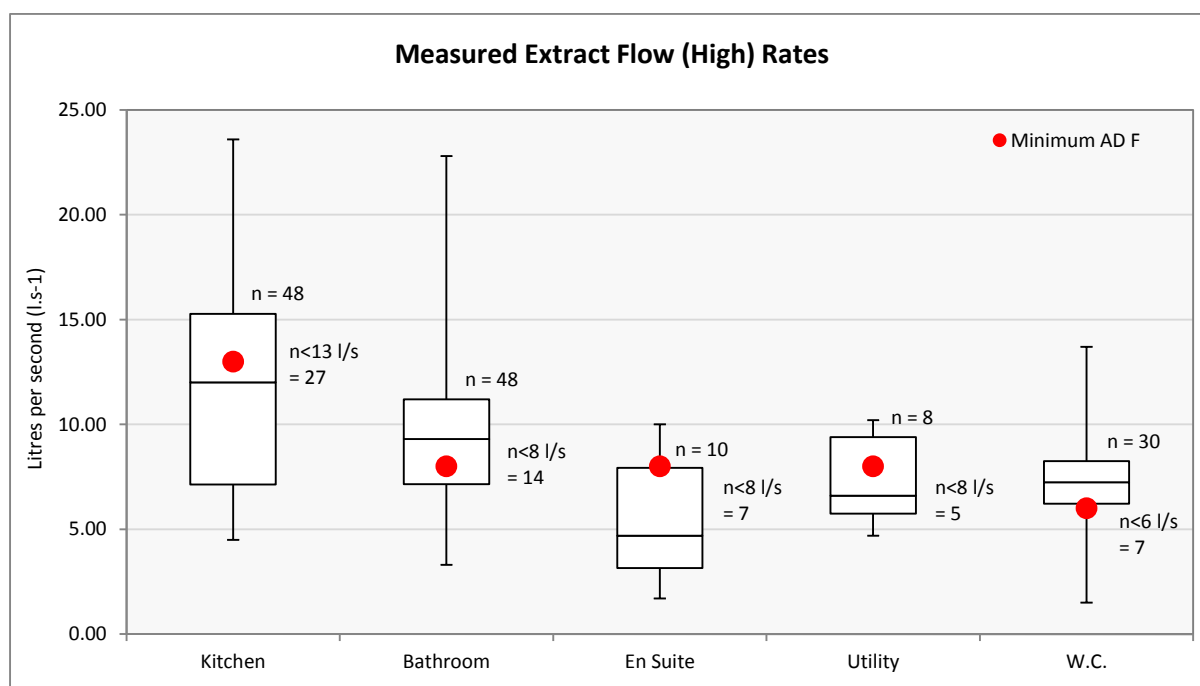
Figure 3.3c Measured individual room extract flow rates in boost

Overall, the measured boost extract air flow rates meet the 13 l/s minimum for kitchens (AD F) in 44% of systems. 71% of bathrooms meet the 8 l/s requirement, whereas only 30% of en-suites and 38% of utility rooms meet the 8 l/s criteria. In W.C.'s, which have a lower extract flow rate requirement of 6 l/s, the flow rates were met in 77% of systems.

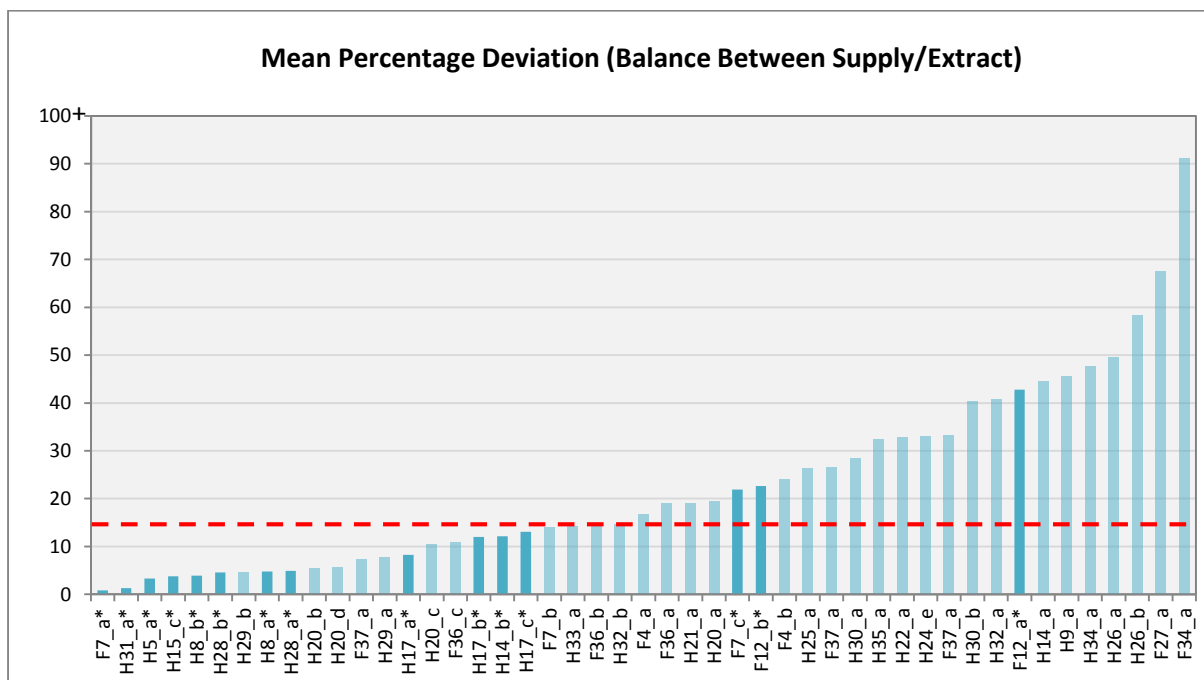
Figure 3.4a. Symmetrical mean percentage deviation between supply and extract rates against dwelling reference denotes Passivhaus.

Figure 3.4a shows the balance observed in 52 MVHR systems set at 'normal' speed. These values are taken from the sum of the individual room supply and extract rates, and not the intake and exhaust measurements, as these were not available in most cases. The red dotted line shows the 15% allowance. Out of the 52 systems, 25 (48%) have an imbalance of <15%, the remainder being above this, with 14 (27%) being significantly out of balance (deemed as >30%). Of the 15 Passivhaus systems, 6 show an imbalance of >10%.

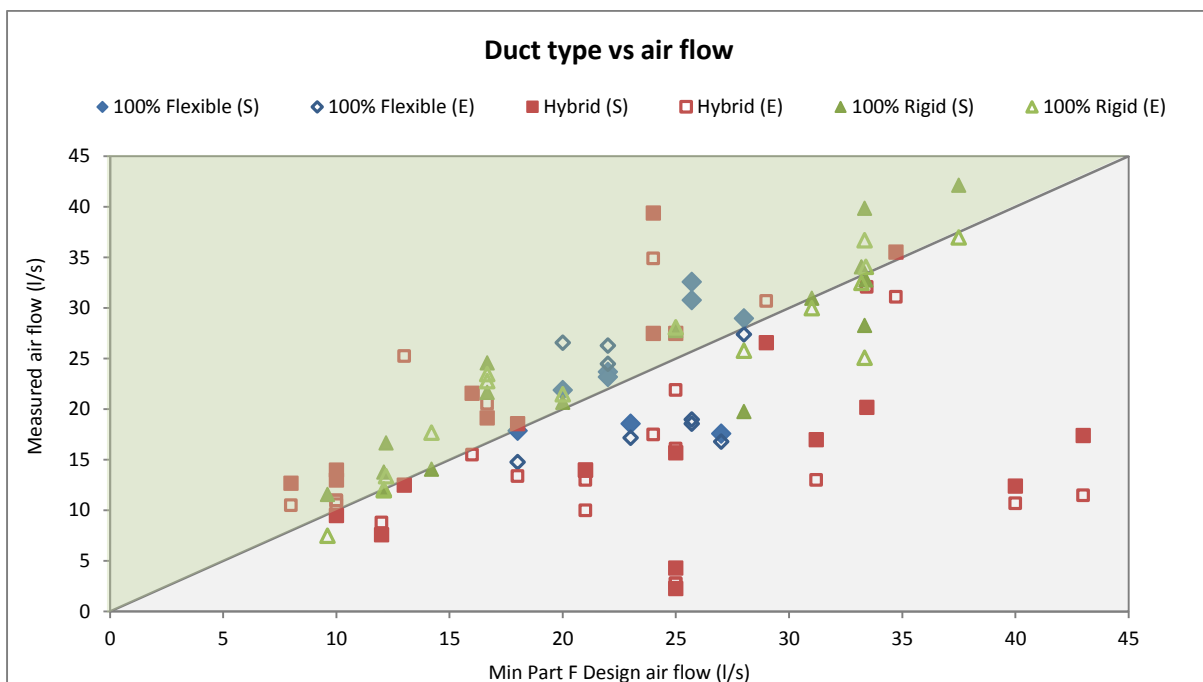
Figure 3.5a Duct types: measured airflow comparison with design air flow.

The results from this review are presented in figure 3.5a. The upper segment of the chart (green background) represents systems where the measured air flow rates are equal to or greater than the design. The lower segment represents system air flow rates that do not meet the design air flow. The air flows for the supply (S) and extract (E) for each duct type are plotted.

Overall, 40% of hybrid ducted systems and 44% of flexible ducted systems meet their design air flow criteria. By comparison, the measured air flow in 88% of rigid-duct systems meet the design air flow criteria. This assessment is limited and some caveats need to be considered. For example, duct pressure drop is not known for any system in the data set, air leakage through ducting is not known, the fan system employed by the MVHR may either be constant power or constant velocity types, quality of installation and commissioning is not known, etc. The results do however indicate a trend toward improved performance with rigid ducting systems.

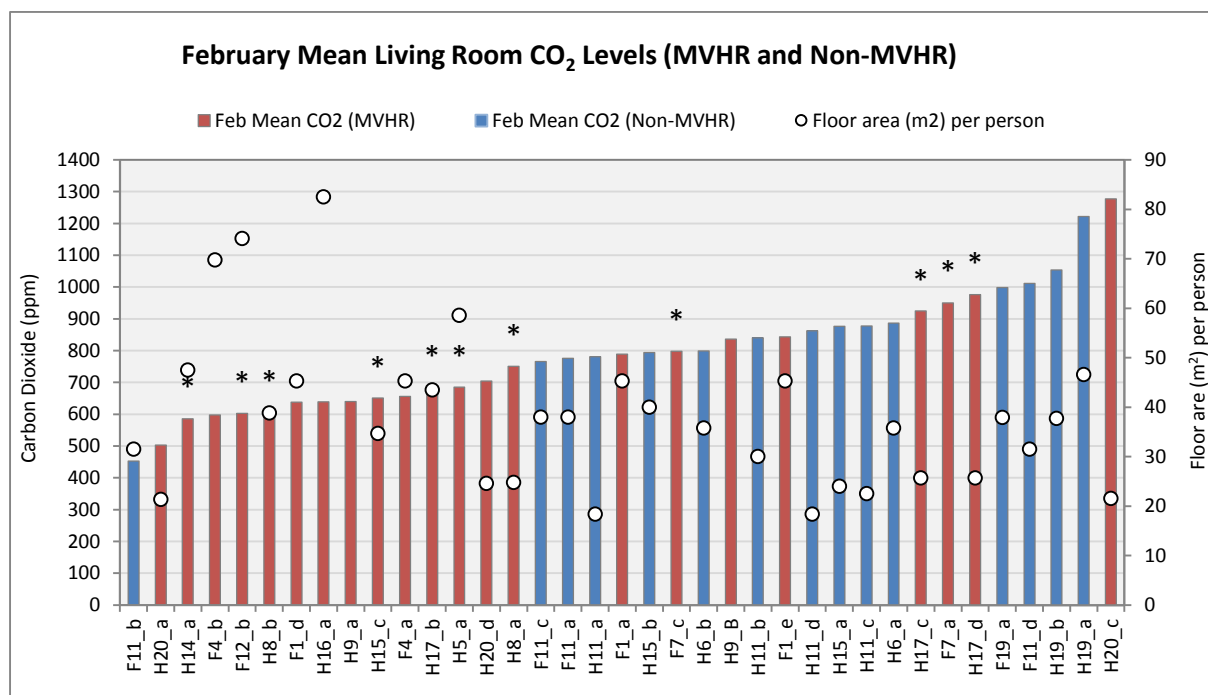
Figure 4.1a. February average (mean) living room CO₂ levels in MVHR and Non-MVHR homes
* Passivhaus dwellings

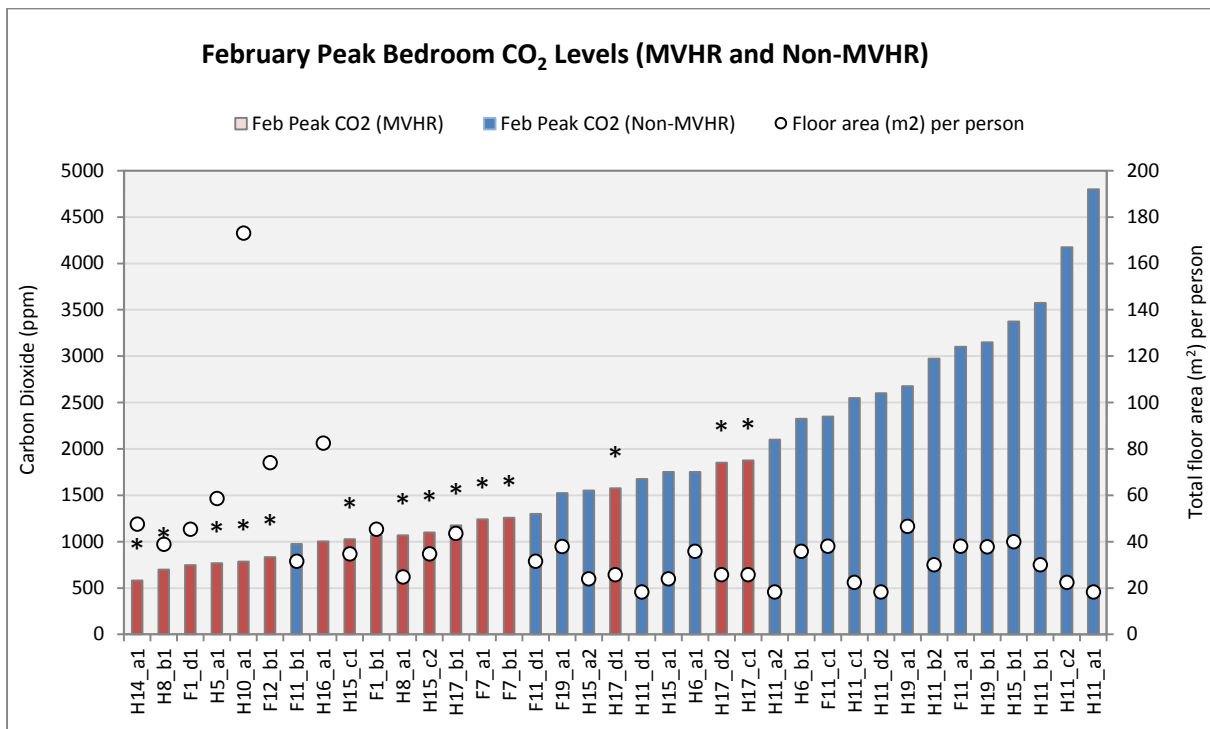
Figure 4.1b. February Peak Bedroom CO₂ levels in MVHR and Non-MVHR homes
 * Passivhaus dwellings

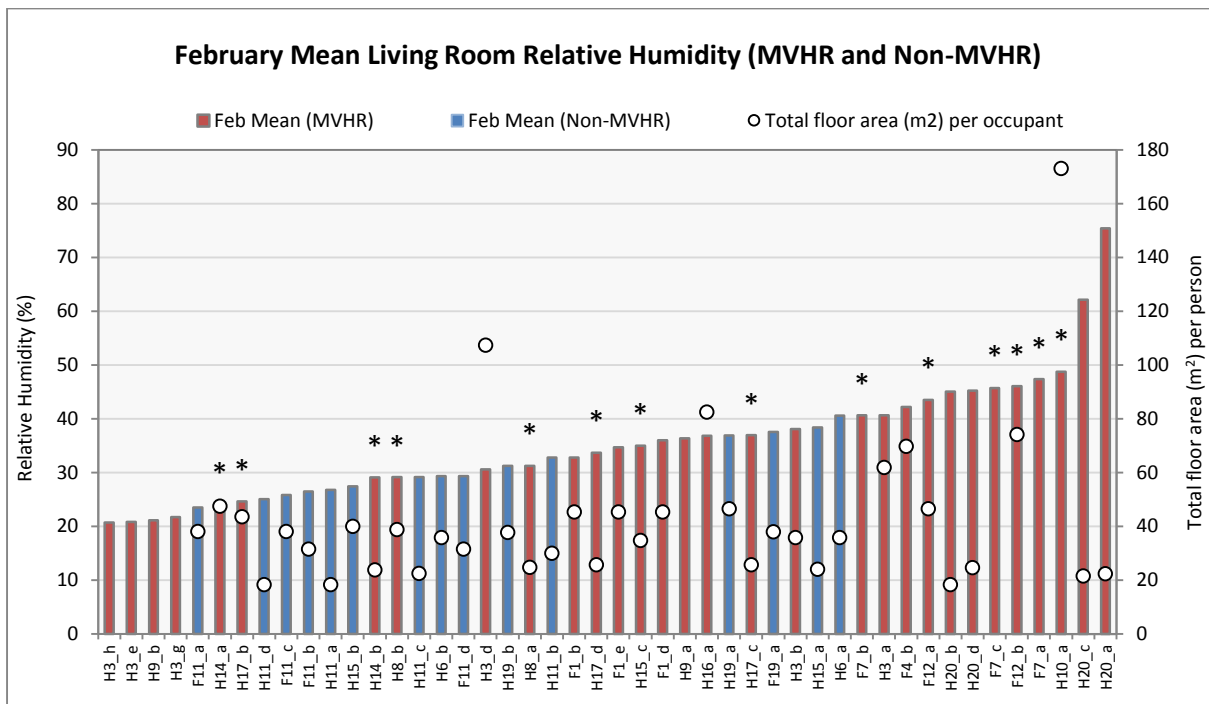
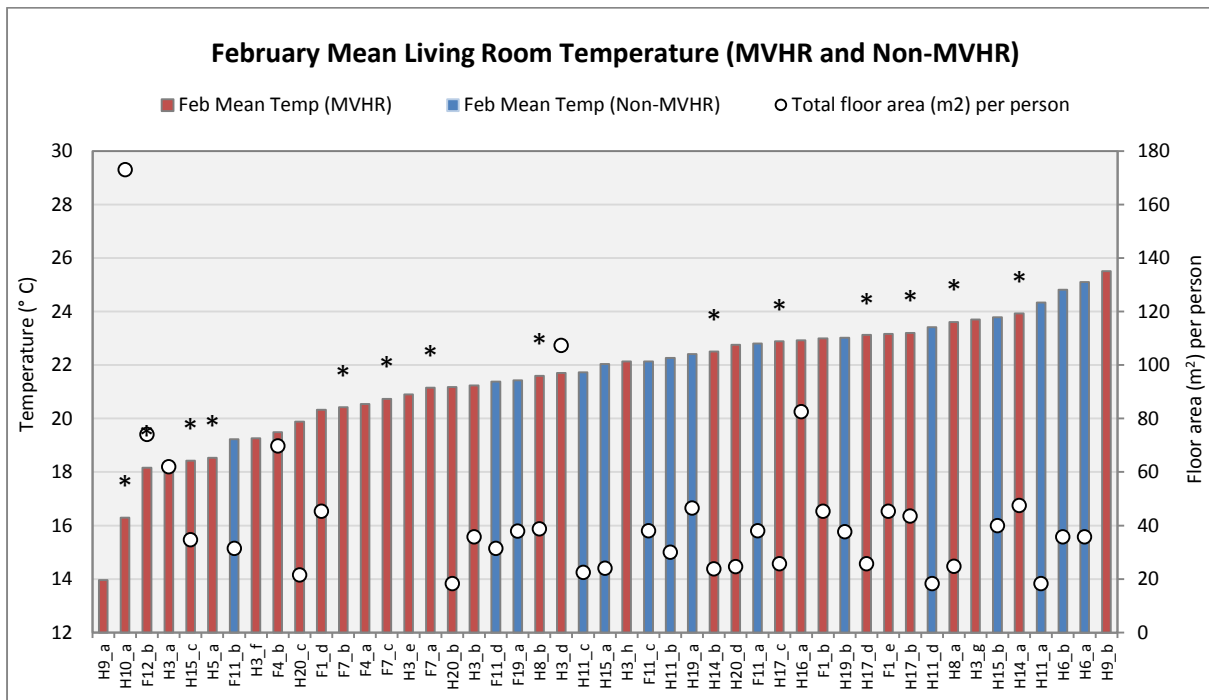
Figure 4.2a. February mean living room temperature and RH% (MVHR and Non MVHR)
 * Passivhaus dwellings

In general RH levels were within reasonable ranges, tending toward the lower end. The average and minimum living room and bedroom RH levels (during February, April and August) were generally higher in dwellings with MVHR systems but were not at unduly extreme levels. However, these relationships are inverted when considering temperature (Figure 4.2a), in general, dwellings with MVHR systems had lower and more stable temperatures, which suggests that the RH is more a function of temperature than ventilation in this data.

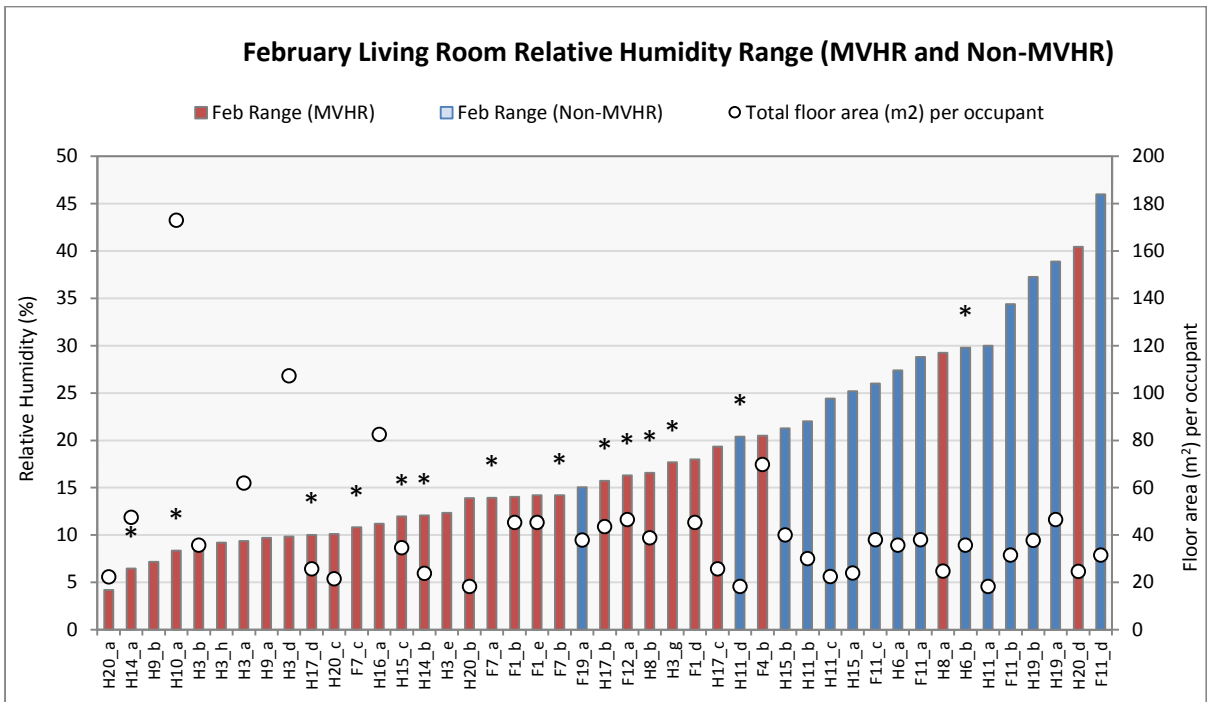
Figure 4.2b. Range of February living room relative humidity levels
* Passivhaus dwellings

However, a clear difference was in the range of relative humidity levels between MVHR and Non-MVHR dwellings. In general RH levels were more stable during all monitored seasons (see Table 4.2a and 4.2b) in the MVHR houses and this trend was particularly evident during winter (Figures 4.2b and 4.2c).

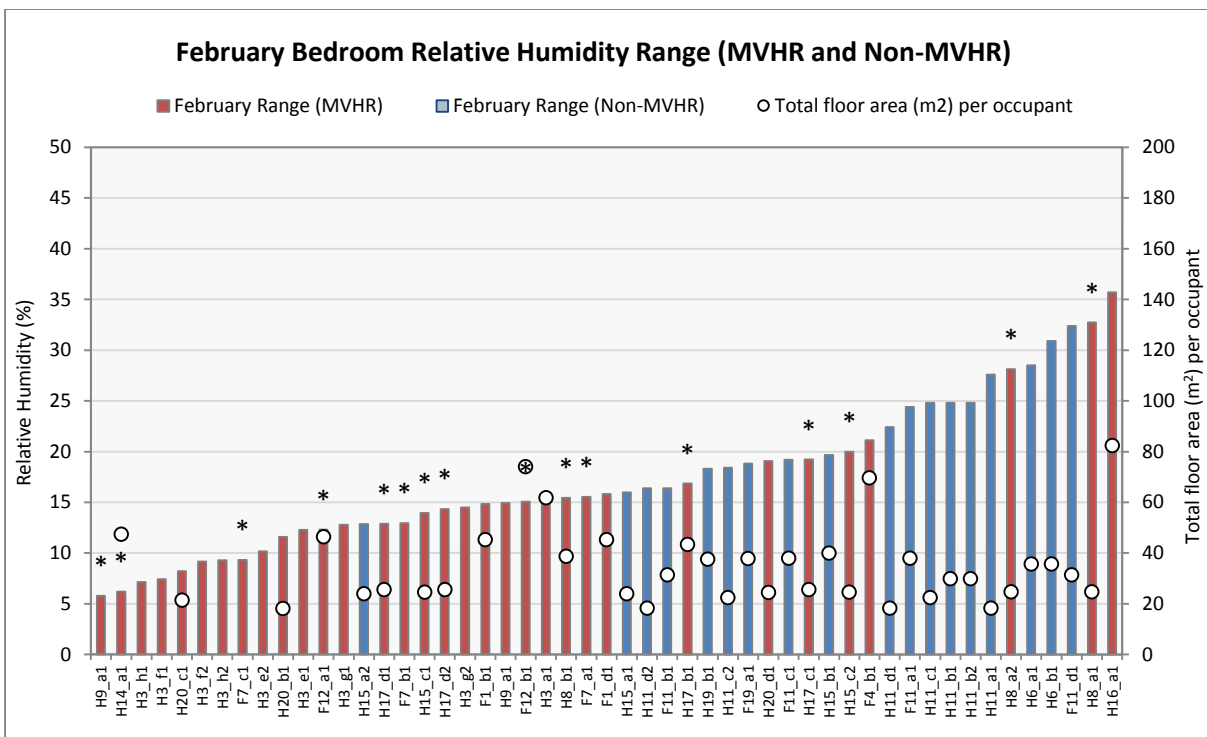
Figure 4.2c. Range of February bedroom relative humidity levels
* Passivhaus dwellings

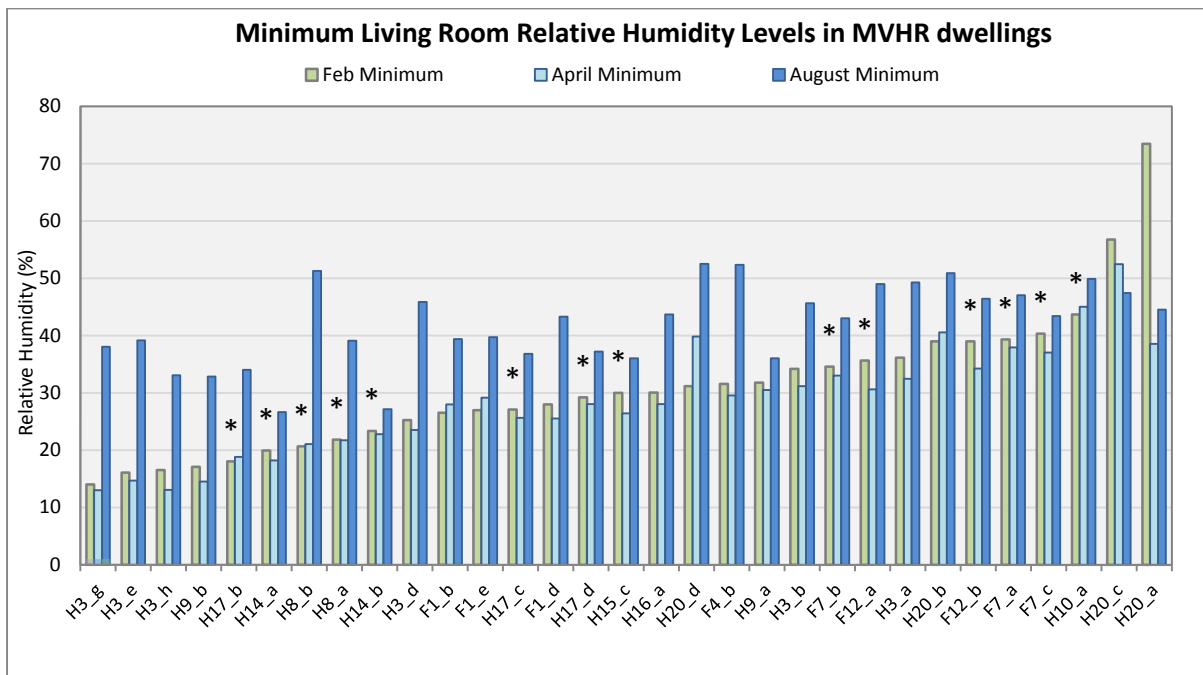
Figure 4.2e. Minimum living room relative humidity levels in dwellings with MVHR
 * Passivhaus dwellings

Monitored relative humidity levels fell below 30%RH in 48% of living rooms during February and 58% of living rooms during April (see Figure 4.2e). Average humidity levels were below 30% in roughly a quarter of monitored living rooms during February (26%) and April (23%) months.

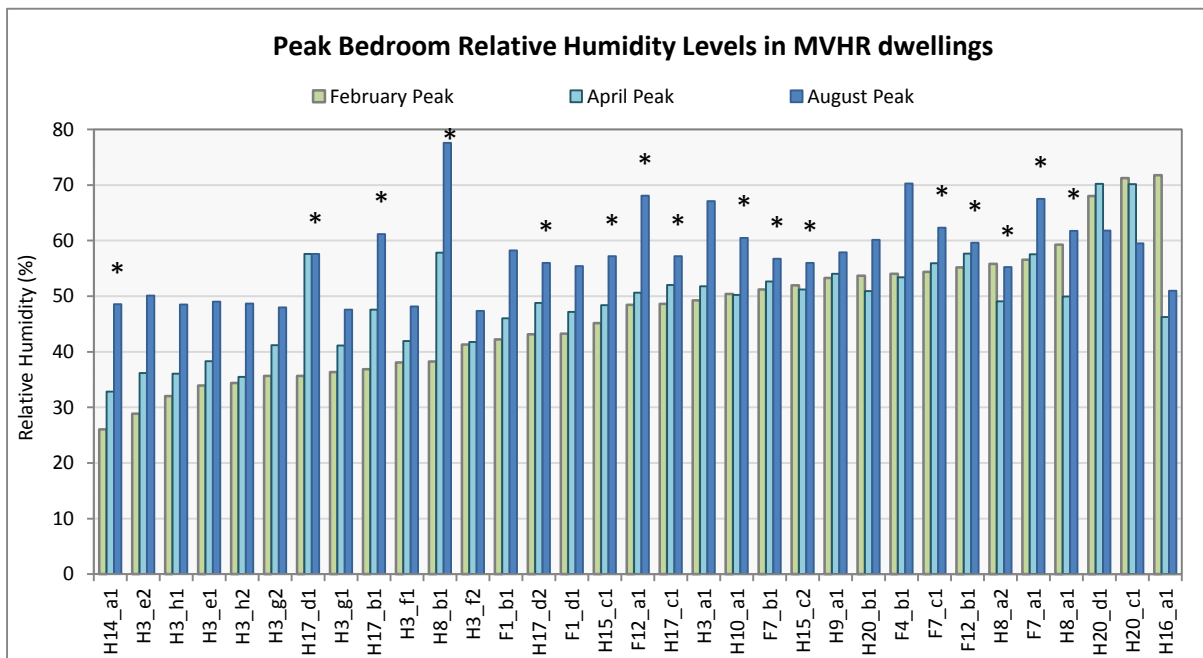
Figure 4.2f. Peak bedroom relative humidity levels in dwellings with MVHR
 * Passivhaus dwellings

In the bedrooms, average humidity levels remained below 70%, with levels peaking above this in 15% of cases (Figure 4.2f). Figure 4.2g shows the percentage of rooms that had average relative humidity levels between 40 and 60%. It is apparent that low RH is common in MVHR dwellings during the heating season.

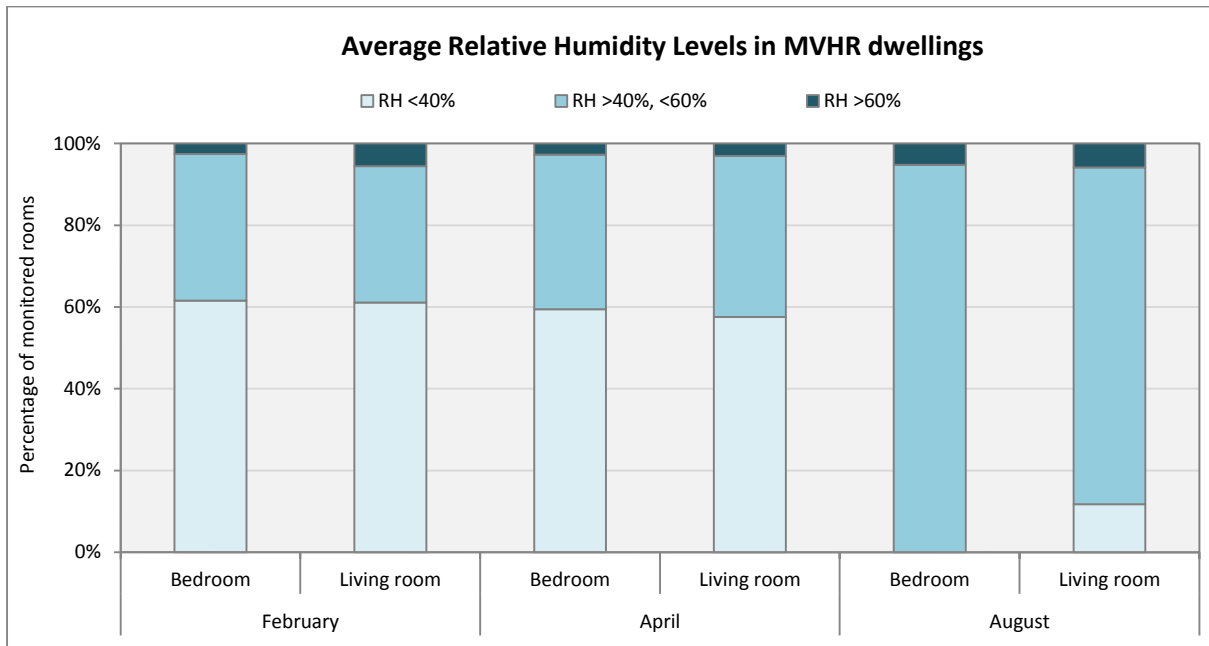
Figure 4.2g. Average relative humidity levels in dwellings with MVHR

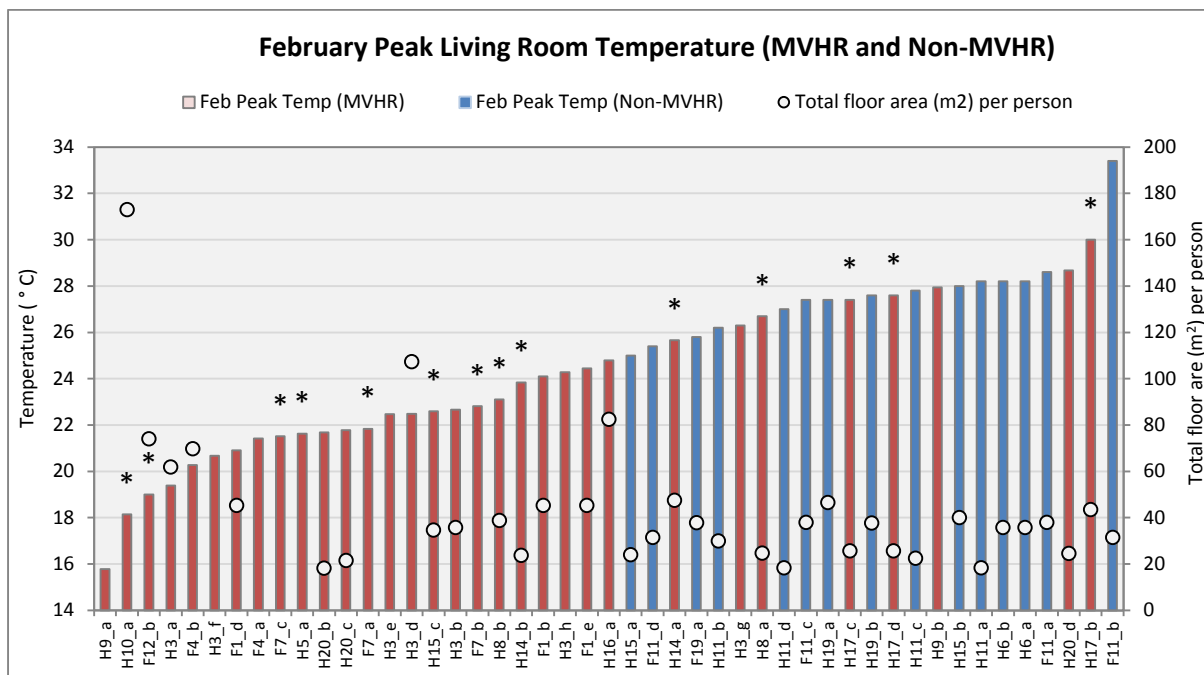
Figure 4.3a. Peak February living room temperatures in MVHR and Non MVHR homes
* Passivhaus dwellings

Correspondingly, an analysis of peak temperatures found higher levels in Non-MVHR dwellings when compared to MVHR dwellings. This trend was most evident in the monitored living rooms during February, (Figure 4.3a). Higher average and peak temperatures during February in Non-MVHR dwellings may be attributed to a number of factors, including oversizing of heating systems in Non-MVHR homes or a lack of awareness of the post heater (where available) in the dwellings with MVHR systems. Average temperatures in MVHR dwellings were closed to the expected norms, so this suggests a tendency for overheating in non-MVHR dwellings. Nevertheless, incidences of high temperatures were also observed in MVHR dwellings.

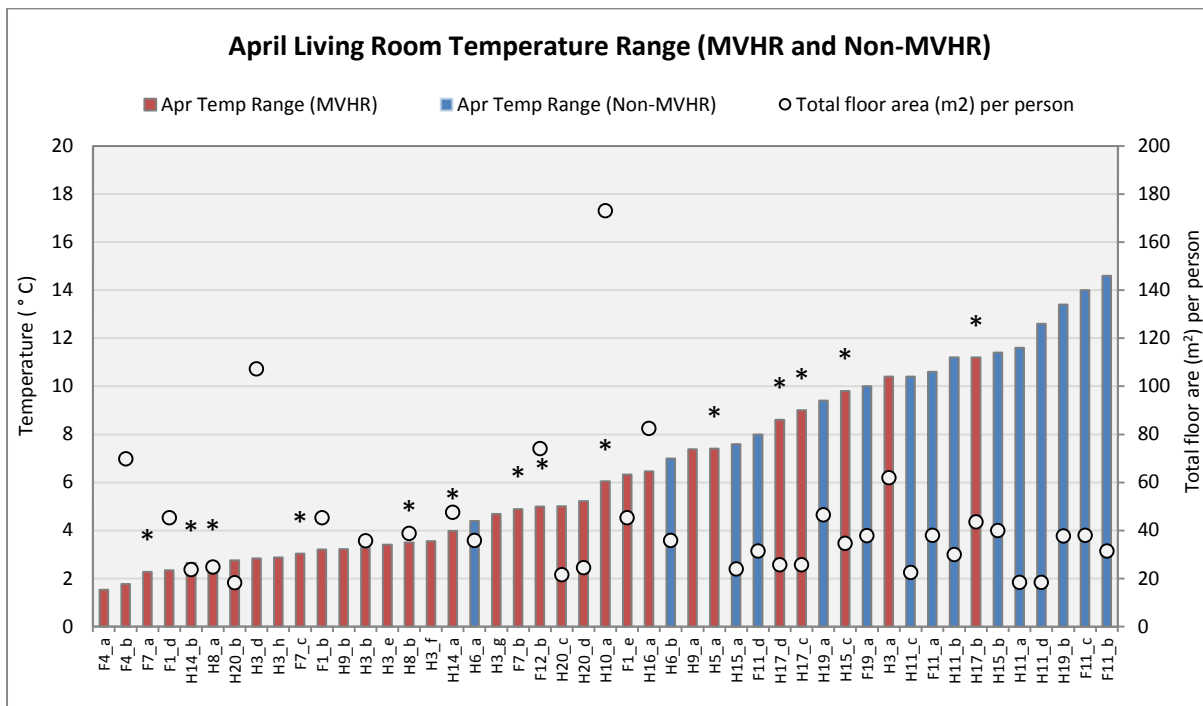
Figure 4.3b. Range of April living room temperatures in MVHR and Non MVHR homes
* Passivhaus dwellings

As with the data on relative humidity, an apparent trend is for houses with MVHR systems to have greater temperature stability, with a greater dispersion of indoor hydrothermal conditions found in dwellings without MVHR systems. For example, Figures 4.3b and 4.3c present the range of living room temperatures during April and August months. Despite the small sample size and uneven sample numbers, the tendency towards lower temperature ranges in MVHR dwellings is clear.

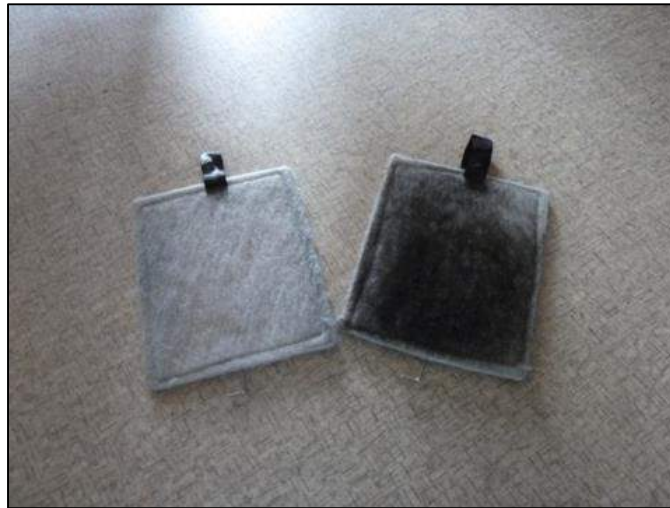
Figure 6.2a. Filter condition

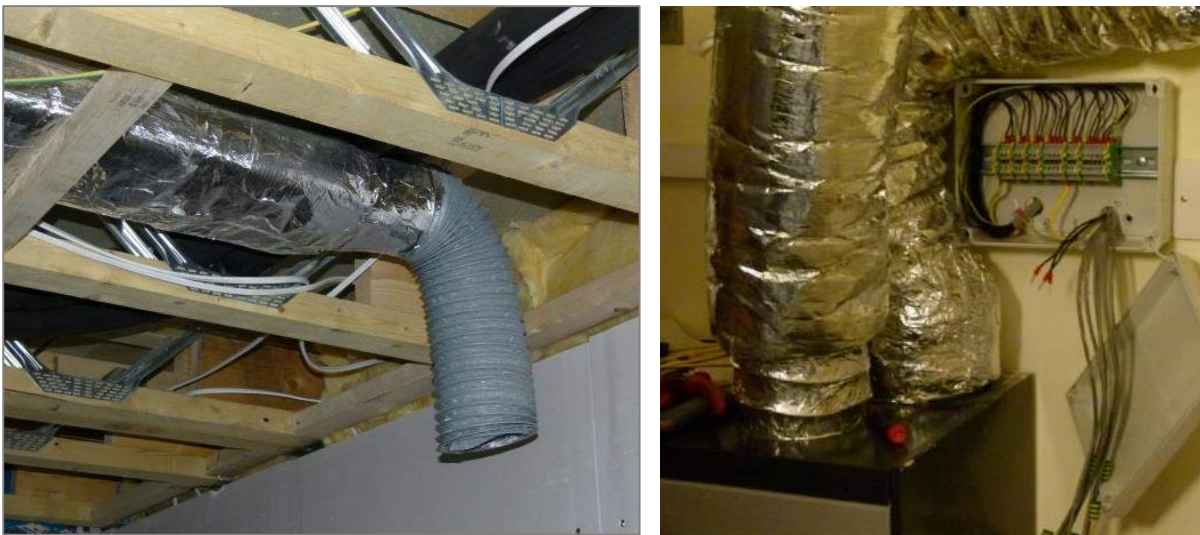
Figure 6.3b. Rigid rectangular ducting and flexible ducting to MVHR unit. Panflex acoustic attenuators employed.

A key technology is the use of an MVHR system. The chosen unit is a Paul Focus 200 system, which supplies air via rectangular ducts. The MVHR supplier recommended Lindab push-fit galvanised steel spiral wound ducting to make installation simple, avoiding the need for mastic and taping, and to minimise leakage, however the M&E Sub-contractor chose a less expensive plastic system, employing a mix of 204x60mm low profile rectangular and 125mm \varnothing circular rigid ducts. Duct joints were sealed with mastic and where necessary tape – access was often difficult, making the task time-consuming, and with high risk of a leak. Flexible ductwork was introduced wherever direct alignment was not possible. The flexible duct was not extended, and thus would introduce significant pressure losses. In particular, flexible ductwork was used in connecting to the MVHR unit, and through walls to the supply and extract terminals.

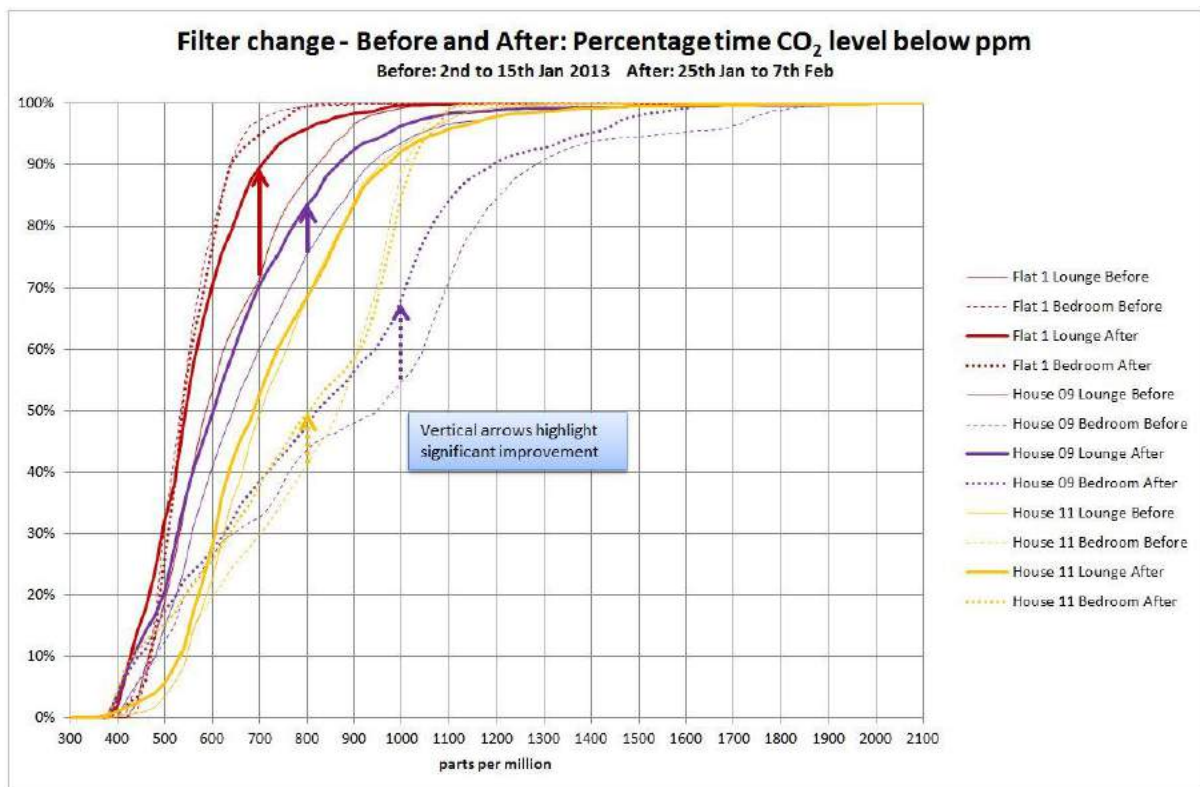
Figure 6.3g. CO₂ levels before and after filter changes
